Safety Alert 016 - ANP/SSM

High pressure gas release and fire following gas-lift line loss of integrity

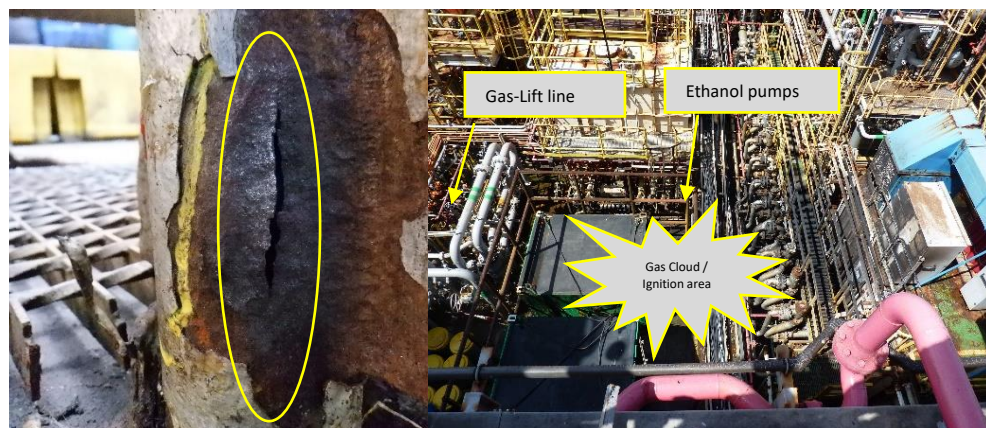
There was an emergency shutdown caused by the use of inadequate compressed air network – instead of the air supply line, the operator used the deluge instrumentation circuit to connect cleaning equipment. It is believed that, during the process plant ramp-up, the reopening of a SDV in the gas-lift line induced a sudden pressure rise in the line, which led to its rupture, generating loss of containment. A gas cloud was formed and then ignited, generating a fire that activated the platform's deluge system. The ignition source was not identified; however, the investigation points out as more likely the presence of a non-ATEX refrigerated container installed in a classified area. The initial event caused residual fire spots that were controlled by the Emergency Response Team. There were no injuries.

Figures 1 and 2 – Gas-lift line rupture point

- Poor integrity of the high-pressure gas line, due to:
 - Inadequate inspection techniques and frequency, and
 - Inadequate management of RTI (Technical Inspection Recommendations) process, with loss of traceability and control of actions in occasion of the operator change.

- Hammer effect in the gas lift line due to pressure differential, caused by:
 - Lack of integrity of check-valves and maintenance plan for the air and gas check-valves, and

- Start-up procedure that does not consider the pressure evaluation across SDV before realignment.
 - Inadequate design that allowed unnecessary opening of *blowdown valves* – BDVs – during the emergency stop, which led – along with the lack of tightness of the check-valves – to the depressurization of the gas-lift header, creating conditions for the occurrence of the hammer effect in the plant start-up;

- Ensure minimum pipe thickness measurement procedures with clear instructions about the amount and locations of measurement points and risk criteria for operation.

- Establish plans and procedures for inspection, testing and maintenance that are compatible with the risks of the installation, including check-valves.
