## *Alerta de Segurança 018 - ANP/SSM*

### *Gas-lift line rupture followed by gas leak*

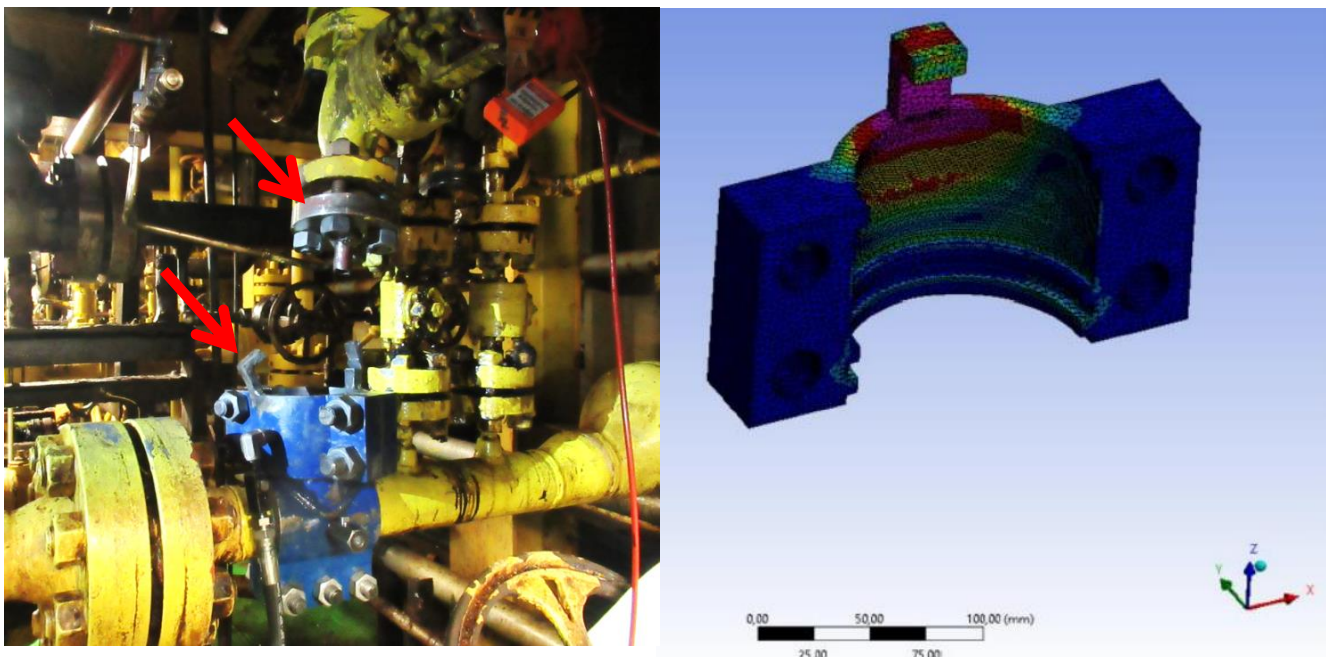
To resume operations of a production well, an engineering solution was proposed: repair a discontinuity in a gas-lift line by installing a clamp. During the installation of this device, manufactured by a specialized company, it was found that it was not properly dimensioned. To complete the device installation, an adjustment and welding of new interlocked clamp was carried out on board. During its commissioning, this new anchorage system did not withstand the efforts during the operational test, performed with gradual pressurization of the 3" line of gas-lift, using natural gas, to monitor possible leaks. After 5 hours of testing, at the level of 120 bar of pressure, the loss of watertightness occurred, with the rupture of the gas-lift line and release of almost 1670 kg of natural gas.

Figures 1 and 2 – Anchorage failure points

- Adjustment performed onboard to allow device installation without Management of Change (MOC);
- Failure to not detail the procedure for carrying out the operational tests;
- Low risk perception since repair type selection, field adjustments and the execution of clamp commissioning;
- Inadequate design for device manufacturing (clamp);
- Failure in contractor management: needed to perform a QA/QC of the clamp before its use and failure to receive the adjusted design;
- Failure to depressurize the GL line.

- Do not manufacture or modify parts onboard, including metallic clamps, without qualified professional approval, project, and material quality certificate/traceability.  
Note: the recommendation arising from the investigation of the explosion accident occurred on 02/11/2015 at FPSO Cidade de São Mateus CDSM\_R35 – "Do not *manufacture on board parts, including rackets, that require material quality certificates*".
- Consult MOC procedure for any process and/or equipment change needed onboard;
- Consider the associated risks and control measures before performing functional tests with process fluids – Check the possibility to use non-flammable fluids (e.g.: inert gas | water) and other available engineering solutions.
- Repair selection shall consider reliability and proper risk management.
