Safety Alert 019 - ANP/SSM

Discharge through the DHSV function control line, at the WCT, during rig intervention

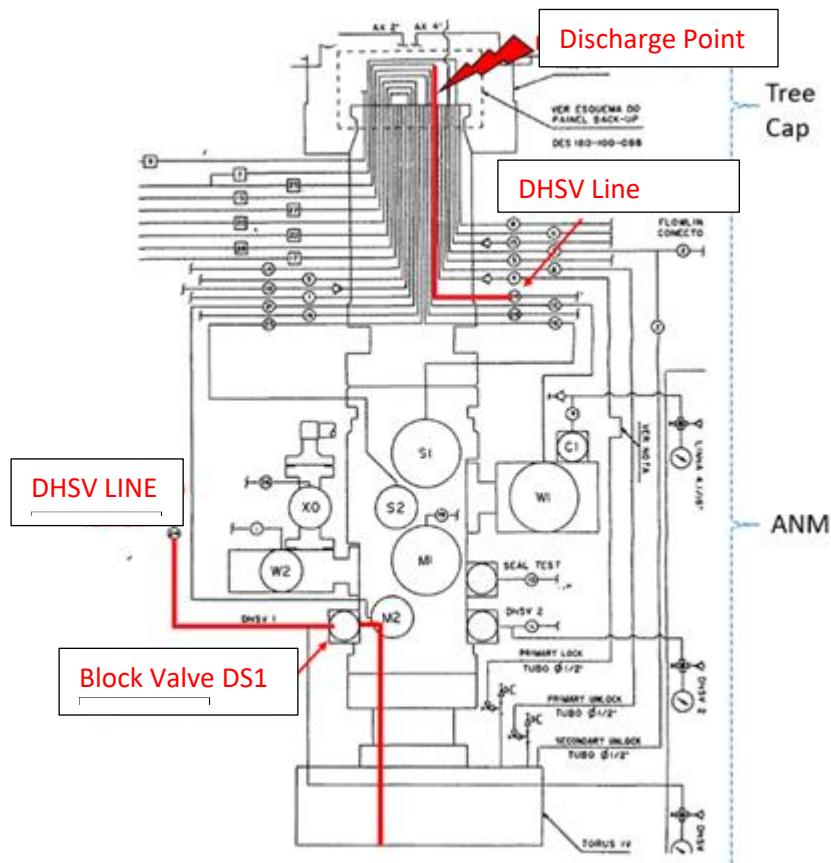
Discharge of a mixture of hydrocarbon plus produced water, through the control line of the DHSV function, during the permanent abandonment operation of the well with rig intervention.

- Step of laying the Tree Installation Tool (TIT) on the Tree Cap: during the repositioning of the Tree Cap panel, due to a mechanical interference generated by the TIT being laid on the Tree Cap, there was a rupture in the control line of the DHSV function and fault in the corresponding lock valve, resulting in the discharge of the mixture into the sea.
- After Tree Cap disconnection: the discharge continued through the top of the WCT (tree manifold), remaining until the Installation Tool (TIT) was reconnected on the WCT.

WCT and Tree-Cap hydraulic diagram: fluid discharge circuit in red.

- Lack of seal of the DHSV control line (below the Tubing Hanger):
 - Deficiency of the downhole control line installation execution procedure in 2004.
- Lack of integrity of the production Column and Gas Lift Valve, establishing column x annular communication:
 - Failure in the process of design, manufacture and qualification of the Lift Gas Valve.
 - Deficiency of the well component integrity management process.
- Impossibility of closing the DS1 block valve (referring to the DHSV1 function) on the WCT panel:
 - Failure in the qualification process for new services: injection of sealant fluid through subsea equipment.
 - Failure in the change management process: injection of sealant fluid through subsea equipment.
 - Failure in the subsea equipment design/manufacturing process.
- Tree Cap instrumentation line damage.

Note: the discharge would occur even if the Tree Cap was not damaged, this event increased the severity of the discharge:

- Execute the production and injection column integrity management process;
- Qualify subsea equipment and services;
- Execute the change management process when identifying scope change and/or expected project condition;

- Use international standards, best practices and technical requirements to design subsea and well equipment and execute the rig anchoring project;
- Perform leakage risk assessment of downhole lines in the well intervention planning phase;
