Safety Alert 004 - ANP/SSM Fall of hoisting assembly due to failure of drilling drawworks

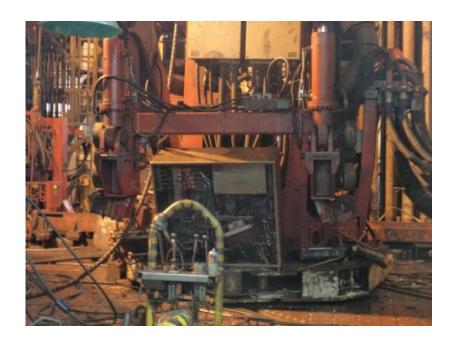
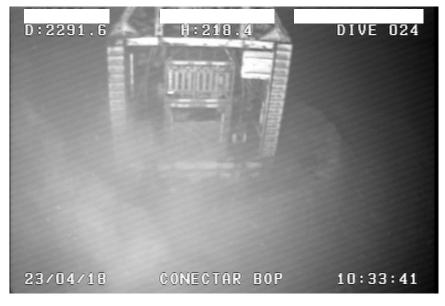
During normal operations running BOP (*blowout preventer*) with marine riser on an offshore drilling unit with dynamic positioning, occurred the unrestrained descent of the hoisting assembly (traveling block and top drive). The load came to a complete stop upon the top drive colliding on the drill floor (rotary table), remaining two thirds of the BOP below the mudline. There was no point of rupture in the marine riser string.

- Maintenance management failure;
- Contamination of disc brake with oily substance.

The accident root cause pointed by the operator investigation was the failure of the drilling unit team in NOT following the original equipment manufacturer instructions for tests, inspections and maintenance tasks.

- Critical equipment for operational safety shall in accordance with item 2.5.1 of Chapter I of SGSO, stablished by ANP Resolution no. 43/2007 or supervening.
- The maintenance plan of the drilling unit shall be corrected in order to better reflect the original equipment manufacturer guidelines.
