Safety Alert 005 - ANP/SSM

Well Barrier Elements Failure

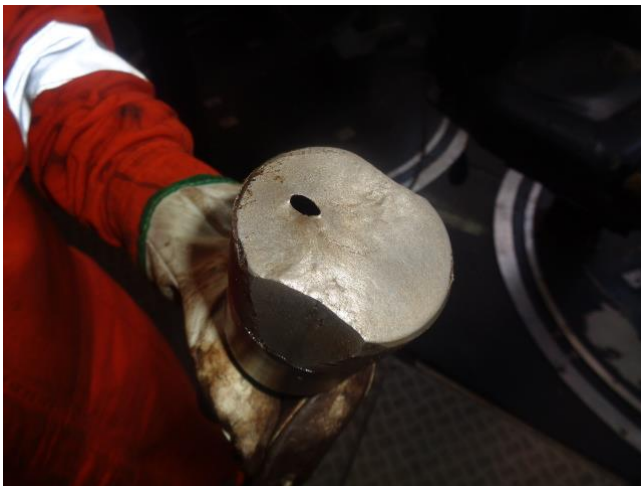
Throughout an offshore 1454 m water depth non-natural flow well abandonment intervention in Campos Basin, an oil leak around subsea equipment was observed while a DHSV test was attempted. The through tubing operation with slick line/wireline to drift the tubing using lead impression block, down hole video (DHV) and caliper multifinger proved a tubing collapsed above DHSV region, characterizing failure in the well barrier envelope.

Figure 1 – Lead impression block with lateral mark

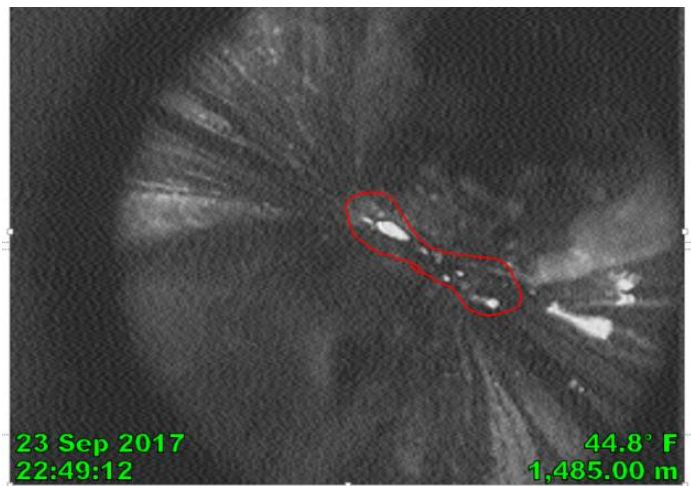
Figure 2 – DHV image

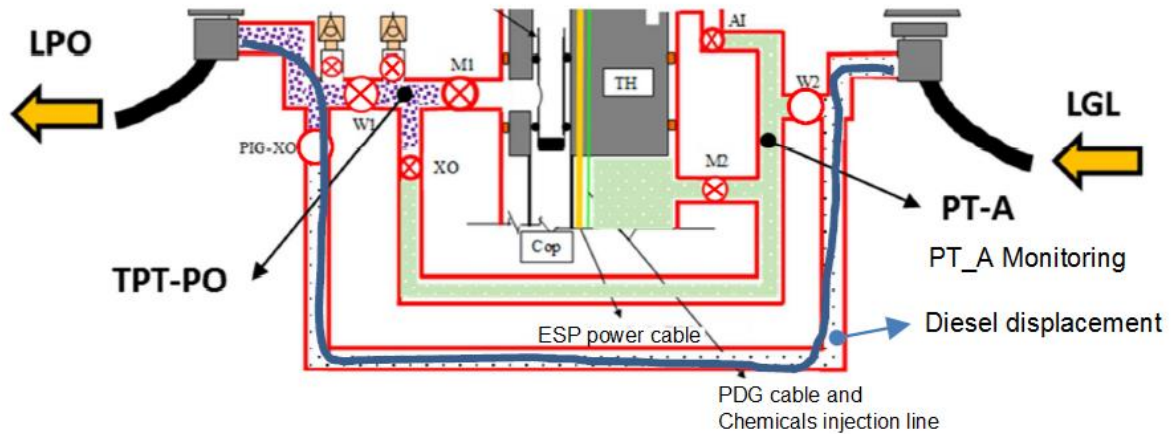
The immediate cause for the failure was a collapse chain reaction in the surface casing, production casing and tubing above DHSV, due to pack-off failure. The last was caused by Annulus A exposure to gas lift line pressure during a diesel displacement operation to prevent hydrates formation in the production line. For this displacement, it was necessary to open the W2 valve in the subsea christmas tree.

The figure below shows the **foreseen** scheme for diesel circulation, with M2 valve closed:

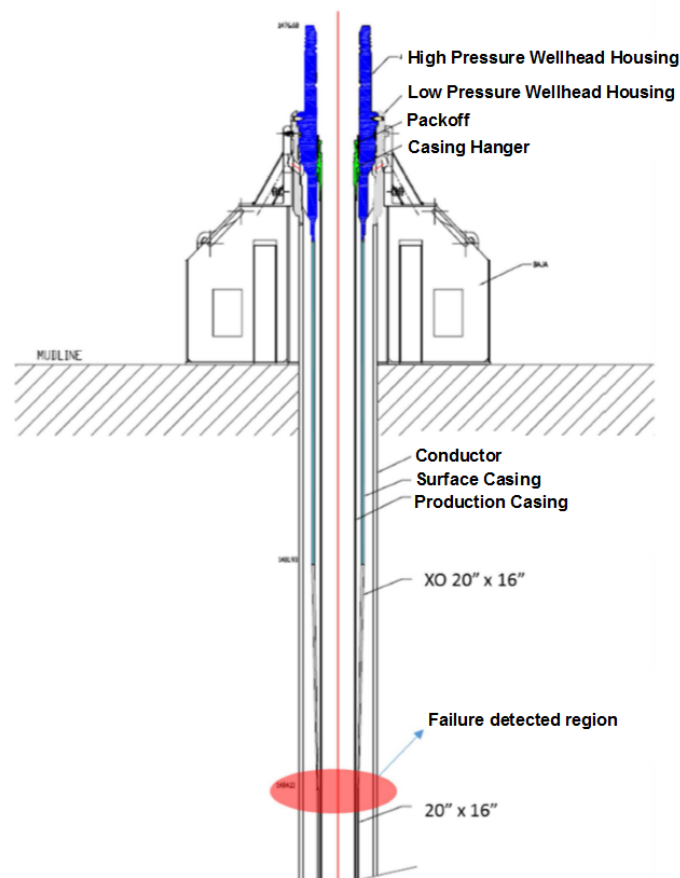
Due to an operational error, the W2 valve was opened without previous closing of M2 valve. Thus, there was unintended pressure connection between the gas lift line and Annulus A, which was depressurized. Subsequently, the pack-off that isolates the Annulus B and Annulus A failed, communicating the two annuluses, which equalized the pressures:

This pressure equalization led to casing collapse due to a loading that generated a stress level above the design limits.

- Establish systematic loading analysis prior to well annulus-depressurizing operations, in order to verify pack-off stress.
- Use supplementary pack-off locking devices, in order to increase design reliability and robustness.
