Safety Alert 006 - ANP/SSM Abnormal Well Head Inclination

The Operational Safety and Environment Superintendency is issuing this safety alert to notify the oil and gas industry and other stakeholders about an abnormal inclination found in a pre-salt well.

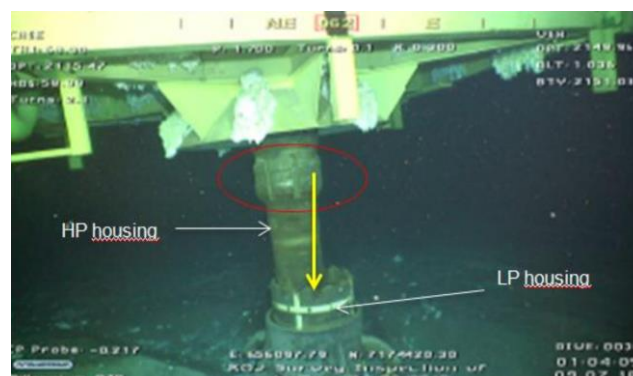
During a routine subsea ROV (Remote Operated Vehicle) survey in July 2018 it was detected an **abnormal inclination around 3°** in the High Pressure Well Head Housing (HPWHH), based on the bull's eye readings, disengagement from the Low Pressure Well Head Housing (LPWHH) of approximately 1.5 m, and seabed deformation around the subsea foundation. Later, it was installed a precision sensor and a **4.9° inclination** was observed.

Figure 1 - First inspection of ROVs. HPWHH disengaged from LPWHH and inclination

- Failure of the Connection between LP/HP housings;
- Wellhead foundation vertical movement;
- Failure of the well foundation;
- Absence of cement between 20" and formation, all the way to seabed.

- Wellhead and well foundation design: The features of the well foundation did not provide enough axial resistance to maintain its structural aspect;
- Santos Basin geotechnical conditions unsuitable for deployment of so-called torpedo conductor;
- Fatigue cycle on well foundation induced by a long shutdown, possibly generates a movement of the assembly of casings;
- Cementing practice implemented: the cementing job of the 20" casing did not reach the torpedo base, what would have added structural reinforcement to the assembly.

- Evaluate the well architecture options as per the local specificities (for example the use of torpedo conductor vs. soil characteristics);
- Assess potential operational events (for example the impact on the well foundation if slurry does not reach seabed during the 20" casing cement job);
- The importance of performing a ROV survey of the subsea assets as soon as possible after transfer of operatorship;
