Safety Alert 009 - ANP/SSM

Production Riser Parted During Leak Test

The Superintendence of Operational Safety and Environment is issuing this safety alert to notify the petroleum and gas industry and other stakeholders about riser rupture during a leak test due to severe corrosion of the tensile armour wires.

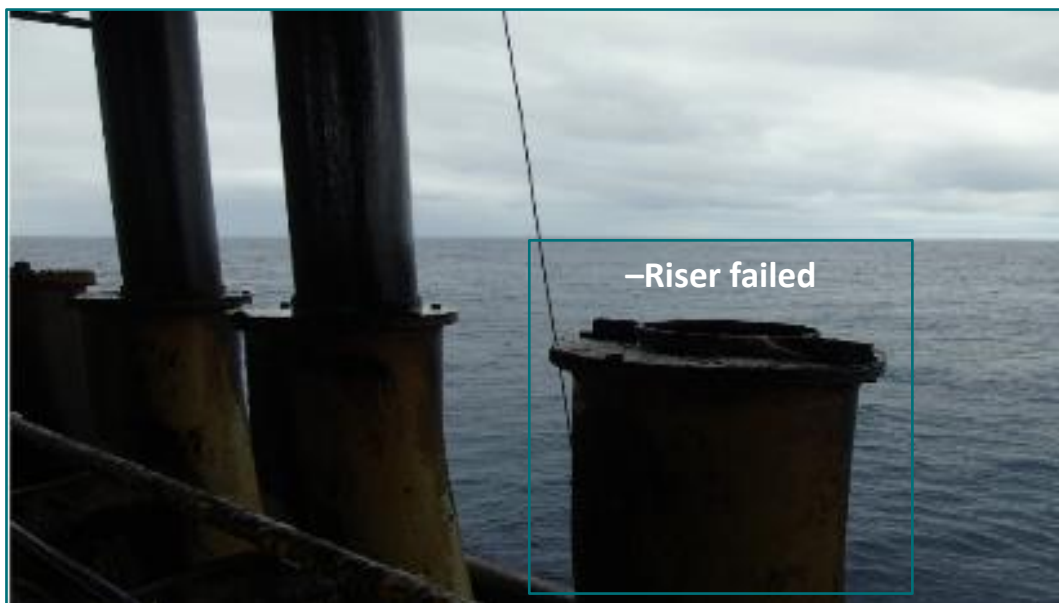
On April 7th, 2020, at 09:36 am, a leak test was being carried out in a subsea pipeline that connects two platforms, consisting of flexible lines (risers) and rigid lines (flowline). The job consisted of replacing the rigid line (flowline) and the leak test was a requirement for its installation. It was planned to leak test up to 136 bar. When reaching 124 bar, a strong noise and vibration on the Platform was noticed, and the pressure dropped to 0 bar. It was observed that the riser ruptured just below the end fitting (connection between the riser with the export line valves in the cellar deck floor). The flexible riser parted and fell inside the I-tube.

Figure 1 - Location of the I-tube of the ruptured riser (spider deck)

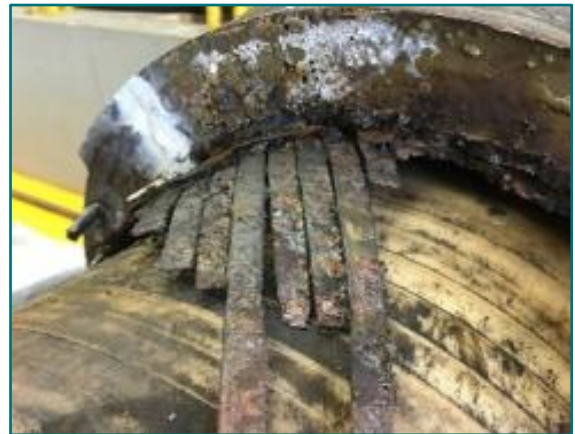
- Immediate Cause: Severe corrosion of the tensile armour wires due to oxygen in the riser annulus. This failure mode was not known by the industry until this event.

- Root Cause: Gas relief valves (GRV), which relieve internal pressure and prevent the return of atmospheric air, were not installed on the riser annulus vent system lines during platform construction, commissioning and operations phases, not complying with project criteria, which enabled ingress of oxygen into the annulus area.

Figure 3 – Severe corrosion of the riser end fitting tensile armour wires

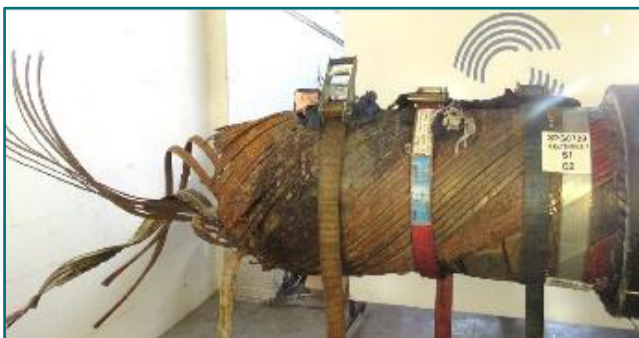
Figure 4 – Severe corrosion of the tensile armour at the end of ruptured riser section

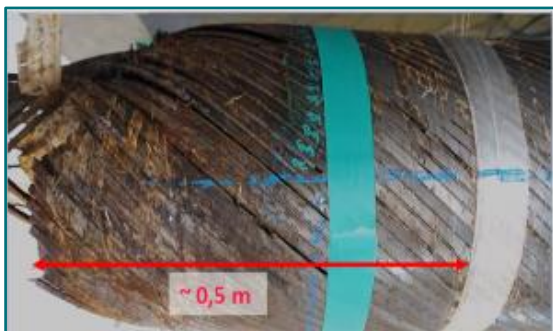
Figure 5 – Severe corrosion of the tensile armour at the end of ruptured riser section (~0,5m)

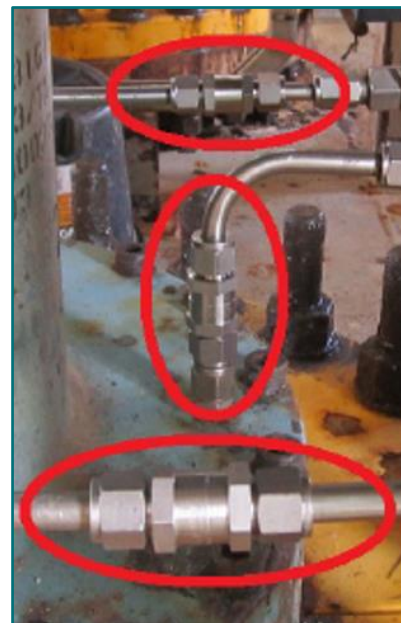
Figure 6 – GRVs installed on the riser annulus vent system lines after the incident

- Address to Projects the importance of Quality Assurance and Control (QA/QC) during the project execution;
- Fabrication and Installation:
 - Assure the establishment of risers' vent system as per project design;
