**anp**  
Agência Nacional  
do Petróleo,  
Gás Natural e Biocombustíveis

## *Safety Alert 013 - ANP/SSM Significant fire in onshore field*

This Operational Safety and Environment Superintendence alerts the oil, gas industry and other stakeholders about the occurrence of significant fire in an onshore field.

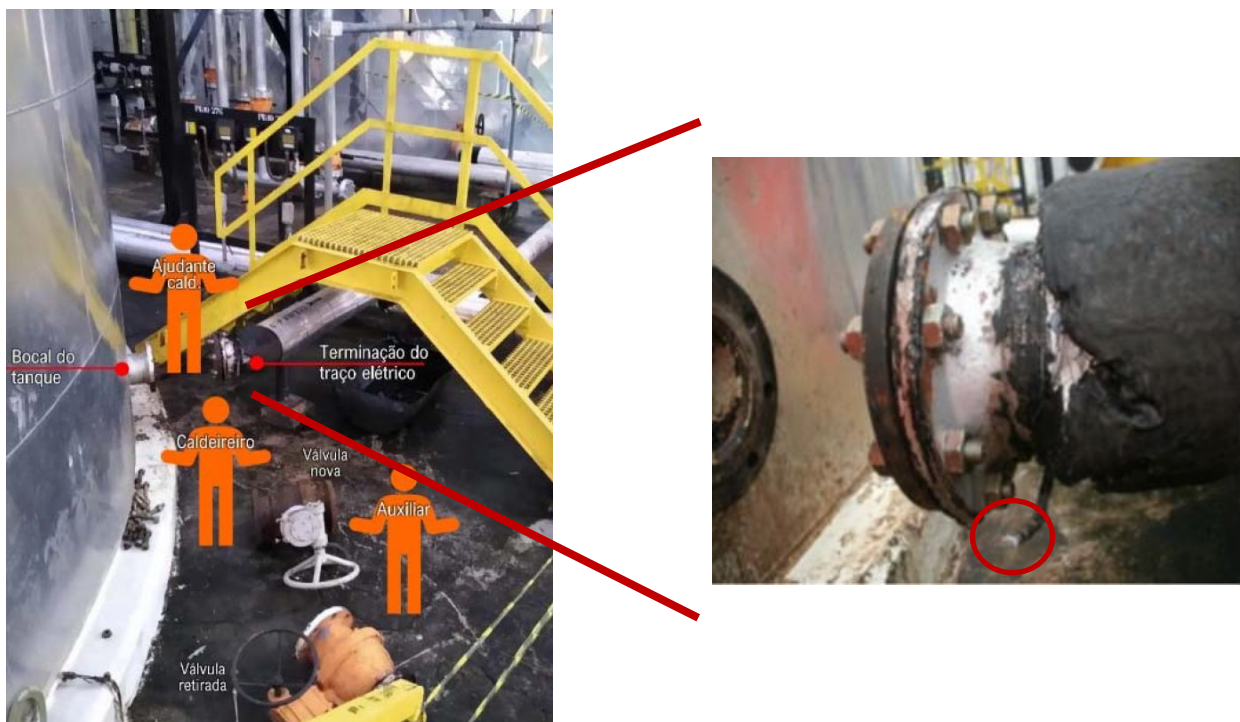
**Figure 1 - Layout of the location and highlight for the electrical trace.**

During the execution of cold service for the replacement of the oil inlet and outlet valves in a production tank of the collecting station there was a flash in the nozzle where the oil outlet valve was being replaced. With this, there was release of inflammable vapors that after contact with an ignition source led to a fire, hitting the worker and his helper. Figure 1 shows the diagram of the accident site during the service execution.

The fuel that fed the flash came from inside the tank, which has been drained, but at a temperature of 40°C and with oil residual content. After valve removal, the vapor phase leaked to the atmosphere through the nozzle, generating an explosive atmosphere, even in an open area.

The ignition source identified as most likely was the electrical energy from the electrical trace installed in the pipe, highlighted on the right in Figure 1. After inspection and comparison with the design, it

was identified that the electrical trace assembly was incomplete, without the termination indicated by the manufacturer, most probably generating the necessary spark for igniting the flammable mixture formed by the fuel flowing from the tank. According to reports, the electrical tracing system was functioning during the intervention.

- Reassess risks related to cold work in open areas;
- Improve the systematics of work permits and release of equipment for intervention;
- Follow engineering standards and good practices.
