Safety Alert 014 - ANP/SSM

Drilling column cutting by spurious actuation of BOP blind shear ram

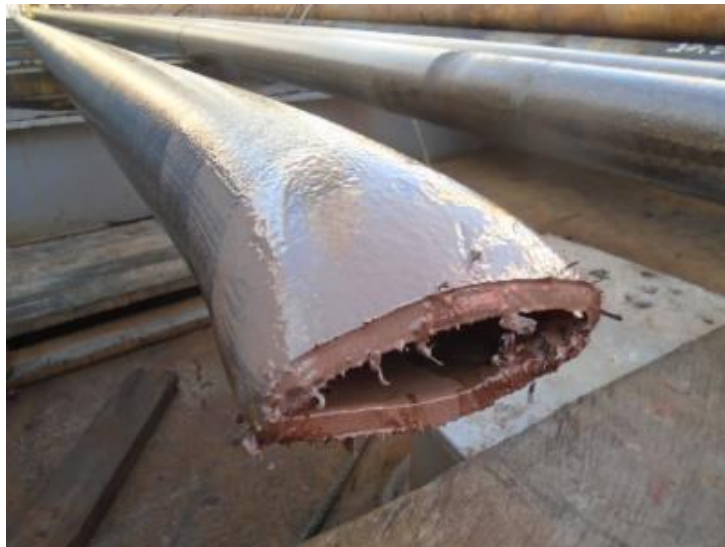
During the drilling of phase 4 of an offshore well, the drilling column was cut due to the spurious actuation of the upper blind shear ram of the subsea Blowout Preventer (BOP). After the event, alarms and loss of communication with the Subsea Electronic Module B (SEM "B") of the yellow pod were verified. There was no record of the shear blind ram activation in the BOP event log. Figure 1 shows how the upper end of the column looked after cutting:

Figure 1 - Top end of the cutted column.

- The investigation determined as the most probable cause for spurious activation, contamination and corrosion on the electronic plates of the yellow pod SEM "B", even though it was inactive at the time of the event. Corrosion damage and moisture contamination were identified on the connectors plates and pins, for both SEMs of the yellow pod.
- Contamination and corrosion were considered as consequences of deficiencies in the BOP maintenance execution and management.

- Establish a humidity control routine of BOP electronic modules in the company's maintenance plan.
- Establish detailed inspection routine of BOP electronic components in the company's maintenance plan.

Note: to perform a detailed inspection it is necessary to perform it in a place with good light and magnifying lens (or camera zoom). In this incident, the plates were inspected in the moon pool, but it was not possible to notice abnormalities in the components. Only after detailed inspection in the subsea workshop was it possible to identify the presence of contamination and corrosion in the electronic components.
