**INVESTIGATION REPORT OF THE  
EXPLOSION INCIDENT OCCURRED ON  
11/02/2015 IN THE FPSO CIDADE DE SÃO  
MATEUS**

**anp**  
Agência Nacional  
do Petróleo,  
Gás Natural e Biocombustíveis

**Safety and Environment Department**

**August/2015**

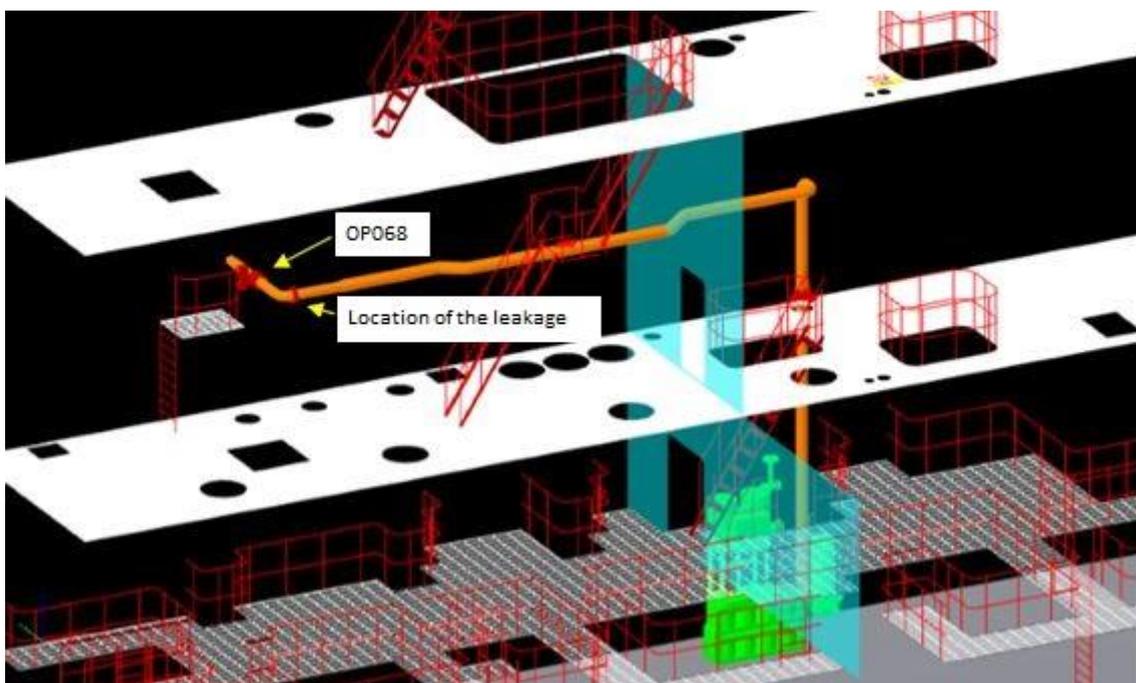
The leakage point was a flange located upstream of a valve (PB-068), connected directly to the tank bombordo slop (slop P), the fourth level below the main deck. At this time, the leak occurred as fillet in a pool of a dark-colored liquid of approximately 2 m on the ground. Figure 2 shows the position of the OP-068 valve and the location of the leak. Figure 3 shows the flange where the leak occurred in photograph taken before the crash.

Figure 2 - Position of the OP-068 valve and location of the leak

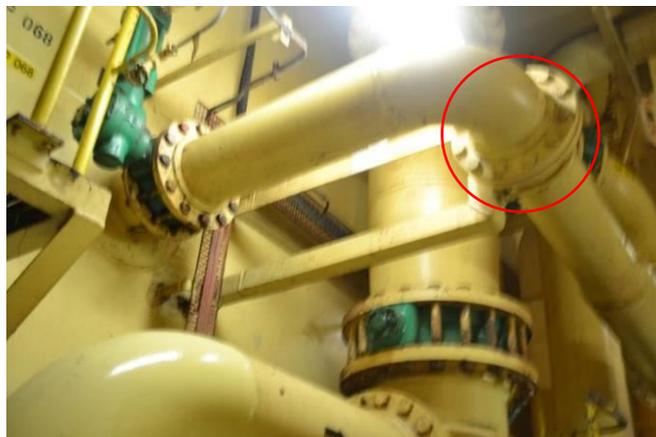
Figure 3 - Photo taken before the crash highlighting the flange where the leak occurred

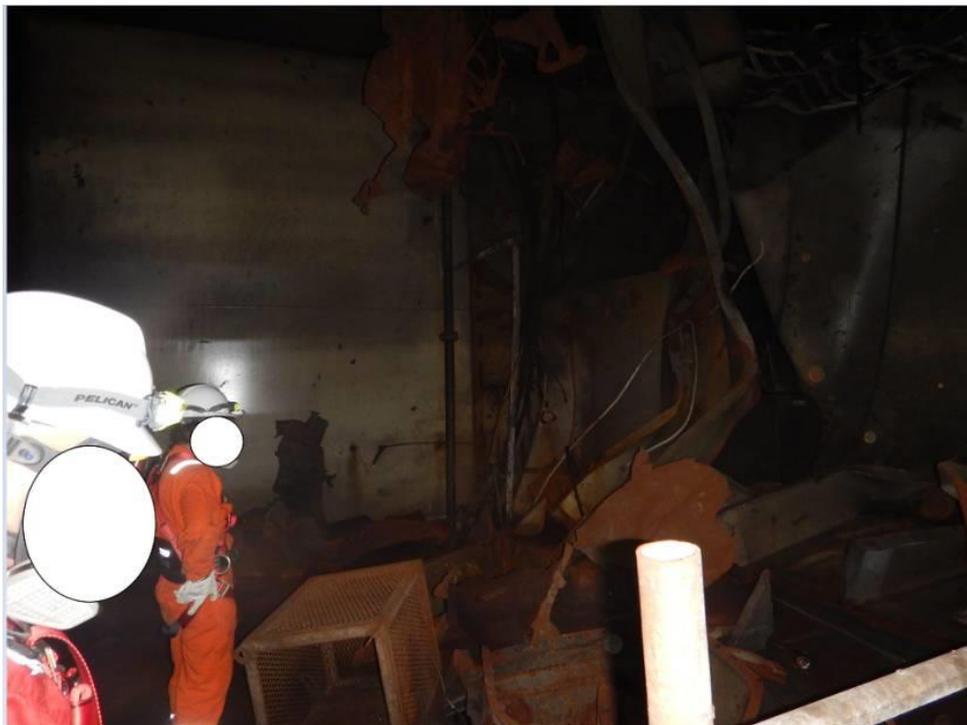
In the back of the pumps room, the pressure caused by the explosion broke the bulkhead between the pumps room and the engine room, causing destruction in this environment. The following figures show the damage caused to this area by the explosion.

Figure 5 - broken bulkhead between pumps room and engine room

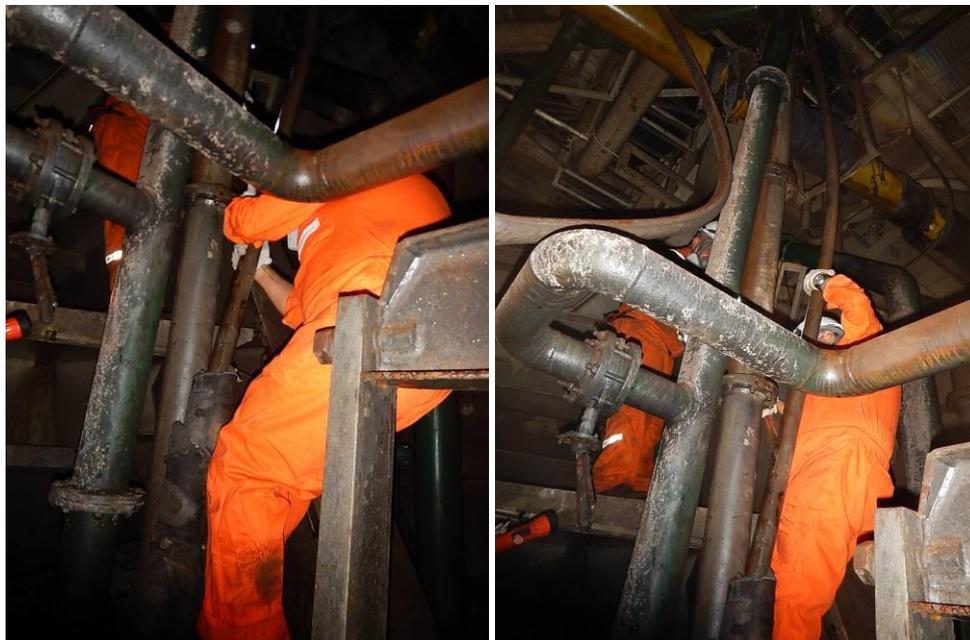
Figure 6 - Access to the area where, due to the explosion, there was communication between the engine room and the pumps room

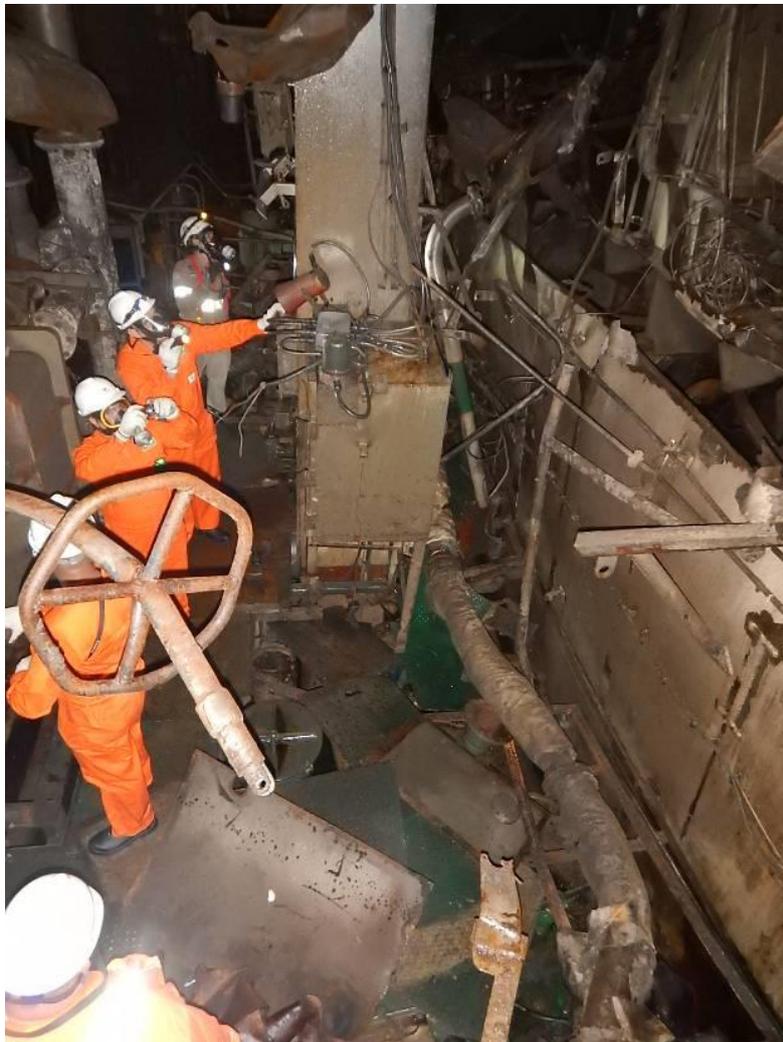
Figure 9 - Destruction caused by explosion

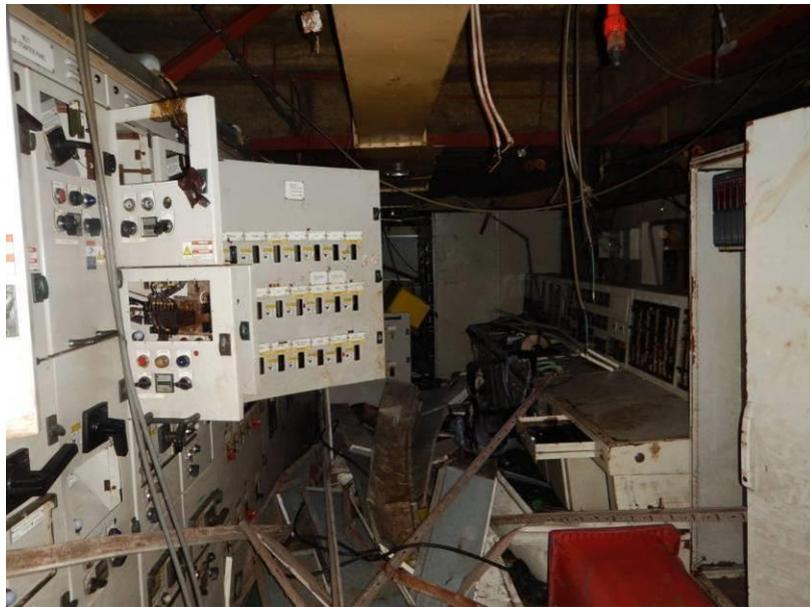
The pressure in the engine room caused the death of an operator of utilities which was located in the muster point in the engine control room (ECR). His body was only accessed and rescued around 0:00 on the day of 12.02.2015, shortly after the arrival of rescuers of the Body of Military FireFighters of Espírito Santo (CBMES). The following figures show the status of the engine room after the explosion.

Figure 10 - engine room control room (ECR) after explosion

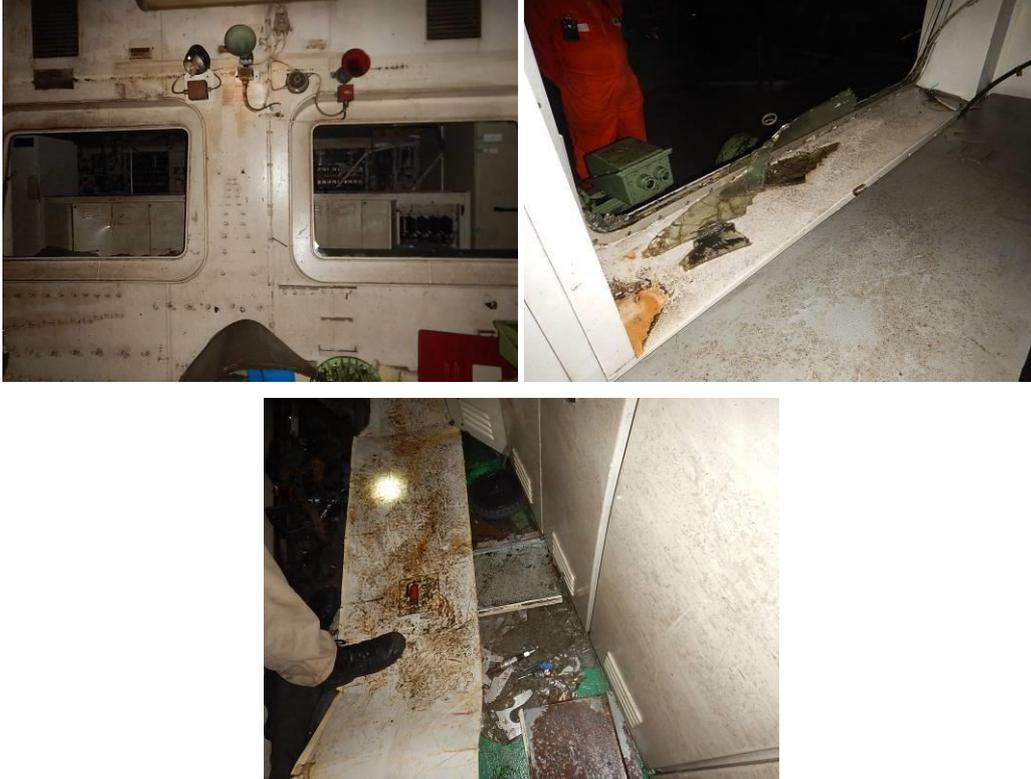
Figure 12 - ECR Windows (broken glass and shrapnel inside the room)

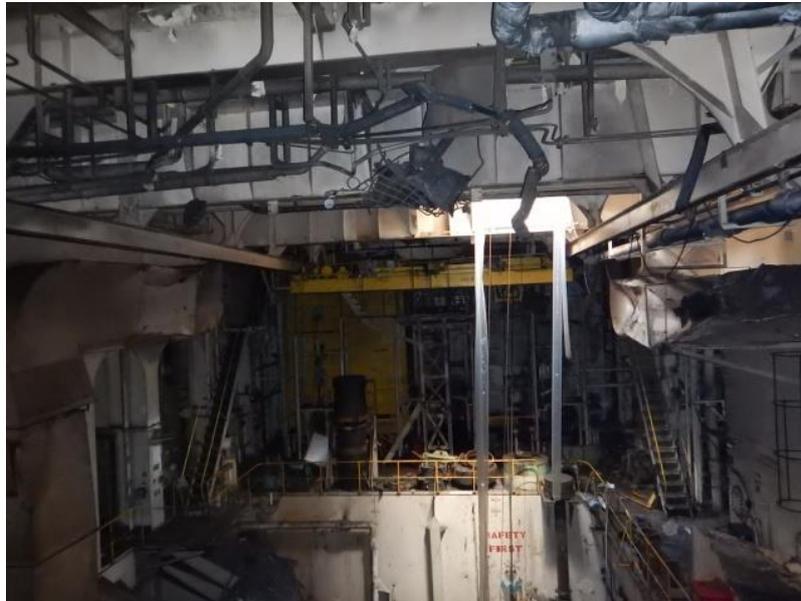
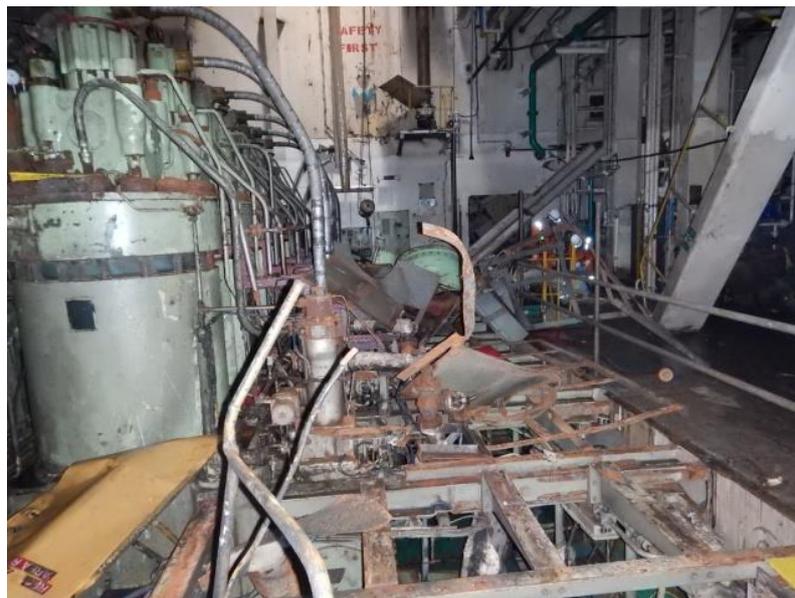
After the explosion, the unit incurred in blackout, and both the main power generation system and the emergency generator were affected. This fact can be attributed to the lack of protection forecast for this area of the unit.

Figure 13 – Machine rooms after the explosion

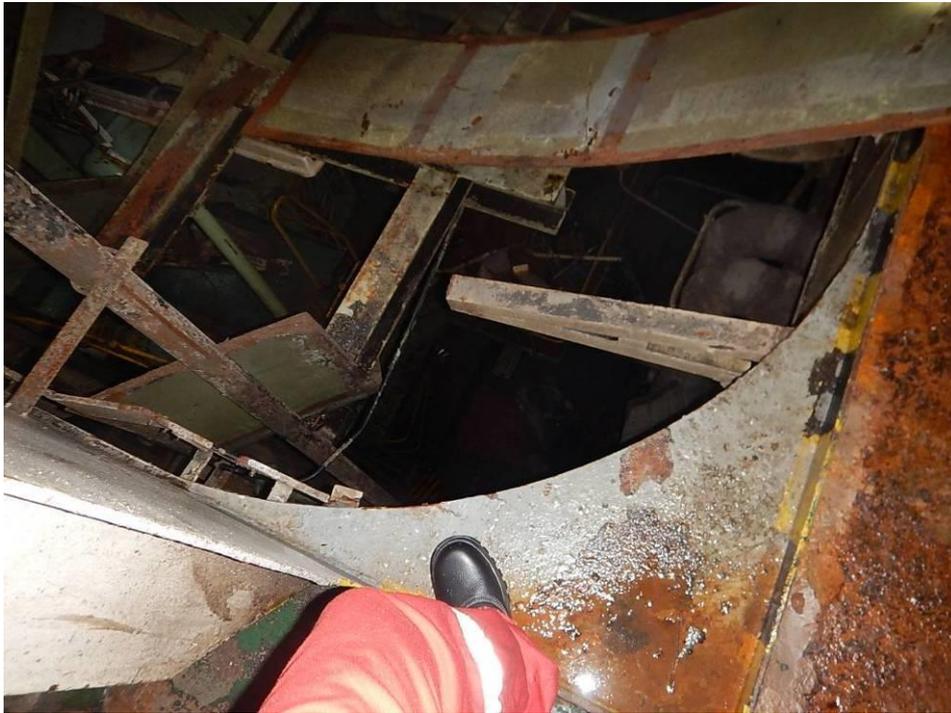
In the engine room it was found several damages, such as damaged engines, loose pieces of equipment, and also the bulkhead separating the pumps room and the engine room with an open tear dent due to the accident, large enough for people to cross. The control room of the the engine room impacted in curved walls, as well as the front door.

Figure 15 - Floor Part missing from in the outside of a room

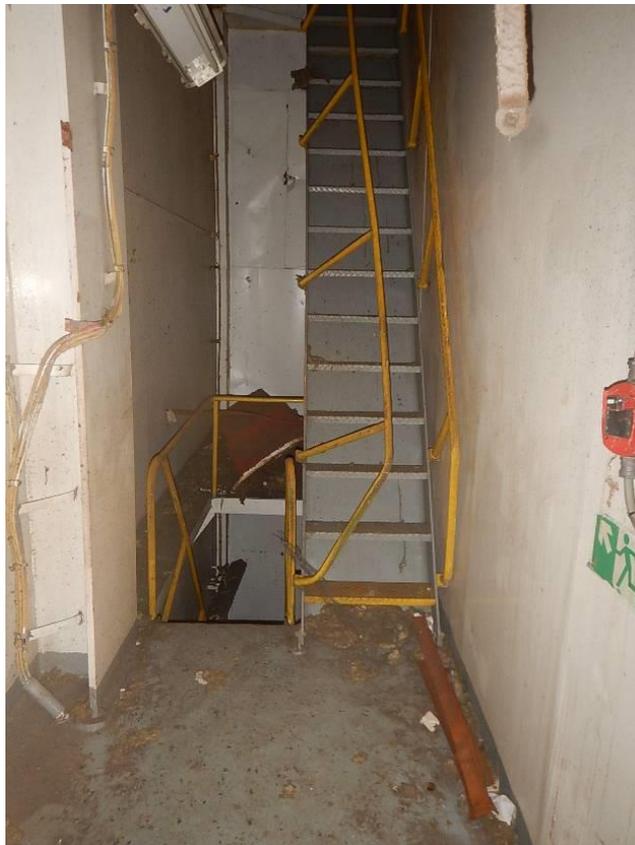
Figure 16 - area of the door adjacent to the maintenance workshop thrown back the stair in distance

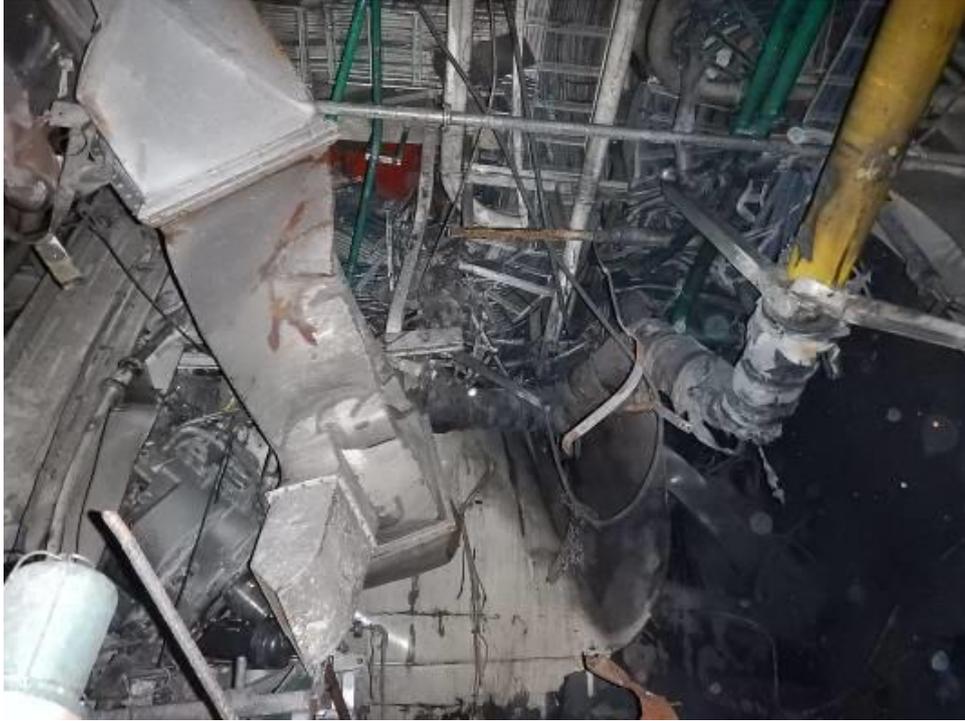
Figure 19 - hanging objects

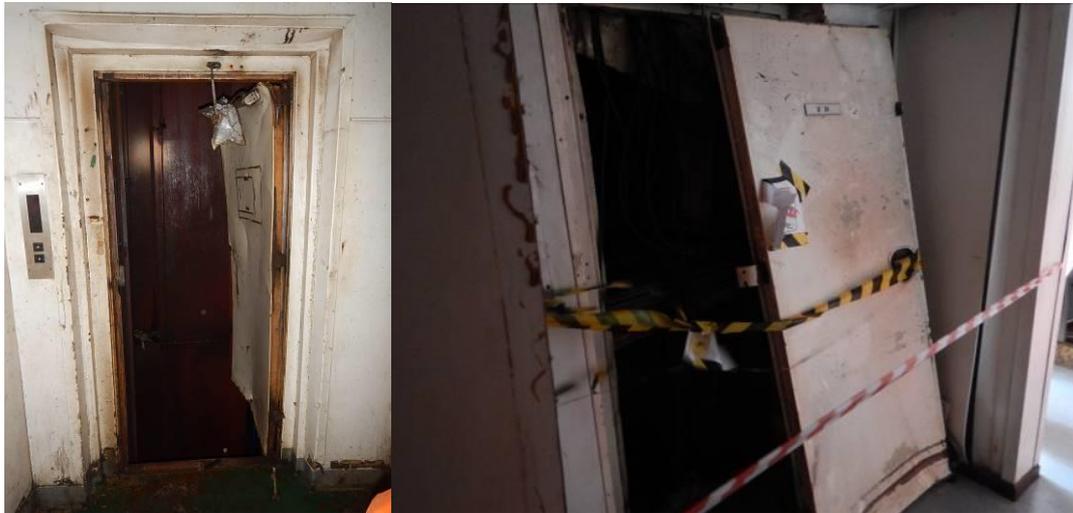
At the FPSO CDSM, the elevator linked decks between the engine room and the “D” level and it was thrown against the ceiling of the last ward on the top floor. It can be seen from Figure 20 that the square of the level of the elevator door machinery moved into the elevator shaft, unlike the other levels, in which the door moved out of the elevator.

Figure 20 - Elevator door in the engine room level (Left) and "D" level (right) after the explosion

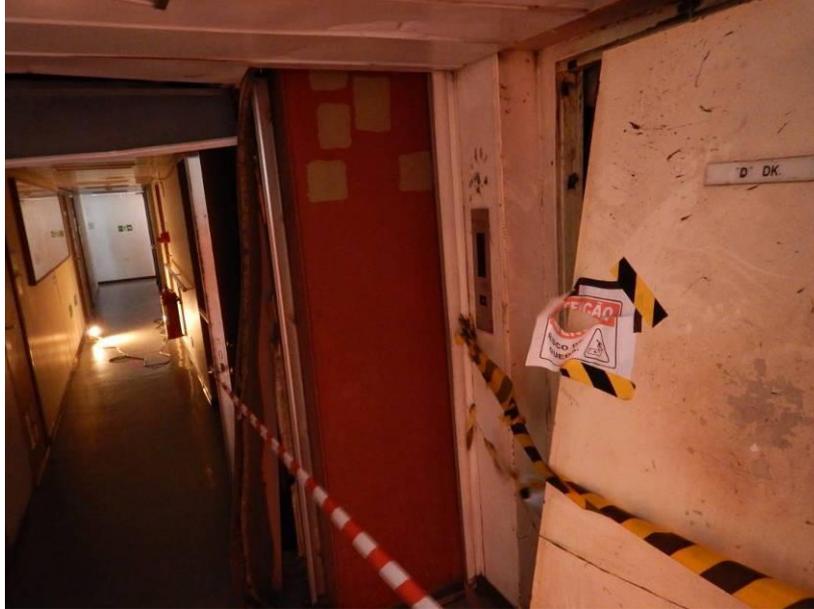
Figure 22 - Elevator door at the "D" deck after the explosion

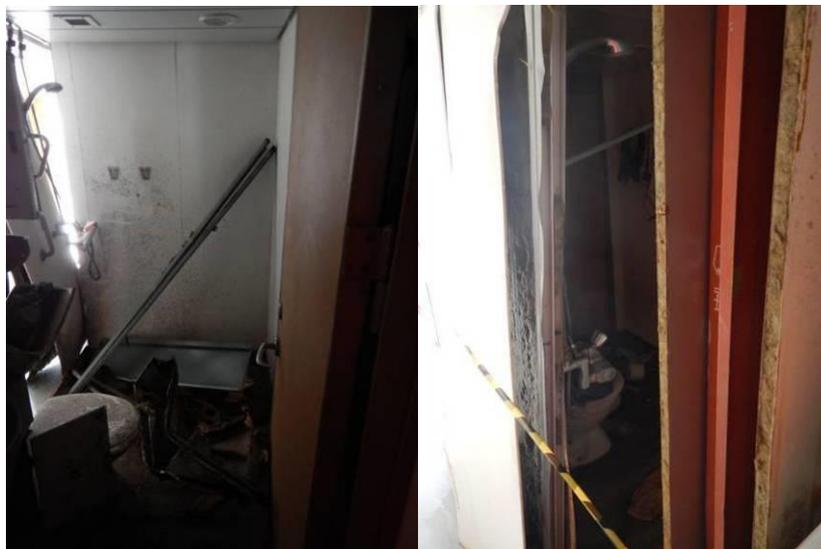
The region near the elevators also suffered damages in the explosion. Figure 23 shows damage to a box in level "D" of the unit.

Figure 23 - Cabin in front of the elevator door after the explosion

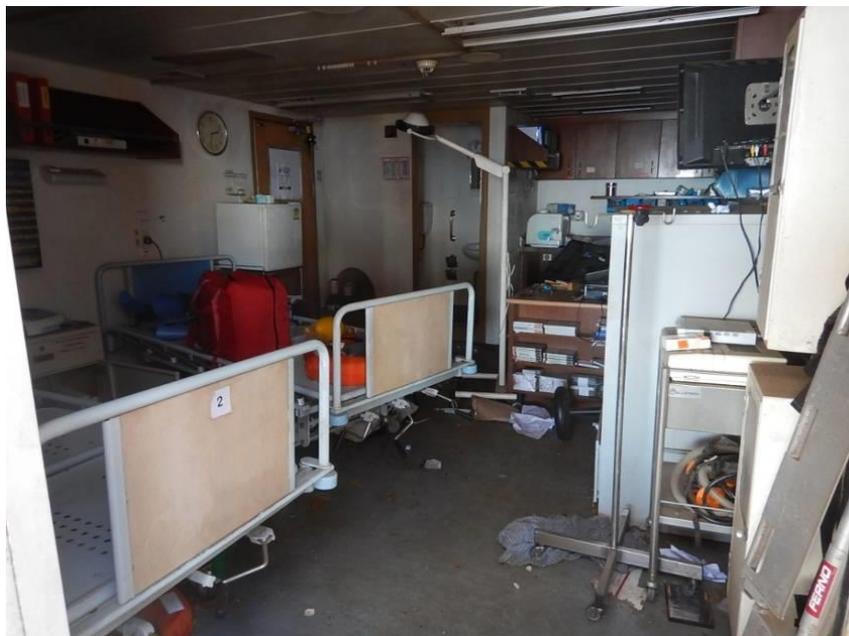
According to testimonies, the explosion damage on the nursery ward had left this environment unable to provide any care to the injured ones. The first aid supplies were contaminated by residues of the explosion and the glass wool which came off of the lining of the accommodations partitions. The ward stretcher was designed to service in the deck of the explosion and it was found without the head protector. Figure 24 shows how the ward was found twenty and two days after the explosion.

Figure 24 – Nursery ward (22 days after the explosion)

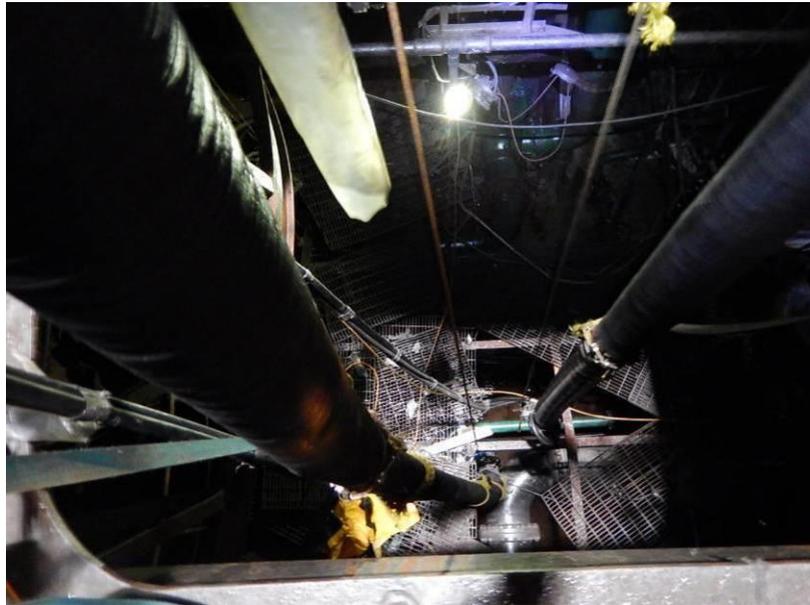
Figure 25 - Floor of the pumps room

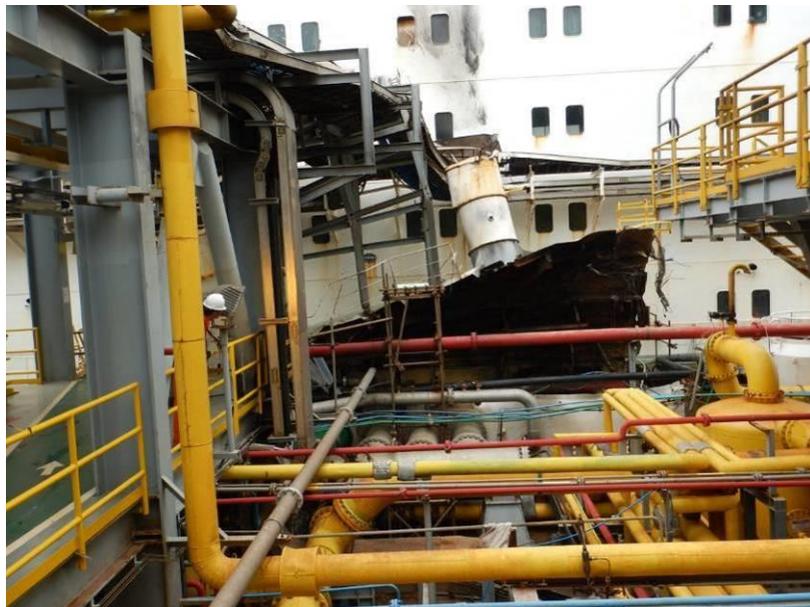
Part of the main deck floor was broken and moved up, as can be seen in Figure 26.

Figure 26 – Pumps room entrance after the explosion.

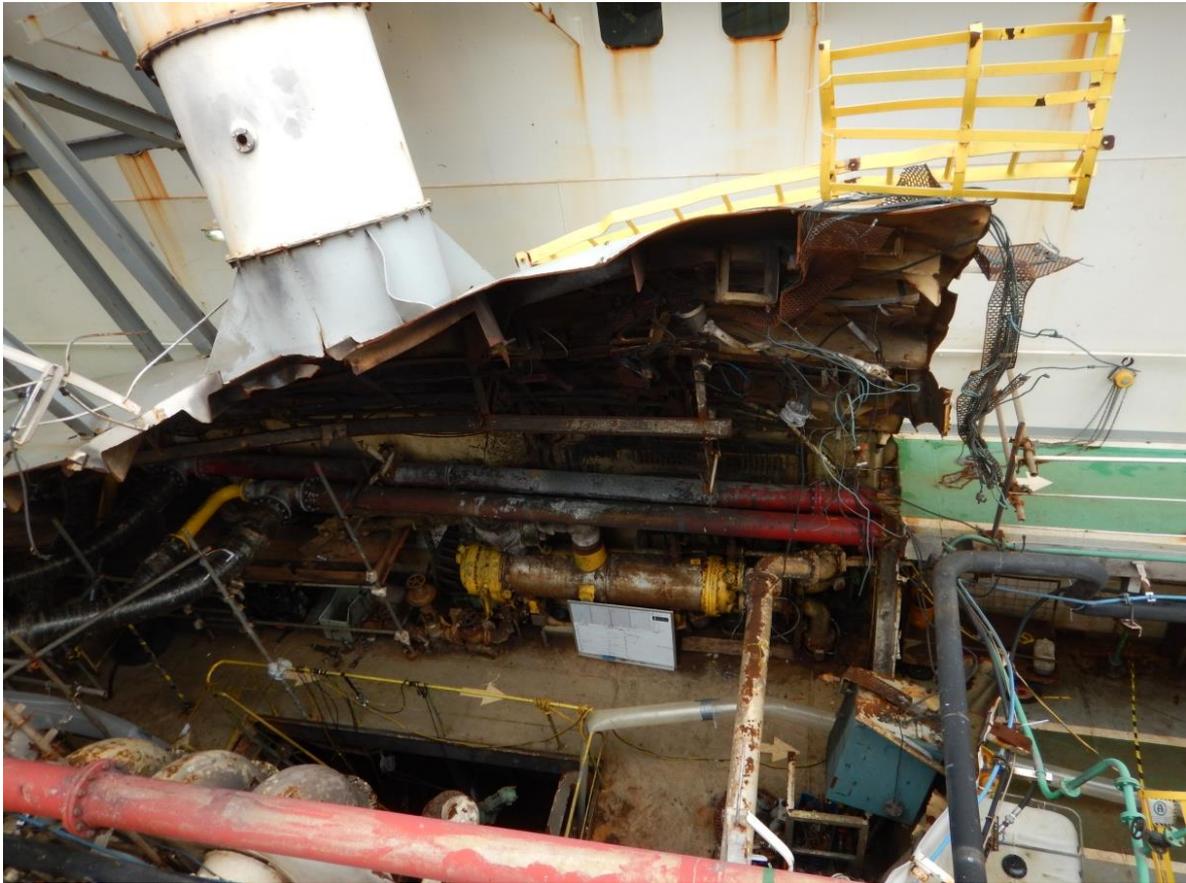
Figure 27 shows the damage occurred in line pipes of fire after the crash. Damaged and blended lines with flexible lines as well as other equipment affected by the explosion can be observed.

Figure 27 - The status of fire line pipe from the input of the pumps room after the explosion

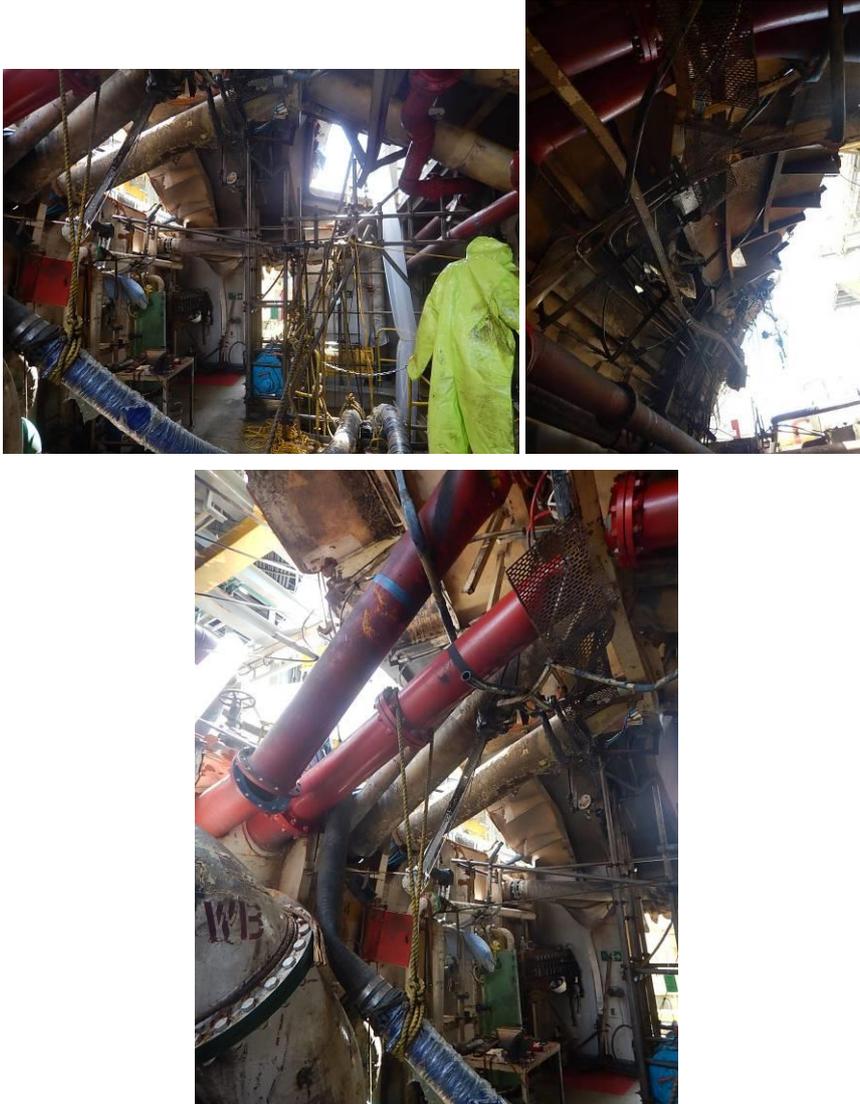
During the inspection activities conducted by the ANP, the floors of the pumps room had low lighting, missing or bulging steps and stairs destroyed replaced by provisional fitted with scaffold pipe. In the described conditions, where the sites were observed steel surface it was raised by the effect of explosion and several destroyed equipment.

Figure 28 - the pumps room entrance with raised roof and pipes

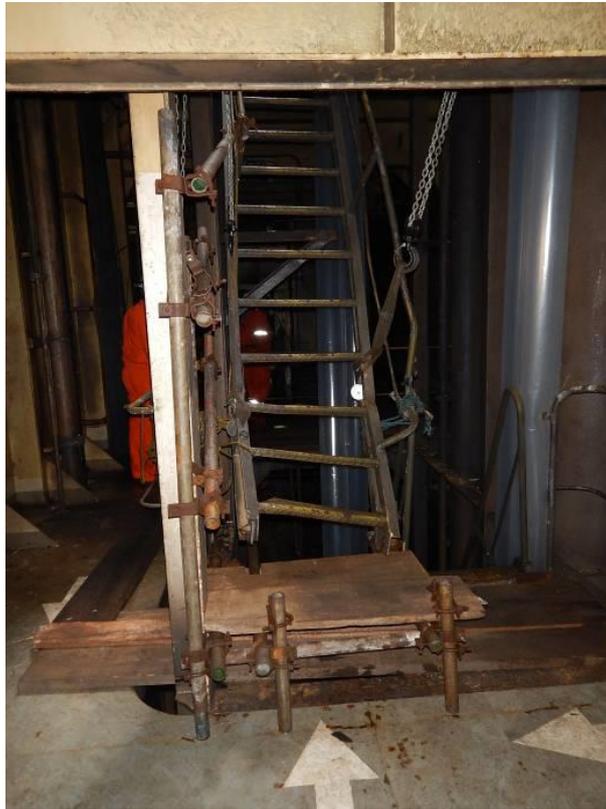
Figure 29 - damaged access and provisionally adapted for people crossing by

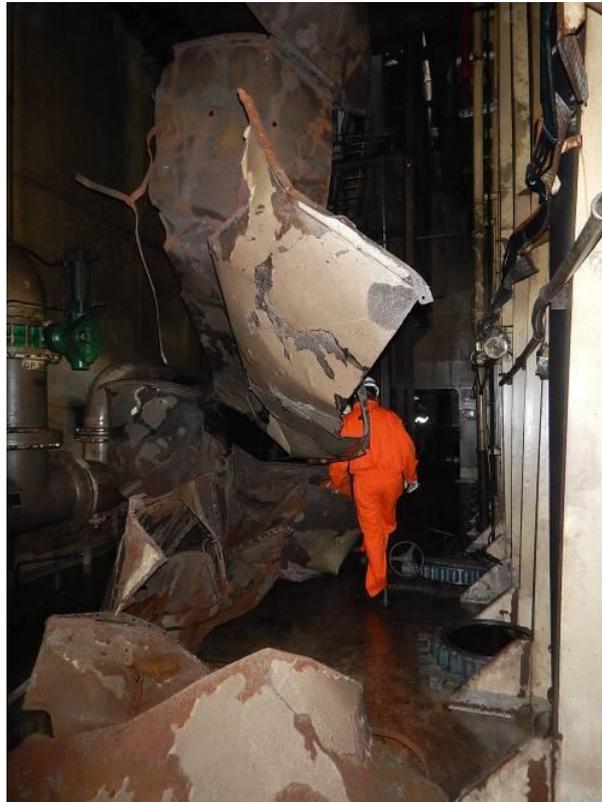
Figure 30 - ventilation system destroyed and hanging

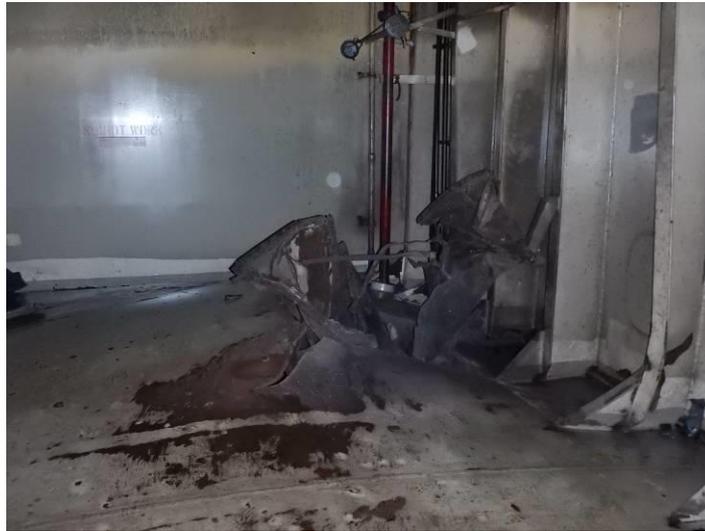
Figure 33 - Ground damaged by explosion

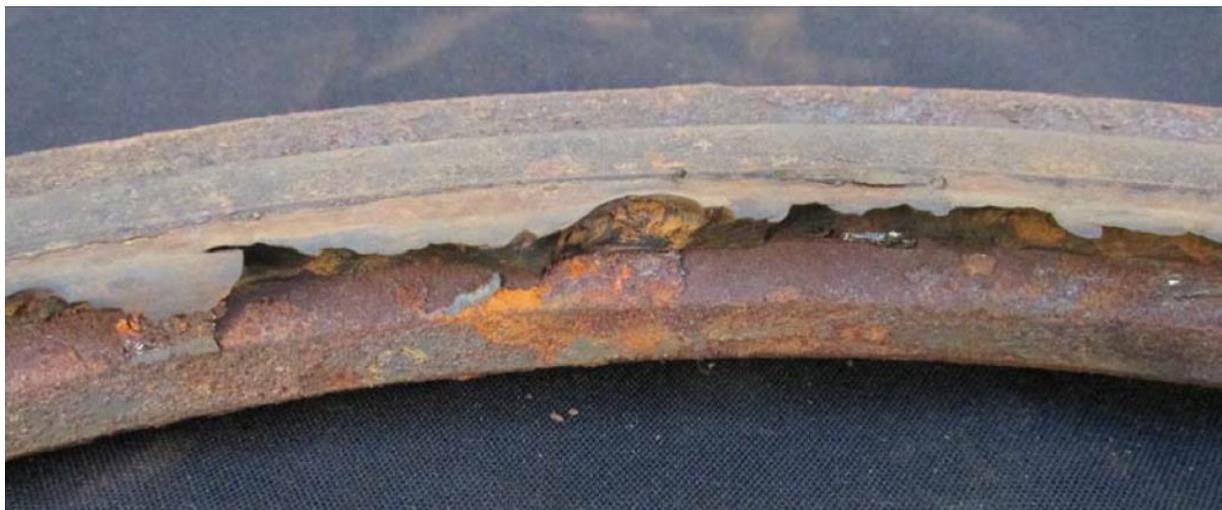
Figure 72 - Macroscopic appearance of a failed gasket seal, showing cracks in the longitudinal direction and next fracture contact transition region with fluid and with the external environment

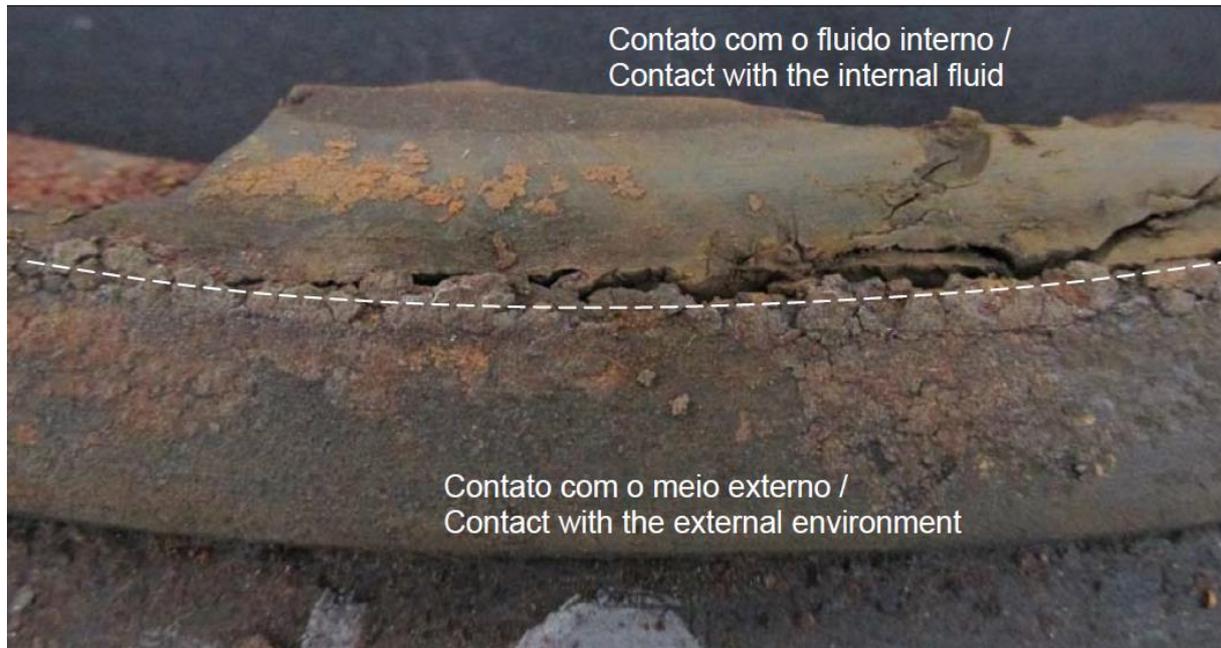
Figure 73 - Macroscopic appearance of a failed gasket seal, showing cracks in the longitudinal and transverse direction and next fracture contact transition region with fluid and with the external environment

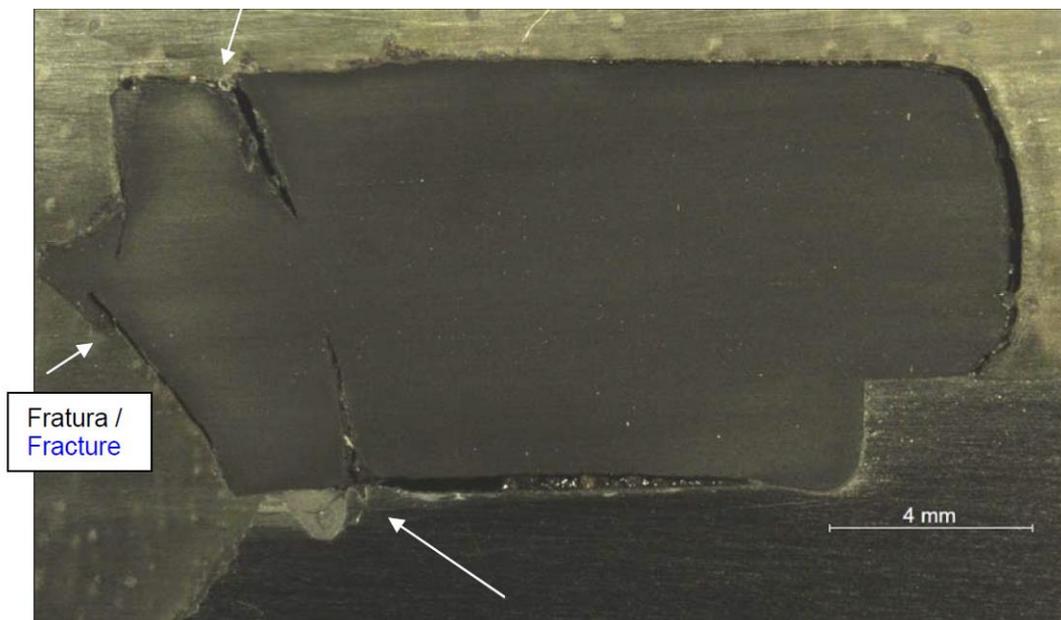
Figure 74 - metallographic appearance of the cross section of the seal, showing internal and surface cracks located in the region of contact with the fluid

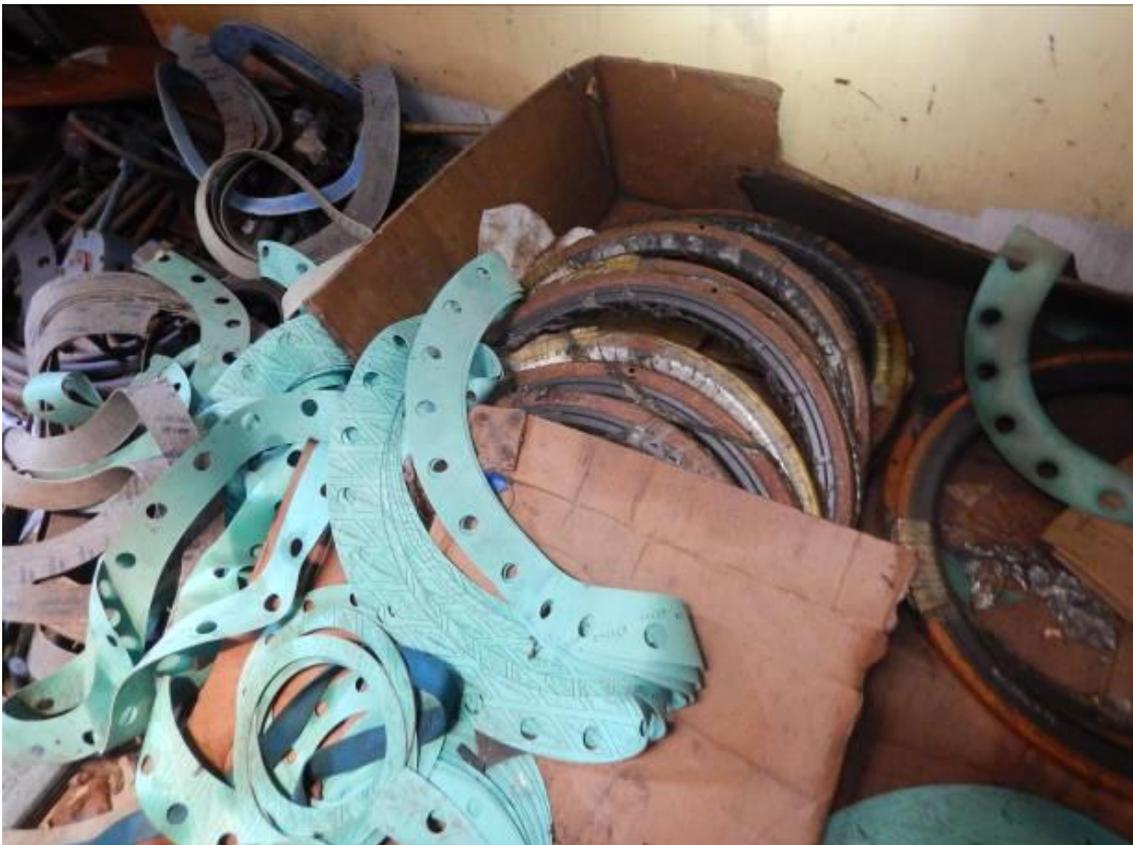
In November 2013<sup>90</sup> the planning to install two valves was postponed and the first exchanges of system valve seals, being followed by a campaign of exchange of valve seals were made. This campaign was initiated by the interior of the pump house, providing the possibility for the board to create personal routes for condensate flow and isolate parts of the system, making it possible to perform interventions and other regular maintenance activities. Some of shaft seals (seat rings) are replaced shown in Figure 82.

Figure 82 - Some of the shaft seals (seat rings) substituted with the goal of correcting the problems of the charging system valves.

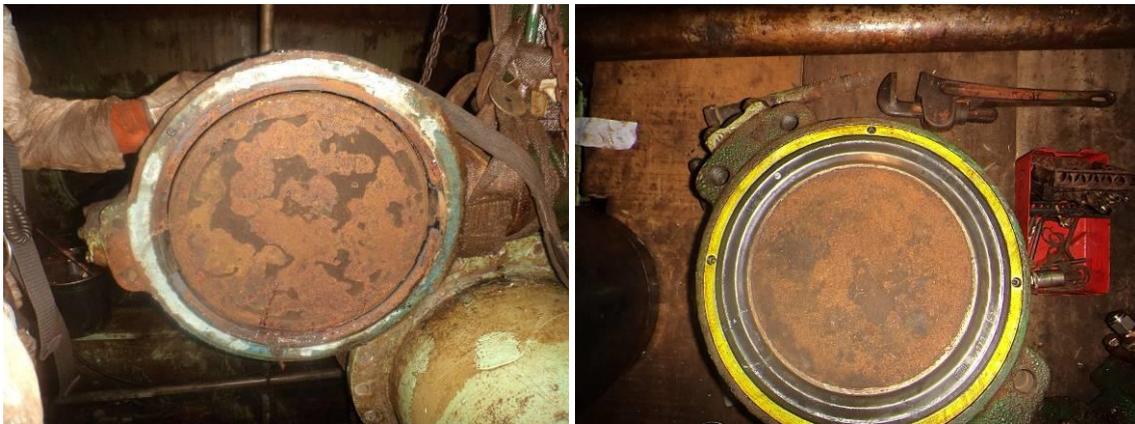
Figure 83 - Left, valve seat ring degraded and right valve seat ring replaced.

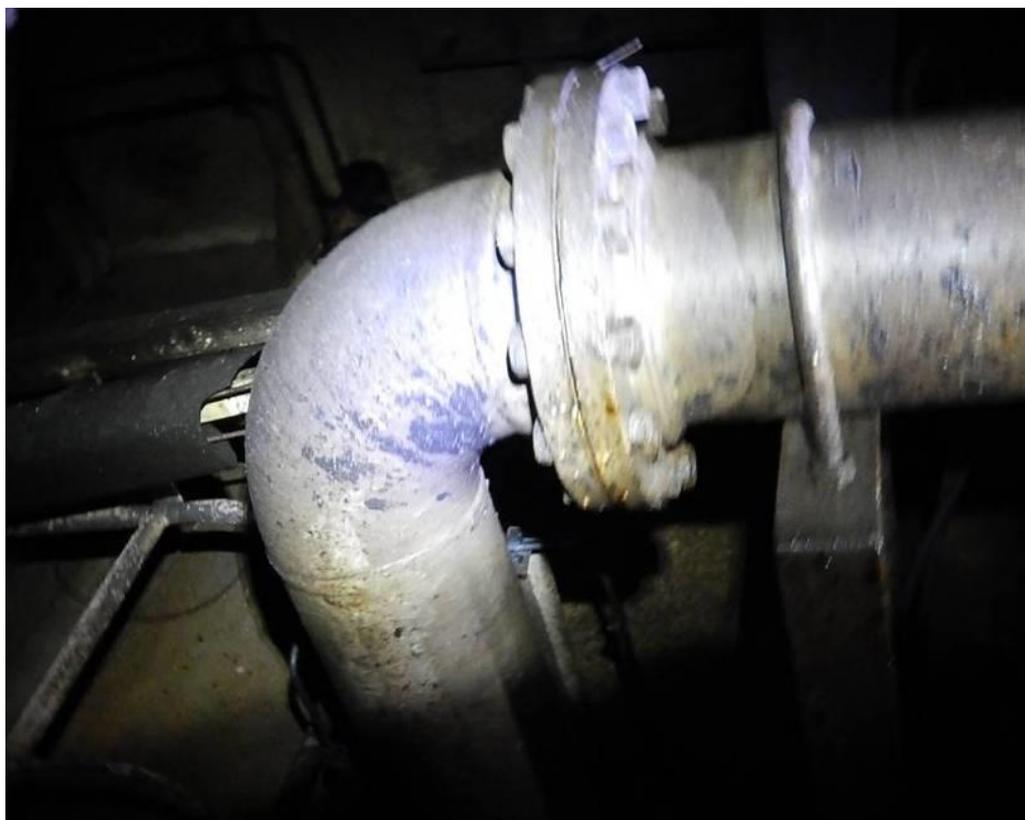
Figure 84 - Spade installed for valve insulation OP-068

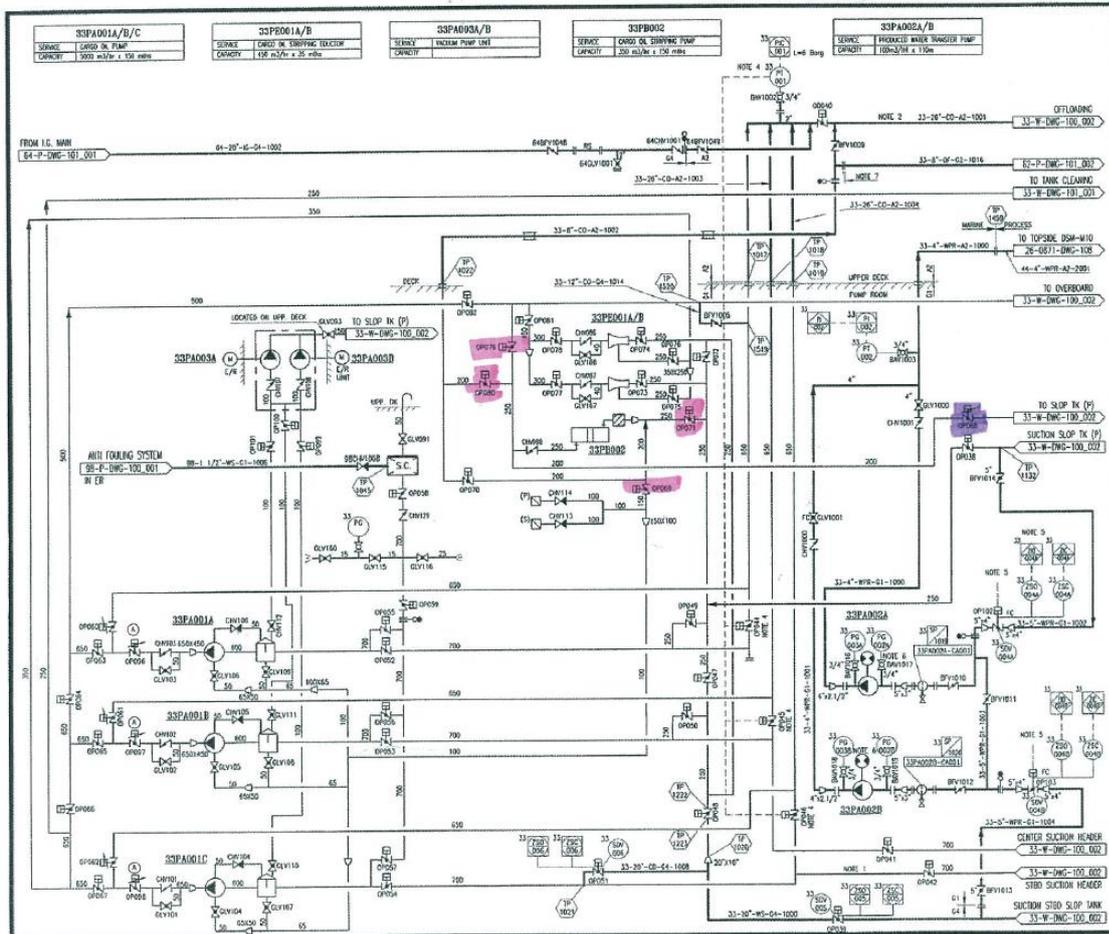
Figure 87 - P & ID marked, but without the spade identify the amount of OP-068

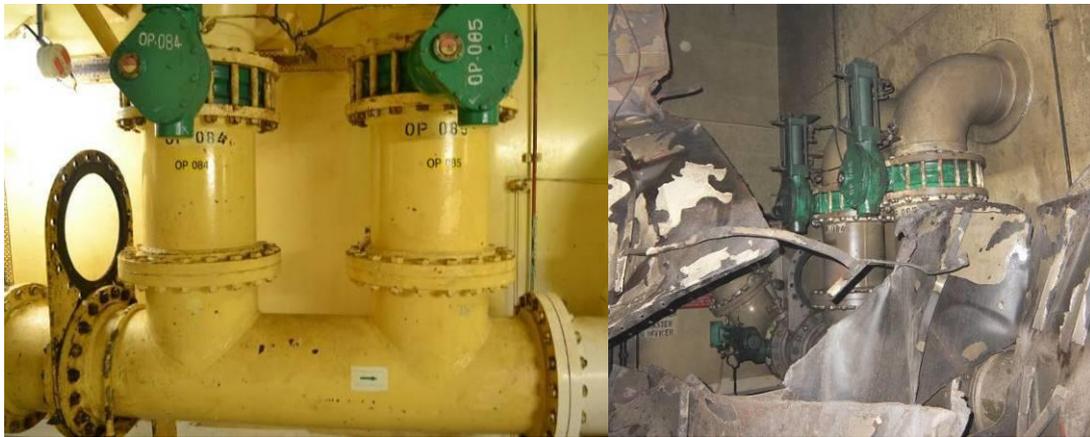
Figure 105 - PB-valve 084 before and after the accident

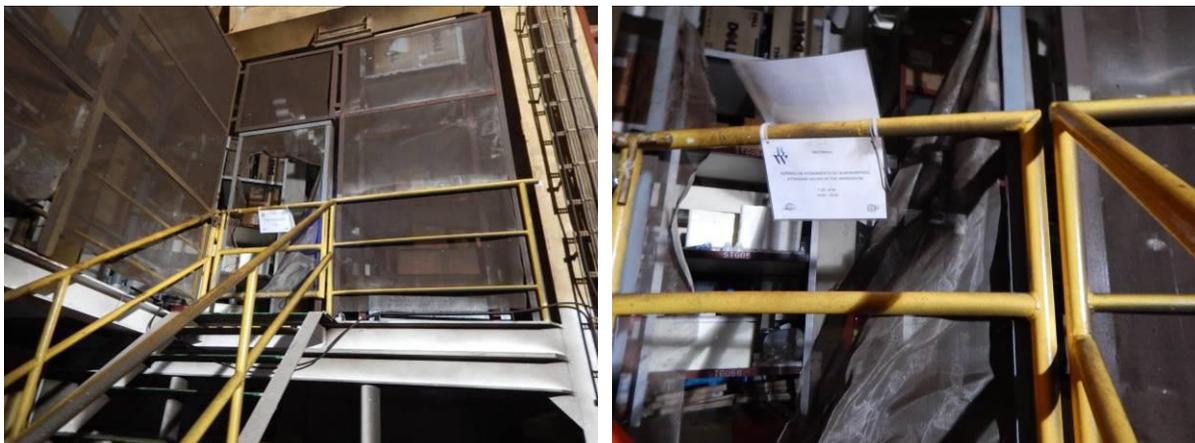
Figure 122 - broken screen on warehouse gateway
