# Safety Alert 015 - ANP/SSM Loss of tightness from flexible service riser during diesel inertization procedure

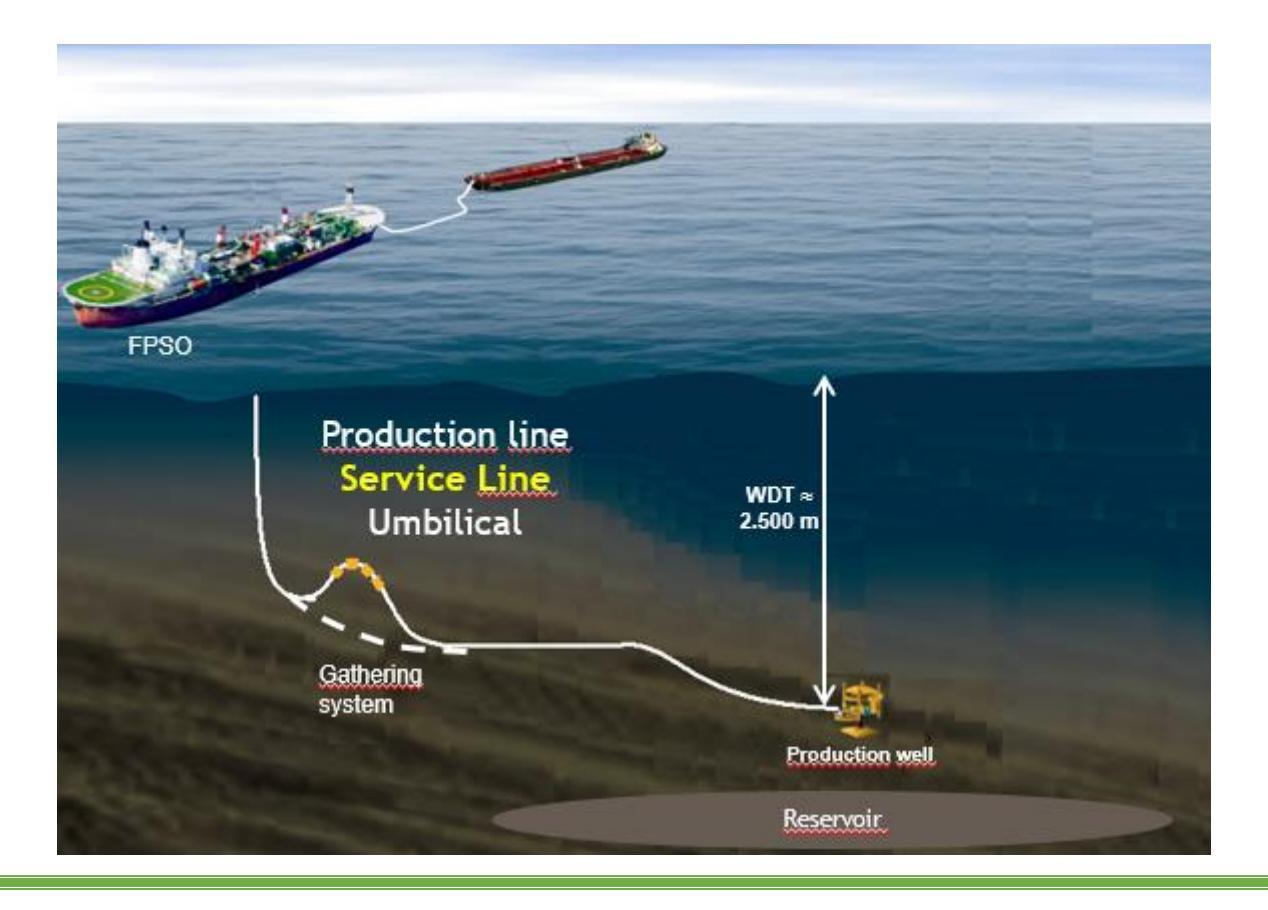
#### Figure 1 – Production System Sketch

During a diesel circulation for inerting the well-platform circuit, after a production shutdown, the service line that connects the annular of the well to the production unit lost its tightness, causing diesel spill for the sea.

The loss of tightness in the service line was due to the reduction of the internal pressure below the minimum limit established for the riser operation, together with a pre-existence of ovalisation located in the lower riser section near to TDP (Touch Down Point ). This pressure reduction occurred at the WCT (Wet Christmas Tree) valve opening for communication between the service line and the production line to permit diesel circulation. The diesel migration flowrate from service line to production line was greater than the diesel pump flowrate from topside to the service line, causing a flow intersection in the service line. With the pressure reduction below the minimum level in the region of the riser ovalisation, the flexible riser layer responsible for supporting the external pressure did not tolerate the differential pressure, causing the riser to collapse. The riser collapse caused a damage in polymeric pressure barrier, which is the layer responsible for tightness.

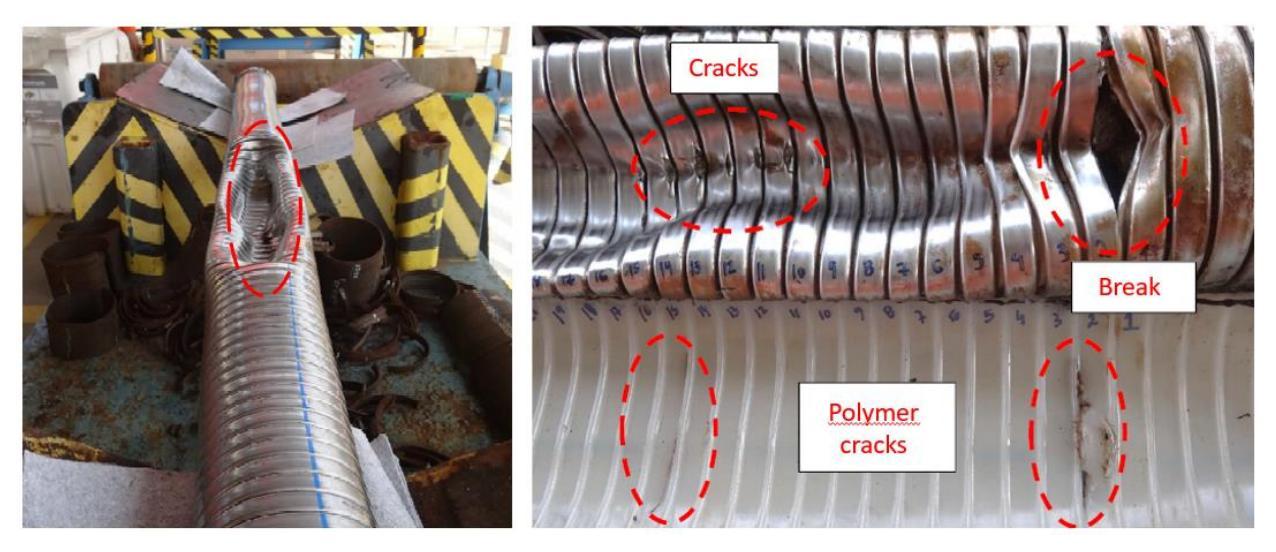
Figure 2 – Pictures of the flexible pipe after dissection (colapsed carcass and pressure barrier damaged)

- Carry out technical evaluations of the flow conditions, either on a permanent or transient periods, after identifying a deviation in the reused flexible pipeline. It will aim to confirm that the operational parameters will not exceed the limits established in the updated pipeline safety envelope;
- Establish a clear rule to identify an operational procedure as critical. This will require a specific procedure PHA, before its execution, with the HSE specialists participation.
- Critically evaluate the operational changes management actions in case of platform operated by a third party (charter platform).
