**Seminário “Avanços  
Tecnológicos Para a  
Gestão de Barragens de  
Mineração” -  
Práticas Samarco x Práticas  
do Mundo**

# AS BUILT DAS ESTRUTURAS E FATOR DE SEGURANÇA PÓS-LIQUEFAÇÃO

# Germano Complex – Tailings Dam Management System

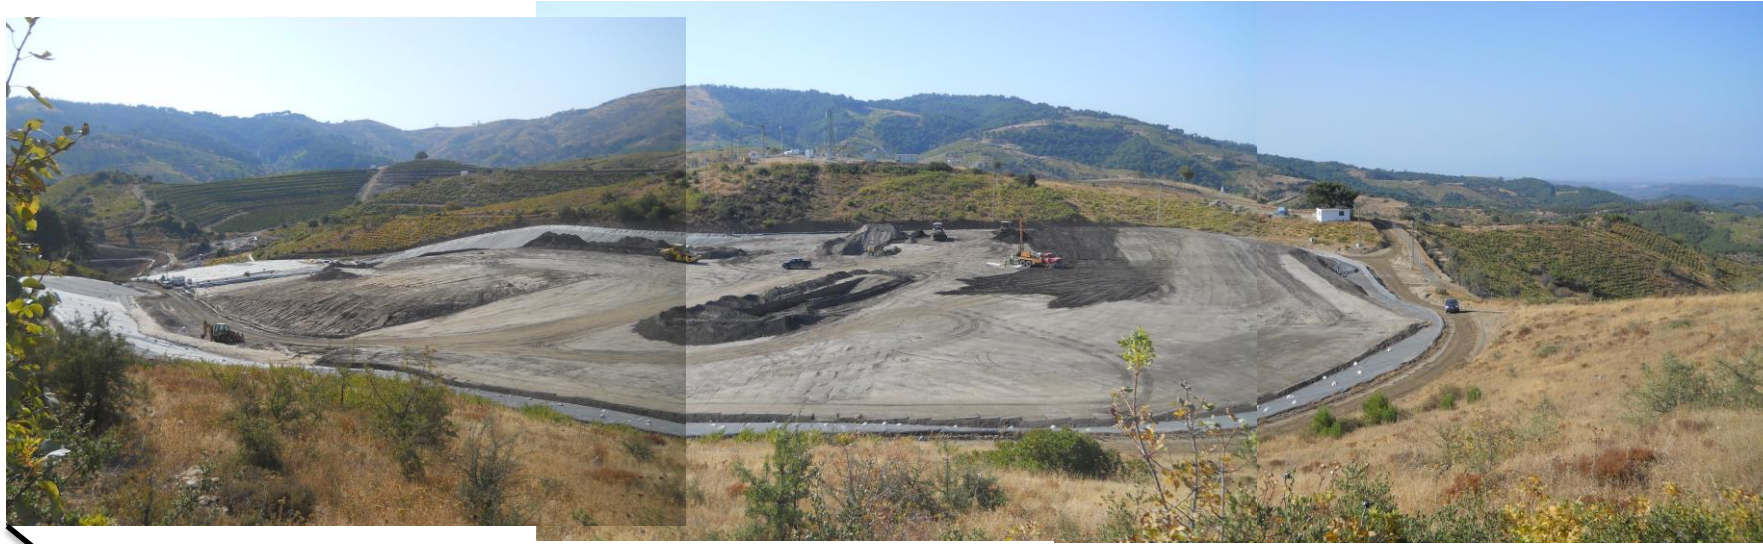
## Eldorado Gold Efemcukuru Mine, Turkey

# Operational Filtered Tailings Stack

| Controlled Material Placement | | | | |
| Transportation | | Spreading | | Compaction |

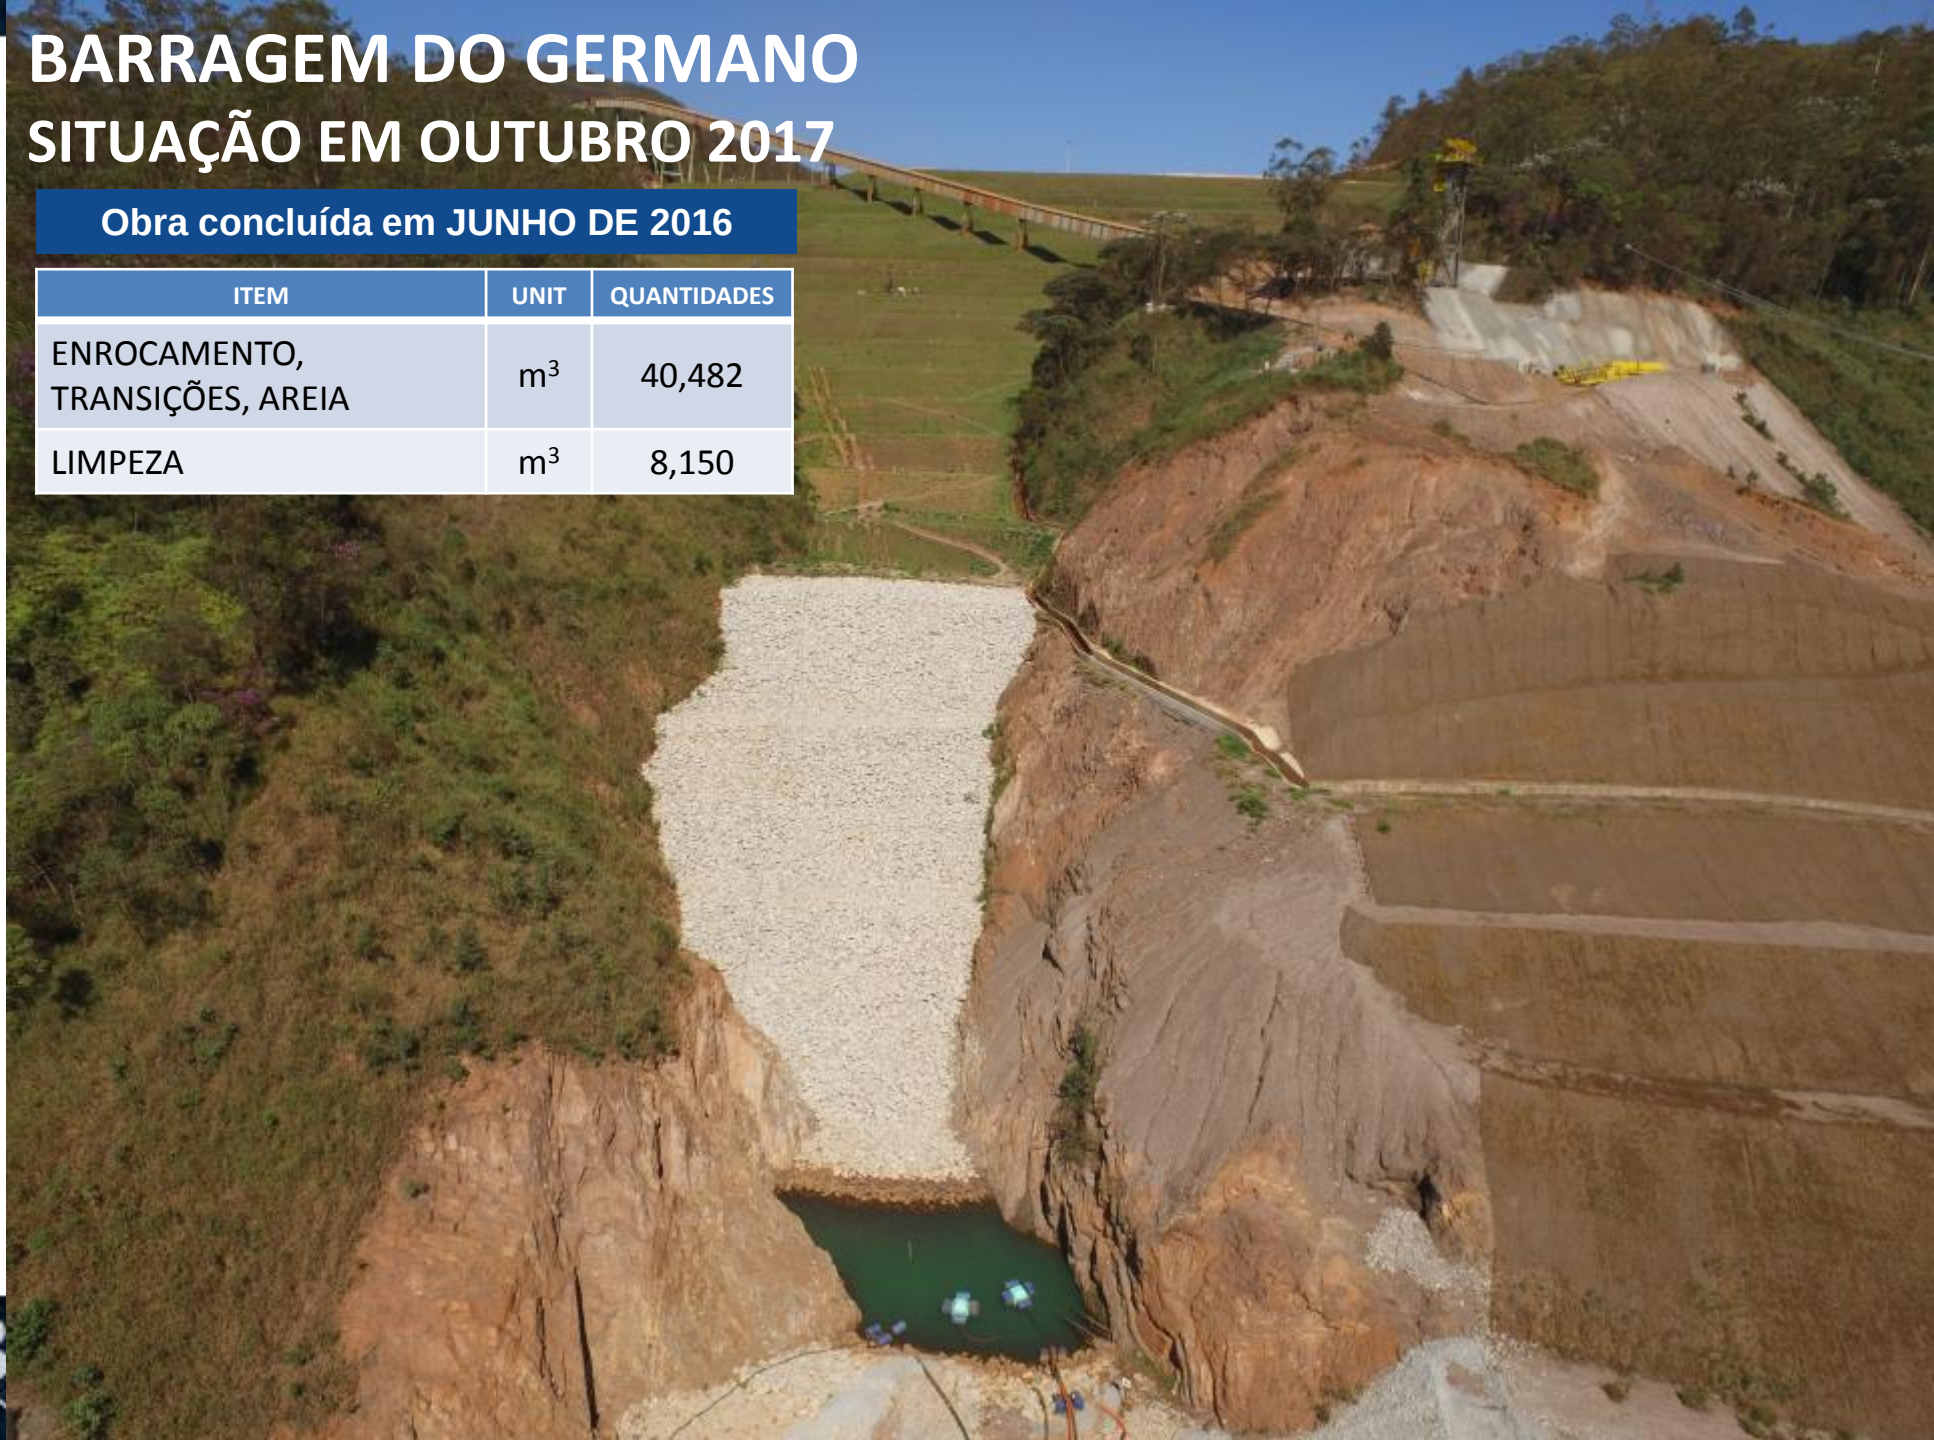
## SITUAÇÃO EM OUTUBRO 2017

Obra concluída em JUNHO DE 2016

| ITEM | UNIT | QUANTIDADES |
| ENROCAMENTO,<br>TRANSIÇÕES, AREIA | m <sup>3</sup> | 40,482 |
| LIMPEZA | m <sup>3</sup> | 8,150 |

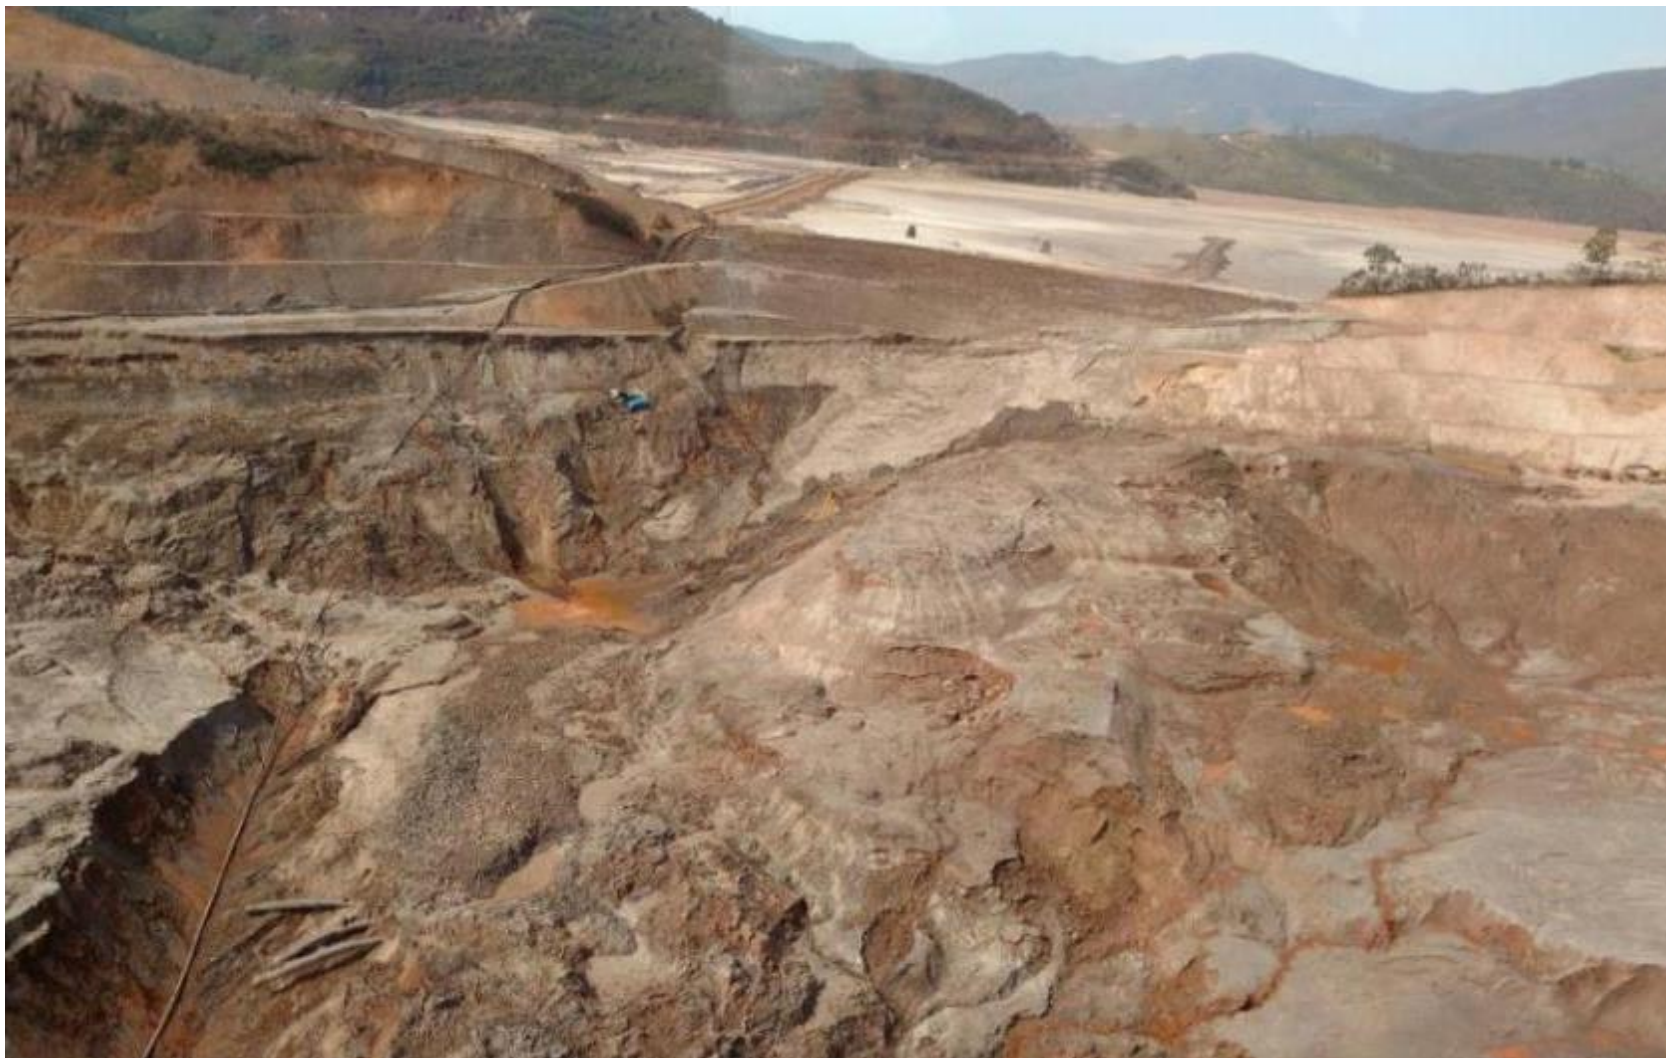
## DIQUE DA SELINHA NOVEMBRO 2015

**H = 90m**

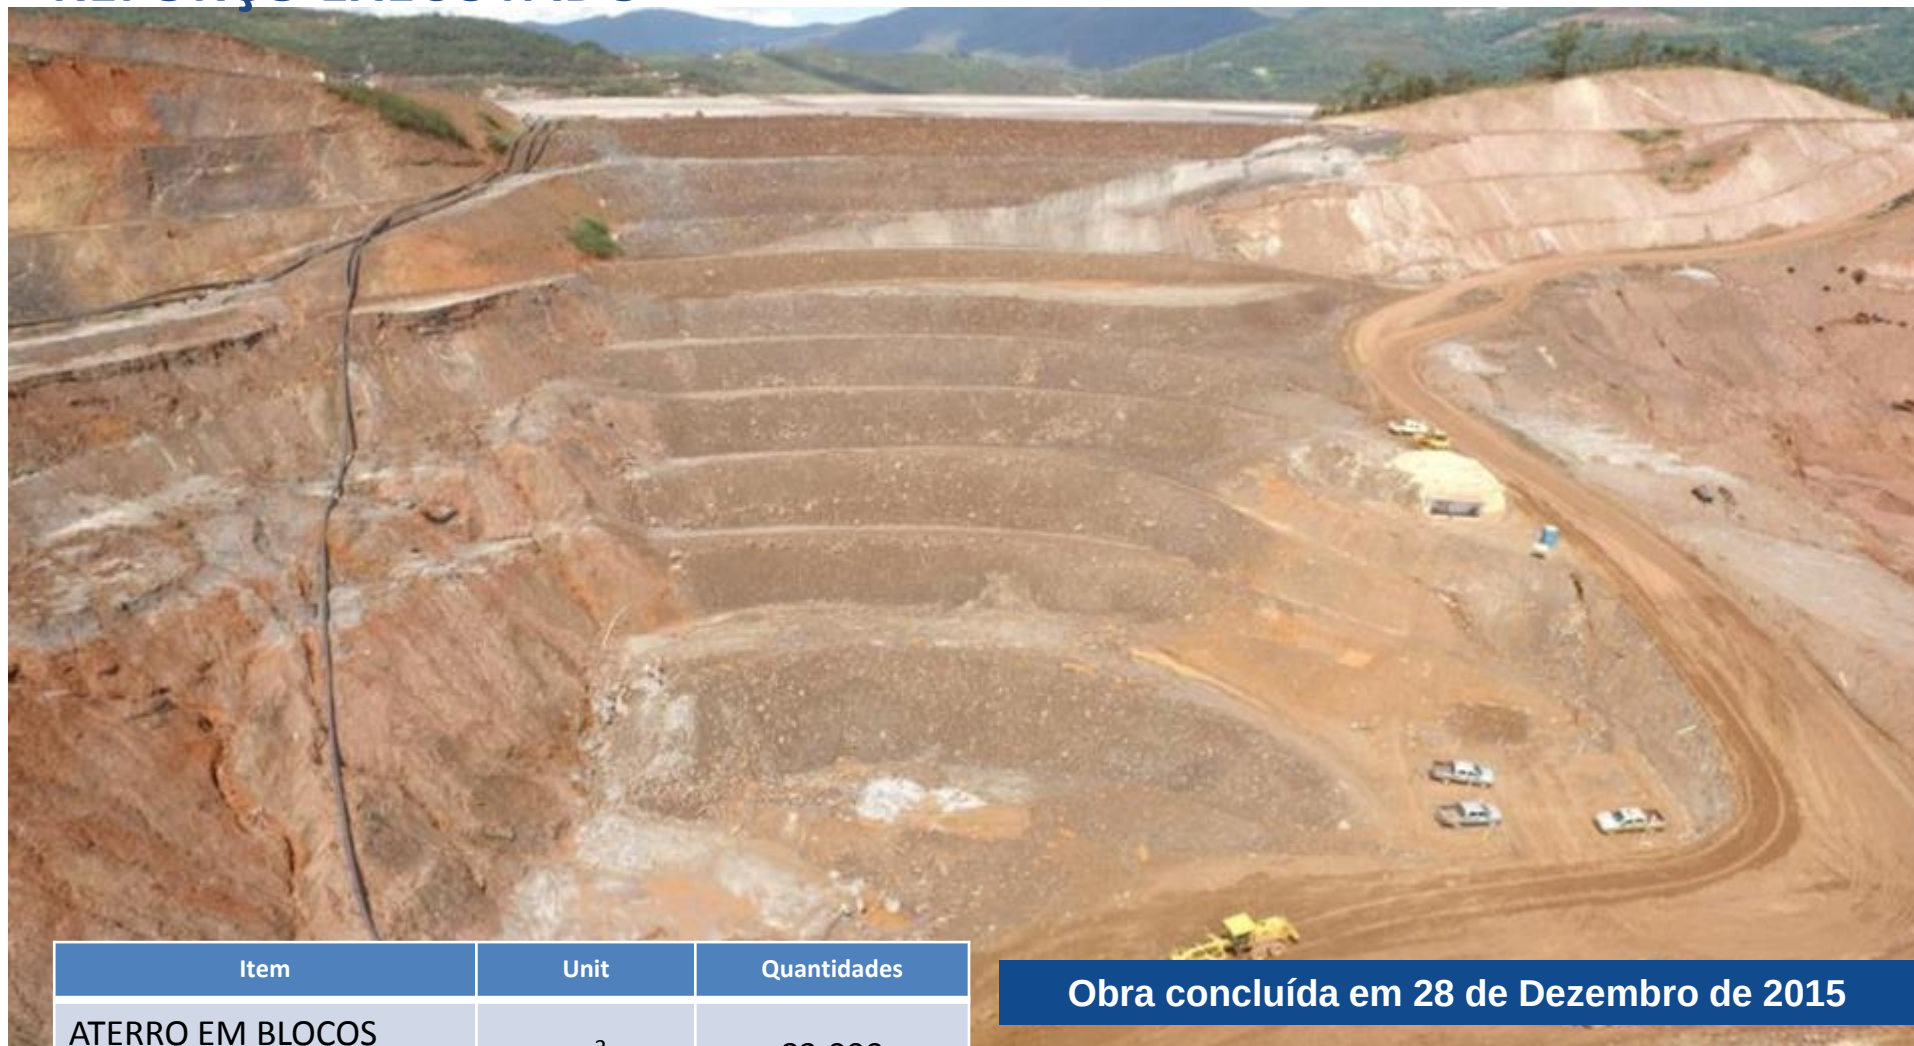
## REFORÇO EXECUTADO

| Item | Unit | Quantidades |
| ATERRO EM BLOCOS<br>COM FINOS | m <sup>3</sup> | 83,000 |
| ATERRO COM<br>ENROCAMENTO | m <sup>3</sup> | 12,894 |

Obra concluída em 28 de Dezembro de 2015

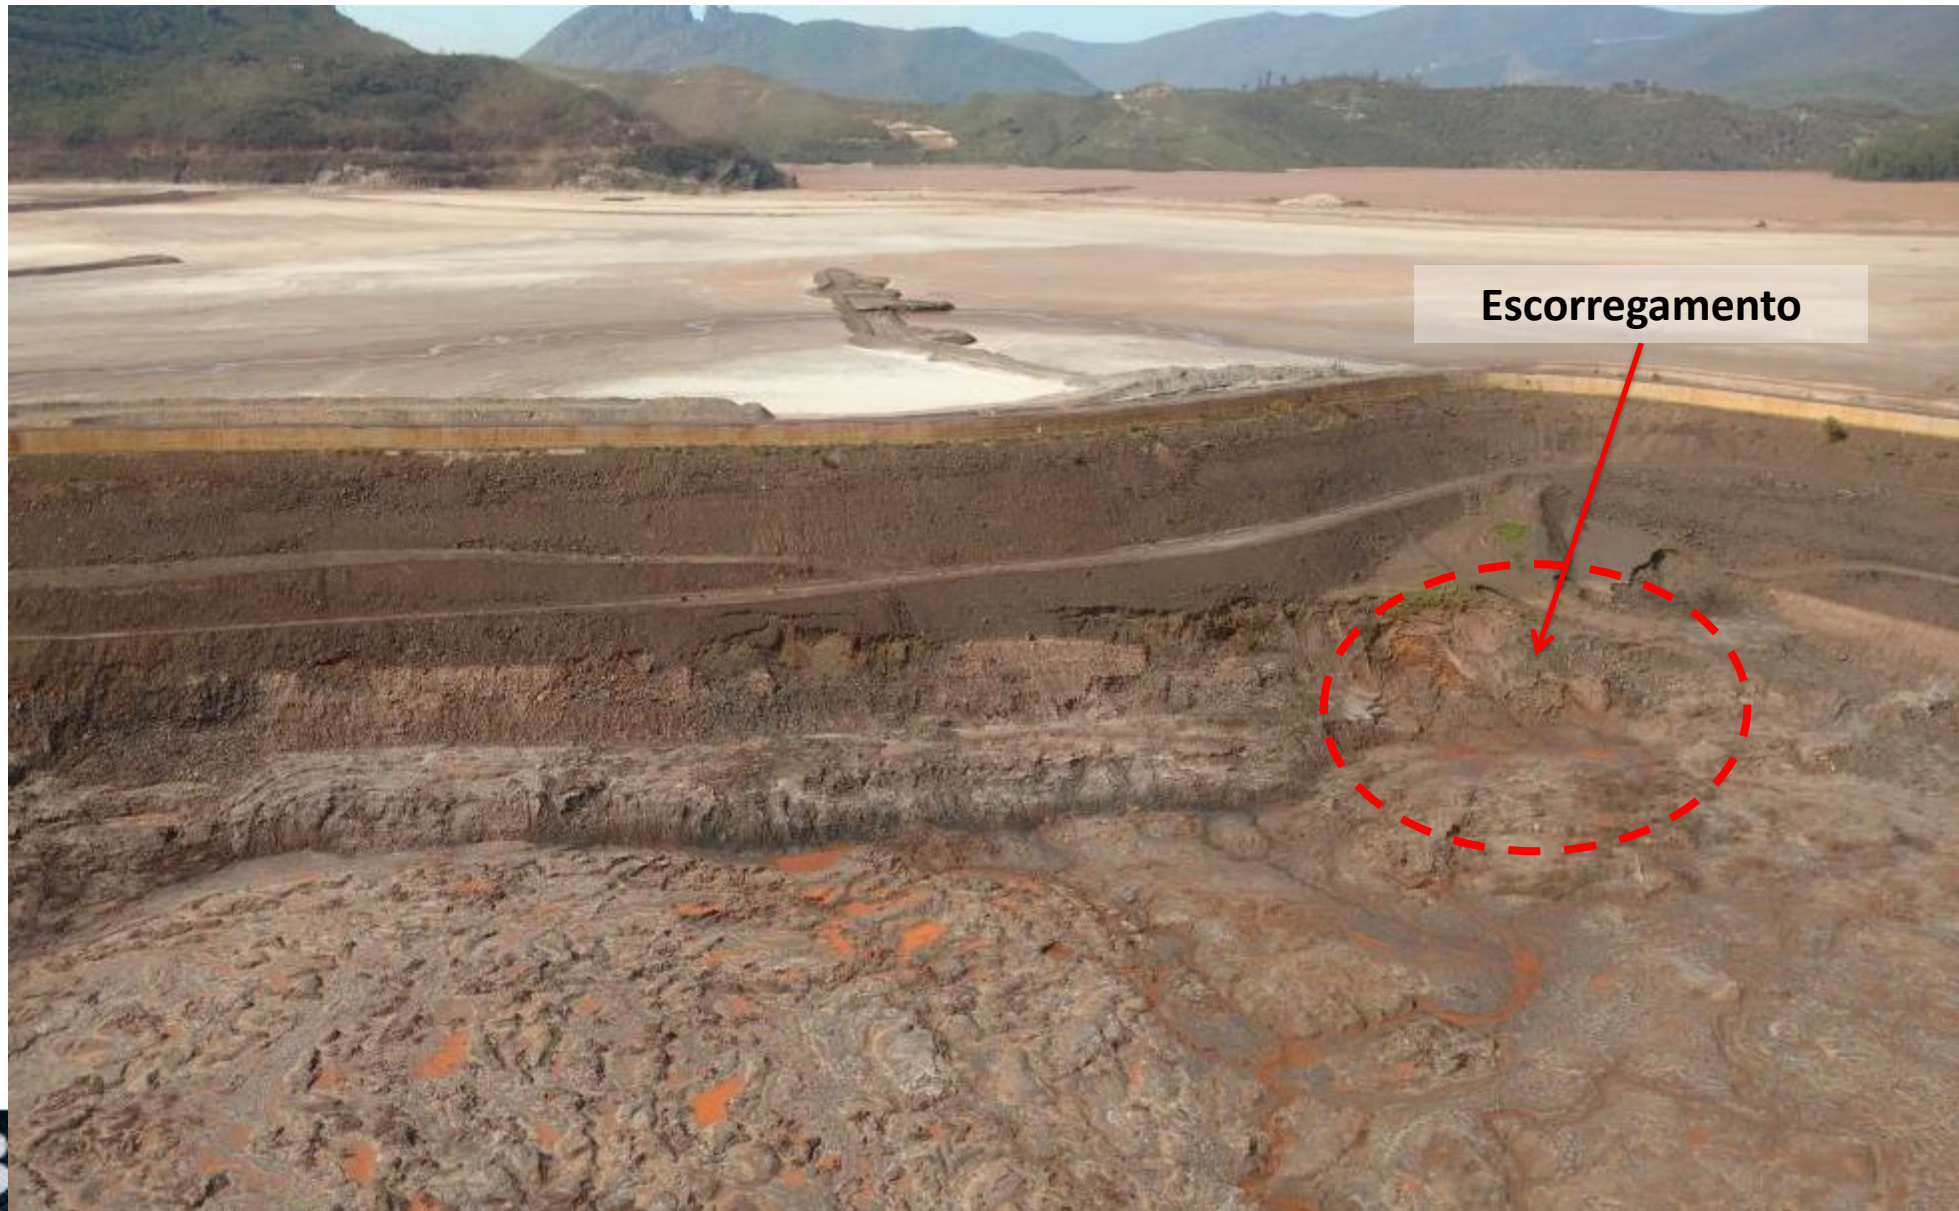
## OMBREIRA COMUM - INÍCIO DE 2016

Escorregamento

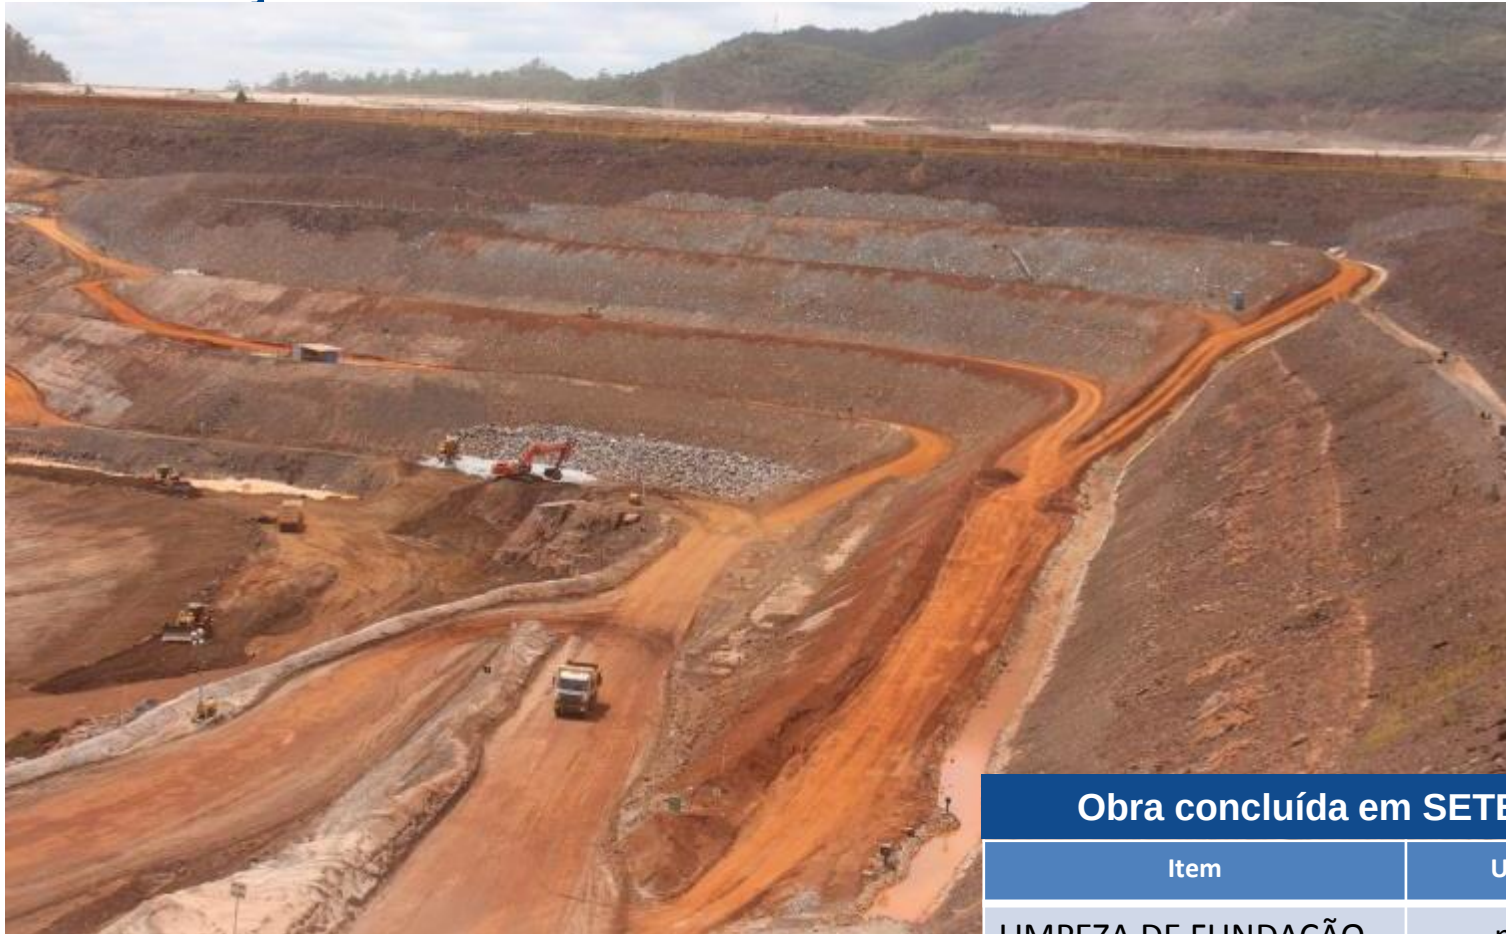
# OMBREIRA COMUM REFORÇO EXECUTADO

## Obra concluída em SETEMBRO DE 2016

| Item | Unit | Quantidades |
| LIMPEZA DE FUNDAÇÃO | m <sup>3</sup> | 57,595 |
| ATERRO EM BLOCOS<br>COM FINOS | m <sup>3</sup> | 50,100 |

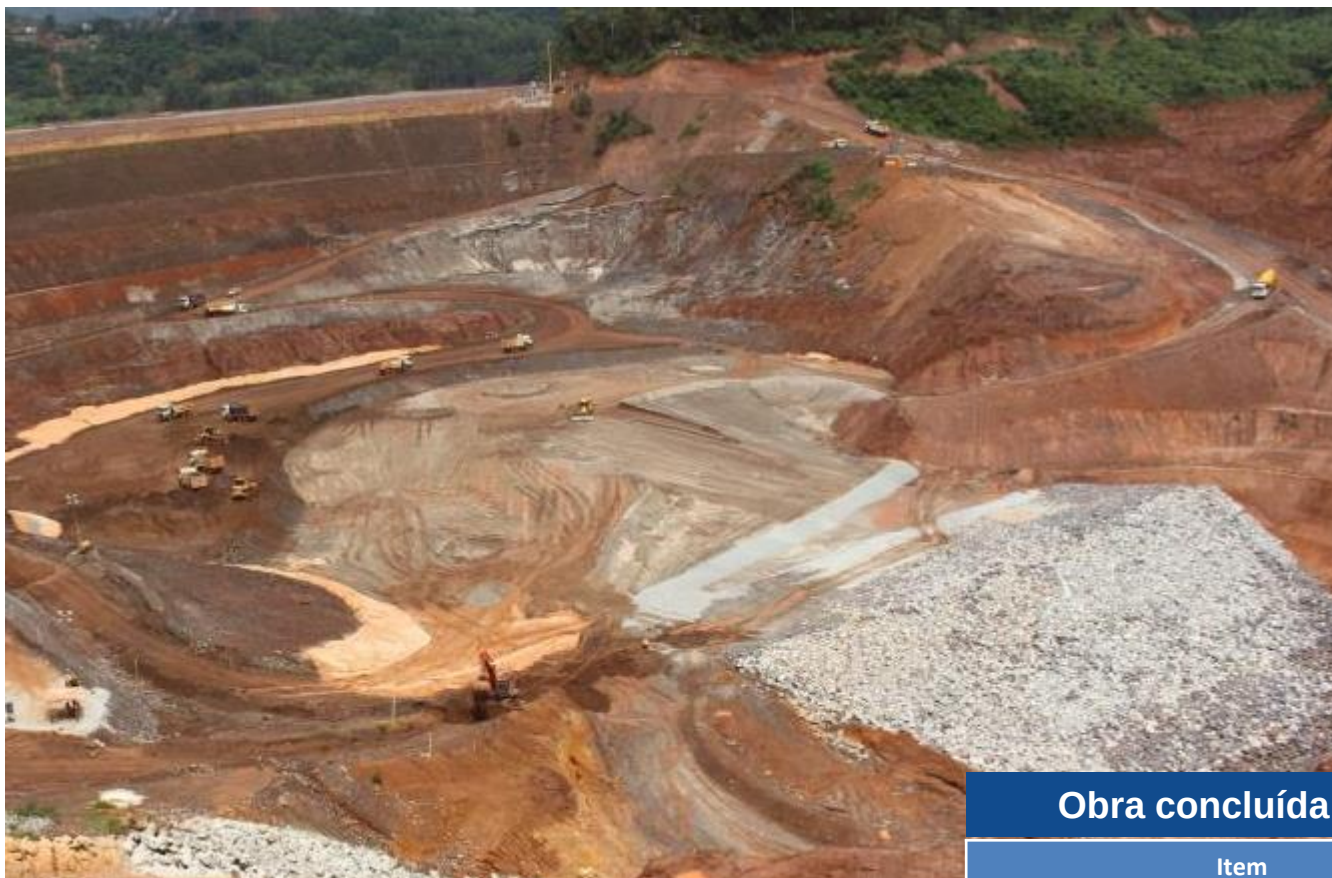
## FASE 2 EXECUTADA

### Obra concluída em NOVEMBRO DE 2016

| Item | Unit | Quantidades |
| LIMPEZA | m <sup>3</sup> | 71,391 |
| ATERRO EM ENROCAMENTO | m <sup>3</sup> | 63,165 |
| ATERRO EM REJEITO ARENOSO COMPACTADO | m <sup>3</sup> | 38,340 |

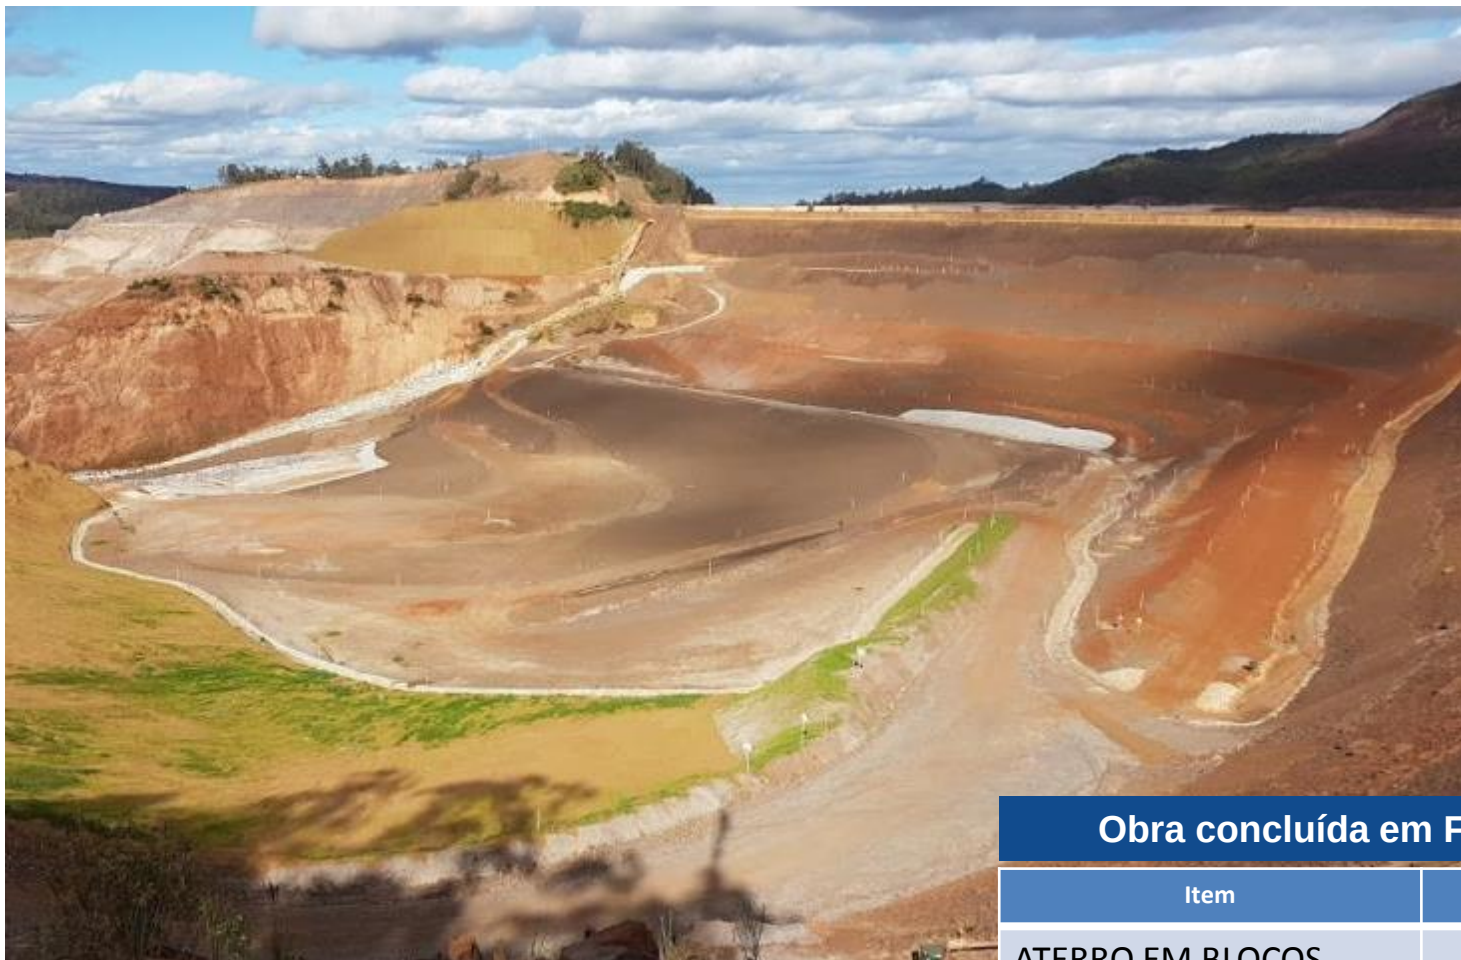
## FASE 3 EXECUTADA

### Obra concluída em FEVEREIRO DE 2017

| Item | Unit | Quantities |
| ATERRO EM BLOCOS COM FINOS | m <sup>3</sup> | 115,400 |
| ATERRO EM REJEITO COMPACTADO | m <sup>3</sup> | 124,184 |

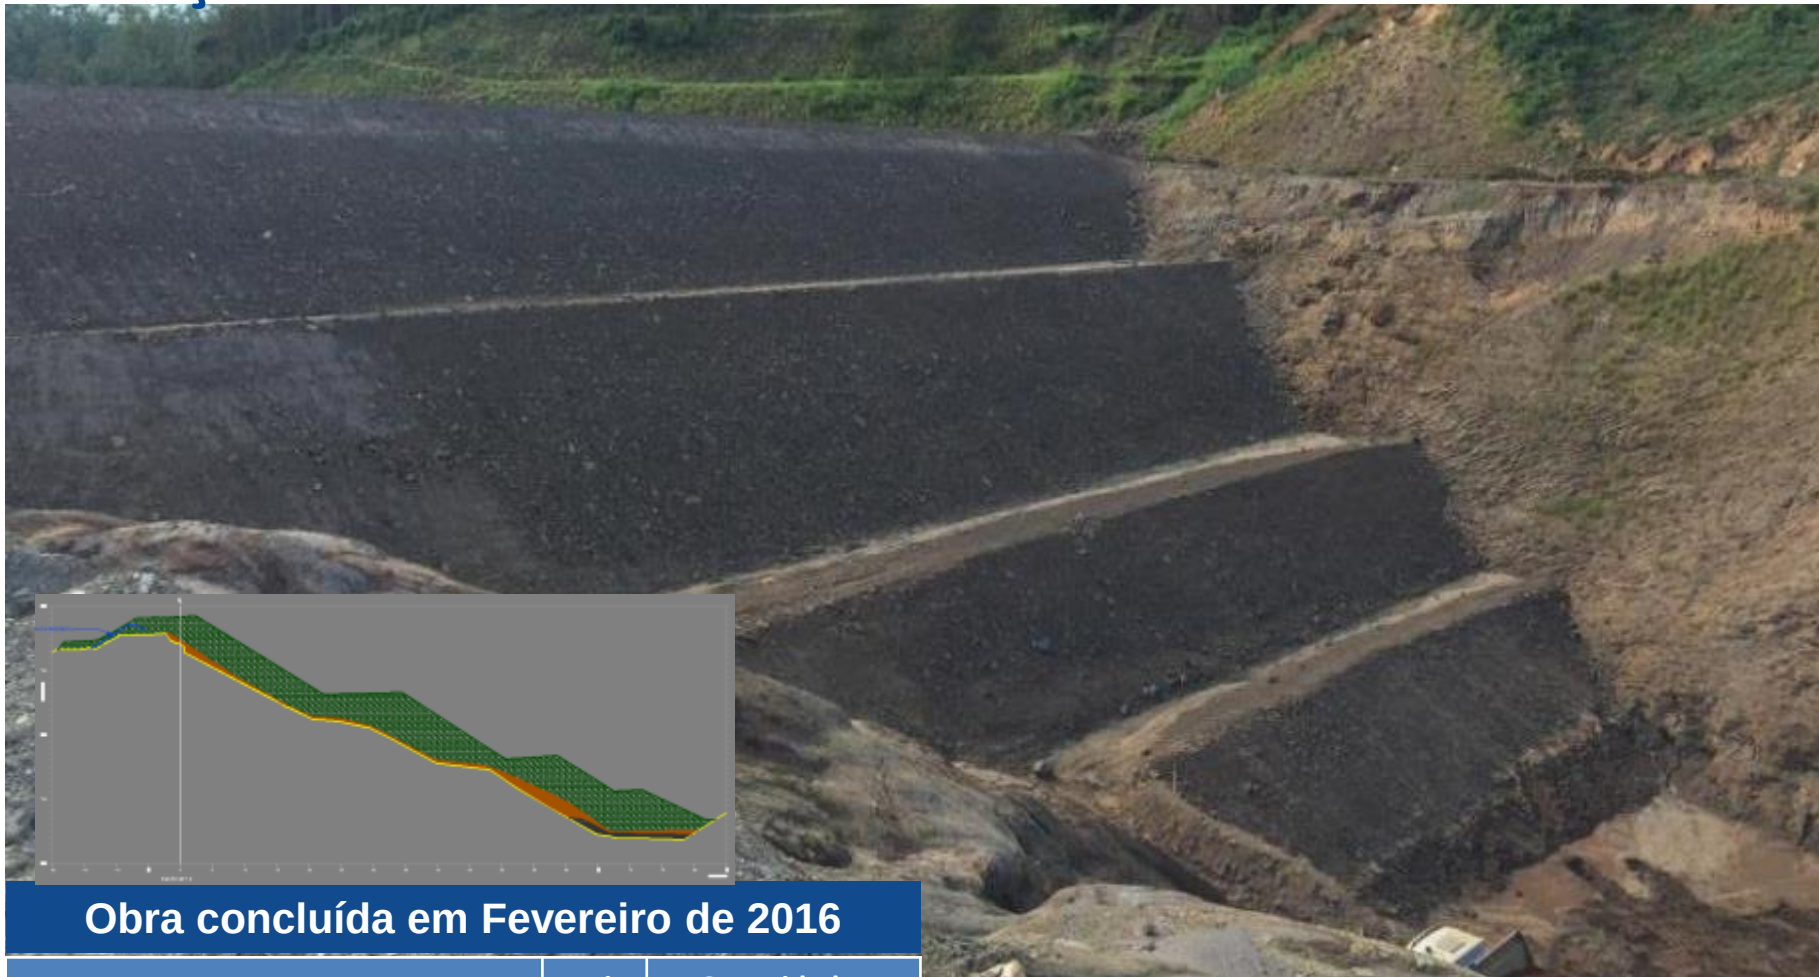
## REFORÇO IMPLANTADO

**Obra concluída em Fevereiro de 2016**

| Item | Unit | Quantidades |
| ATERRO EM BLOCOS COM FINOS E TRANSIÇÕES | m3 | 67,000 |

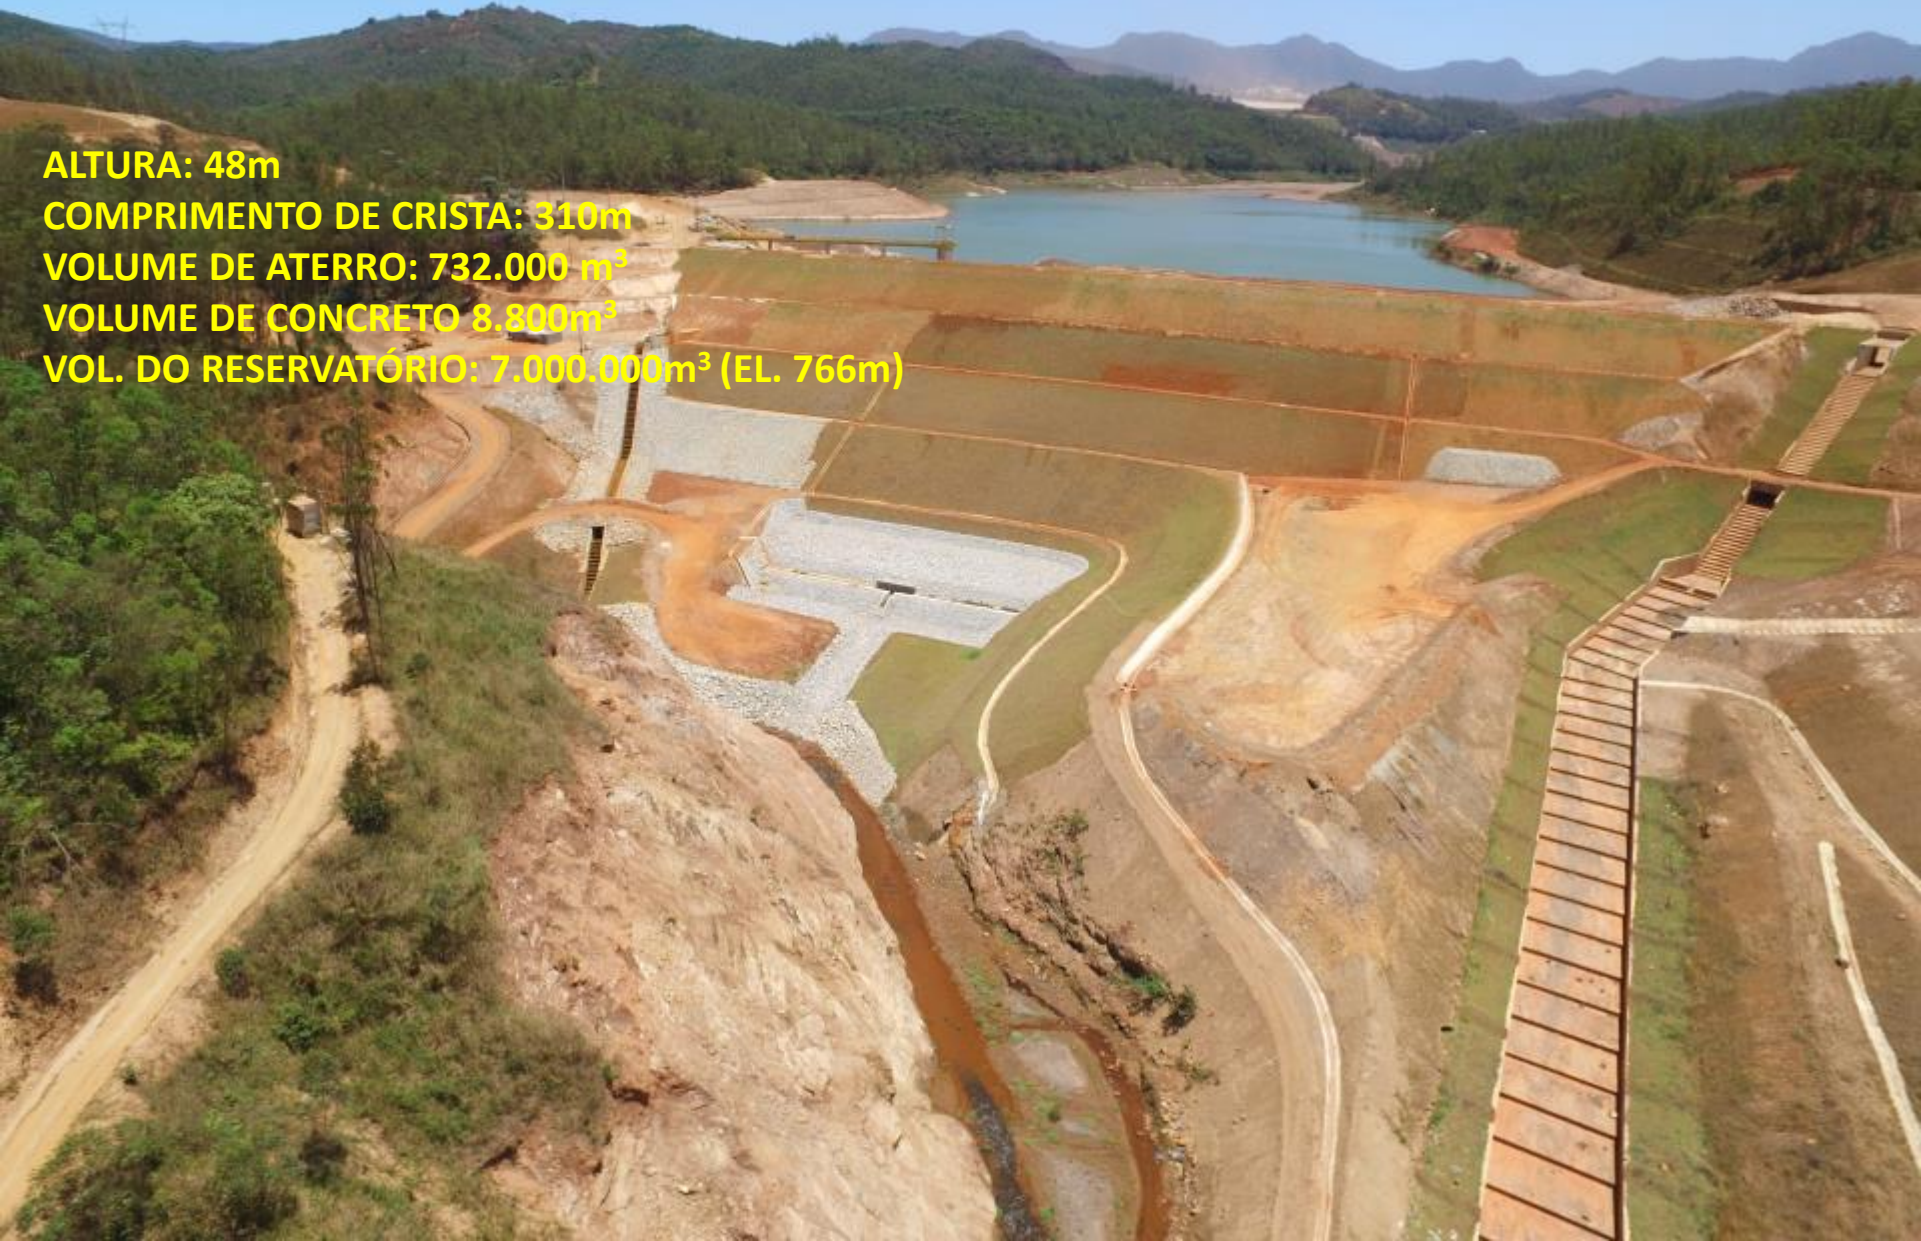
**VOLUME DE CONCRETO 8.800m<sup>3</sup>**

**VOL. DO RESERVATÓRIO: 7.000.000m<sup>3</sup> (EL. 766m)**

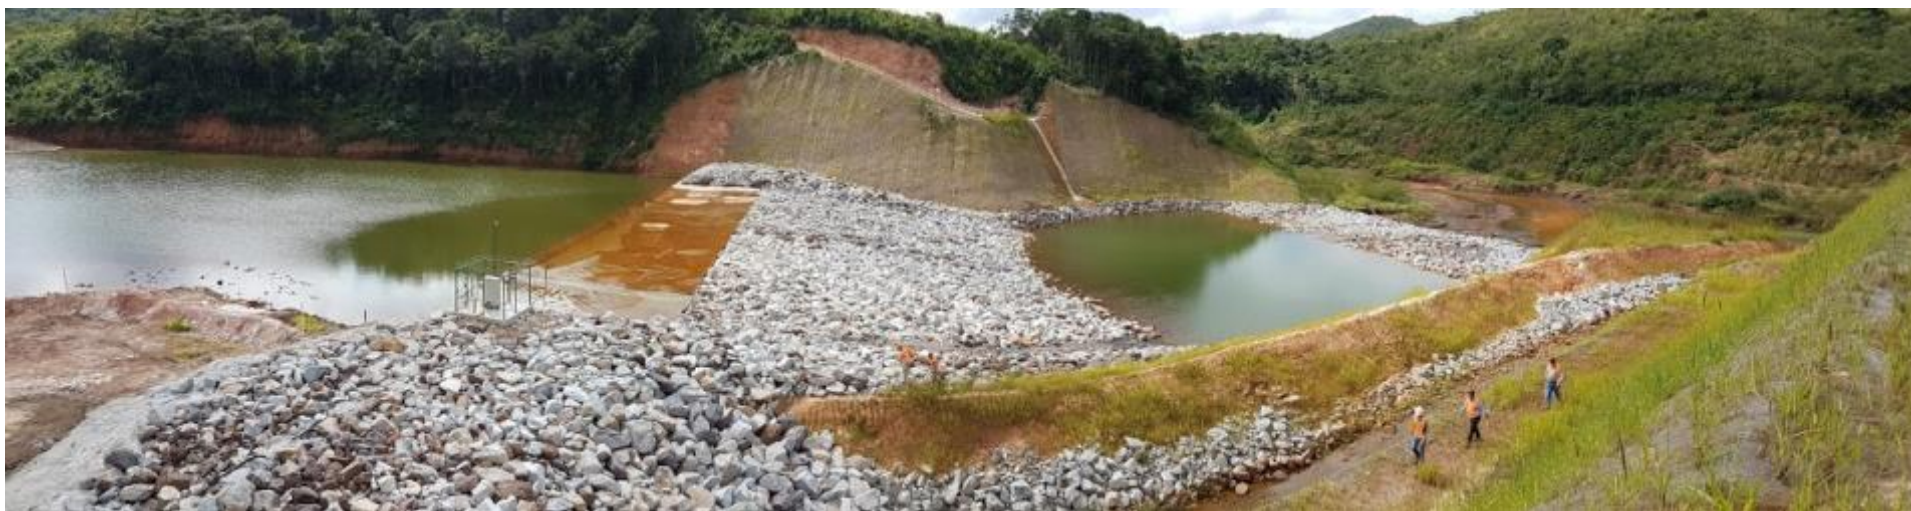
Concluído em Janeiro de 2017
