**INVESTIGATION REPORT OF THE  
EXPLOSION INCIDENT OCCURRED ON  
11/02/2015 IN THE FPSO CIDADE DE SÃO  
MATEUS**

**anp**  
Agência Nacional  
do Petróleo,  
Gás Natural e Biocombustíveis

**Safety and Environment Department**

**August/2015**

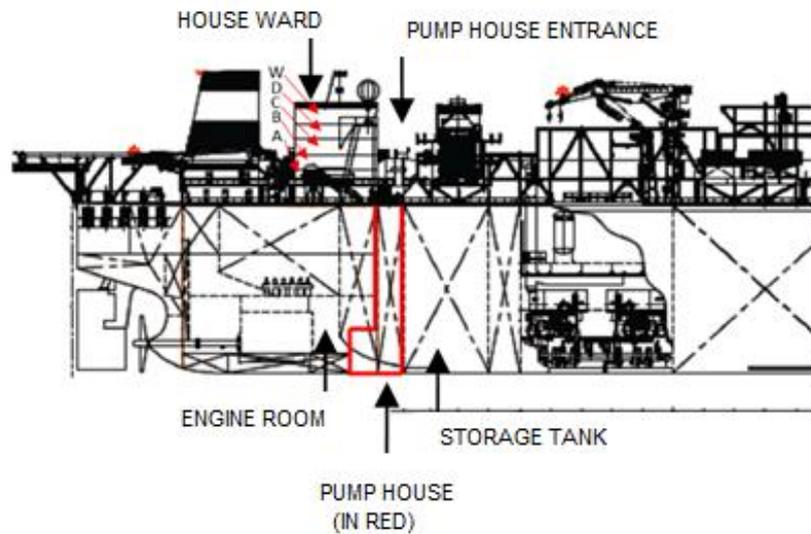
The pumps room and engine room were positioned below the houses. The location of the pumps room and engine room and the identification of the floors of the houses are shown in Figure 4.

Figure 4 - Location of the pumps room and engine room

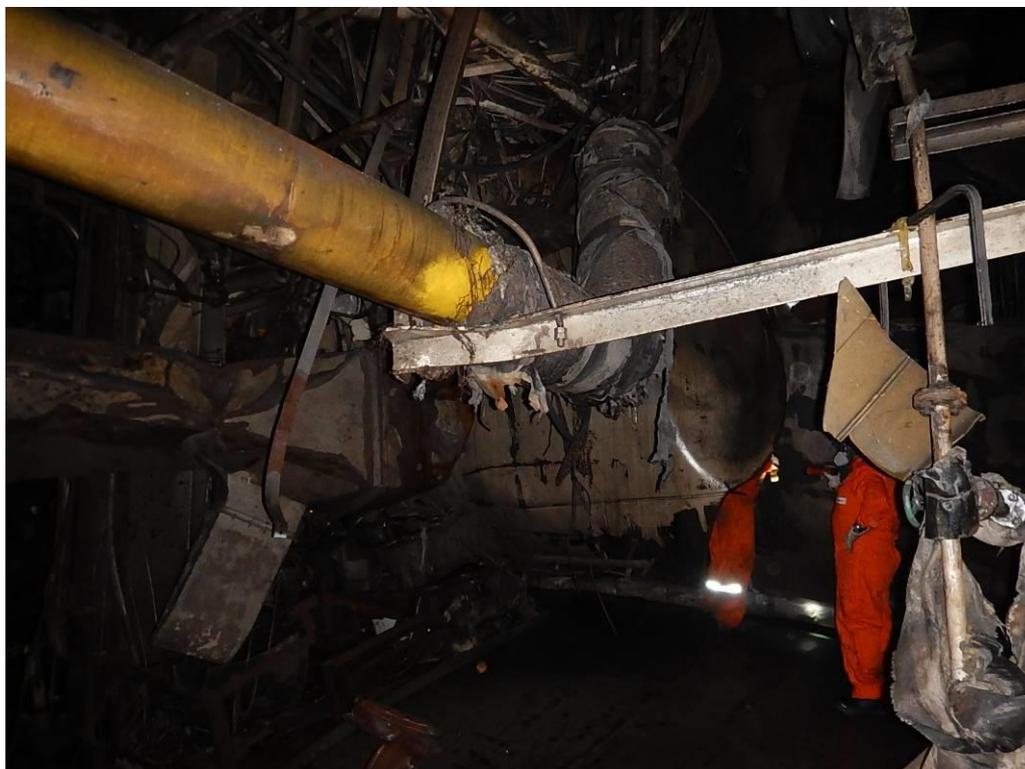
In the back of the pumps room, the pressure caused by the explosion broke the bulkhead between the pumps room and the engine room, causing destruction in this environment. The following figures show the damage caused to this area by the explosion.

Figure 7 - Area where, due to the explosion, there was communication between the engine room and the pumps room

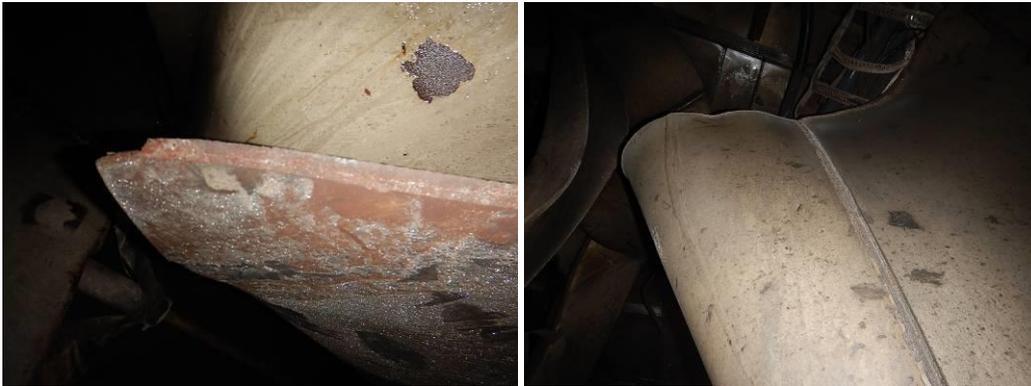
Figure 8 - bulkhead between the pumps room the folded engine room

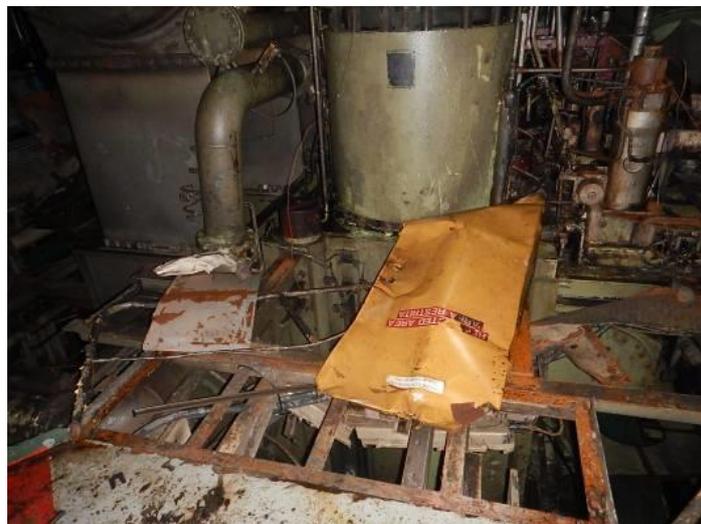
The pressure in the engine room caused the death of an operator of utilities which was located in the muster point in the engine control room (ECR). His body was only accessed and rescued around 0:00 on the day of 12.02.2015, shortly after the arrival of rescuers of the Body of Military FireFighters of Espírito Santo (CBMES). The following figures show the status of the engine room after the explosion.

Figure 11 - Port from the other control room entrance to the engine room which was located outside the room

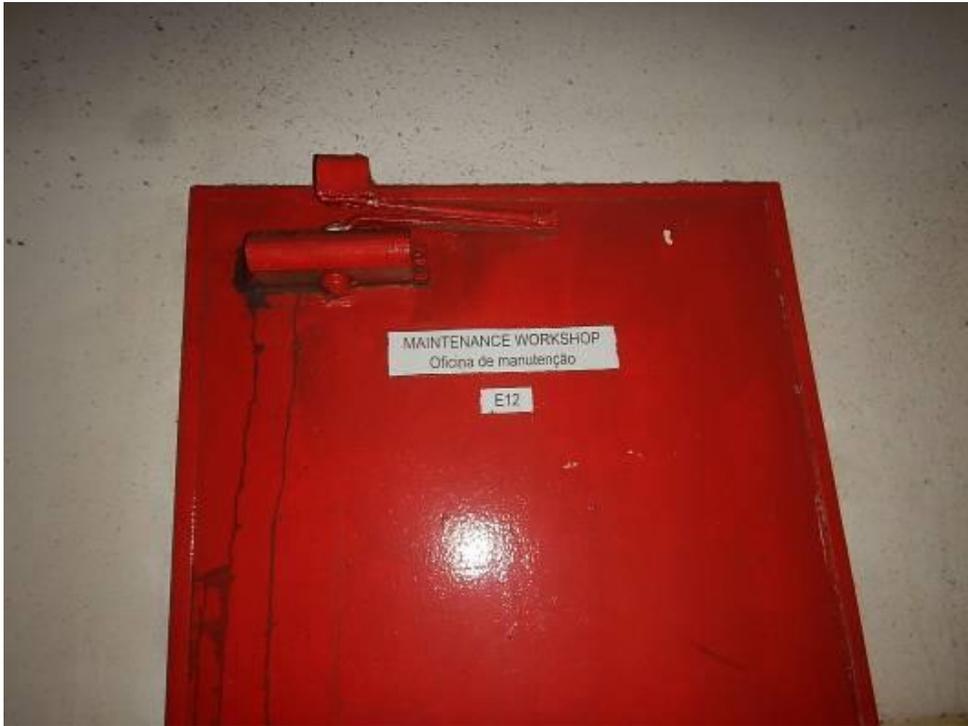
Figure 17 - vapored door maintenance workshop

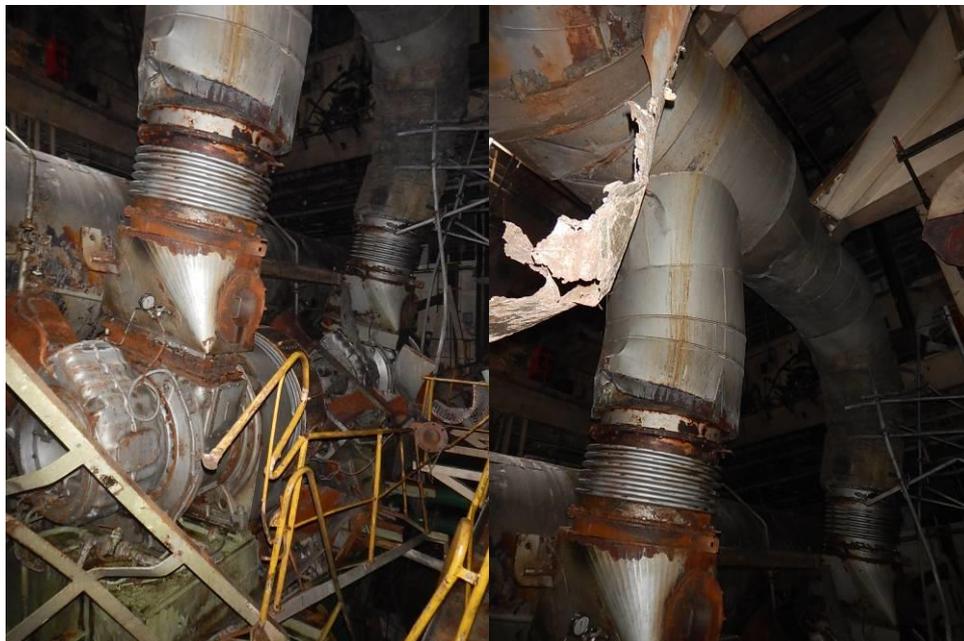
In the engine room it was found several damages, such as damaged engines, loose pieces of equipment, and also the bulkhead separating the pumps room and the engine room with an open tear dent due to the accident, large enough for people to cross. The control room of the the engine room impacted in curved walls, as well as the front door.

Figure 18 - Other systems destroyed in the engine room

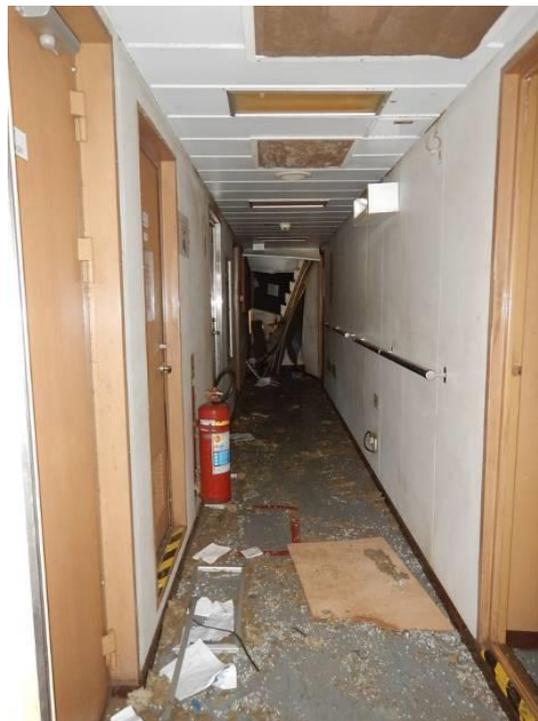
This situation is considered critical, given that the houses should be the safest place the unit, providing for the gathering of people for normal operation and for emergency situations. The houses was where the greatest number of people would be during the emergency, as people focused points against the CCR, ward and temporary refuge (cafeteria). However, the houses proved to be vulnerable to the scene of the accident. Figure 21 shows the state of one of the corridors of the houses after the explosion.

Figure 21 – house ward corridor in level "A" of the unit after the explosion.

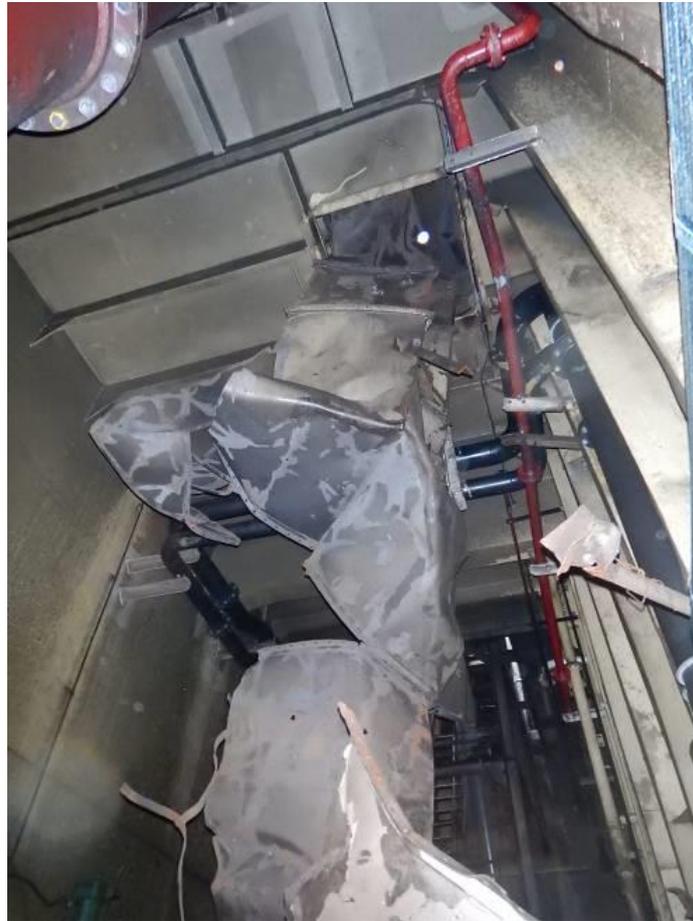
Figure 31 - ventilation ducts hanging

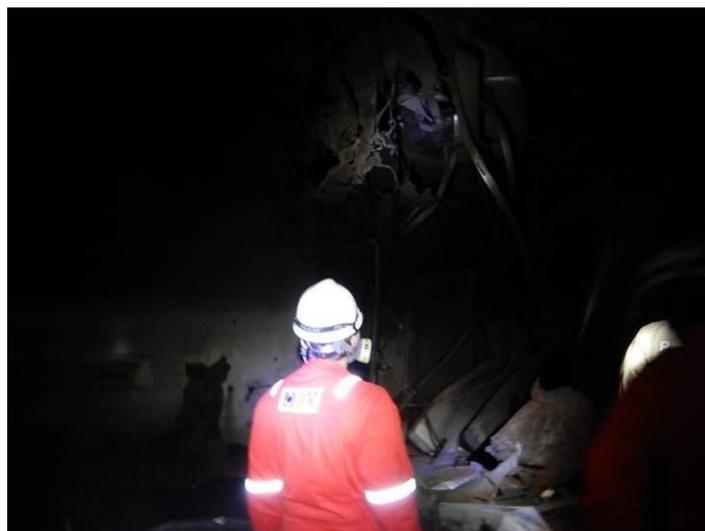
Figure 32 - Low luminosity in the pumps room

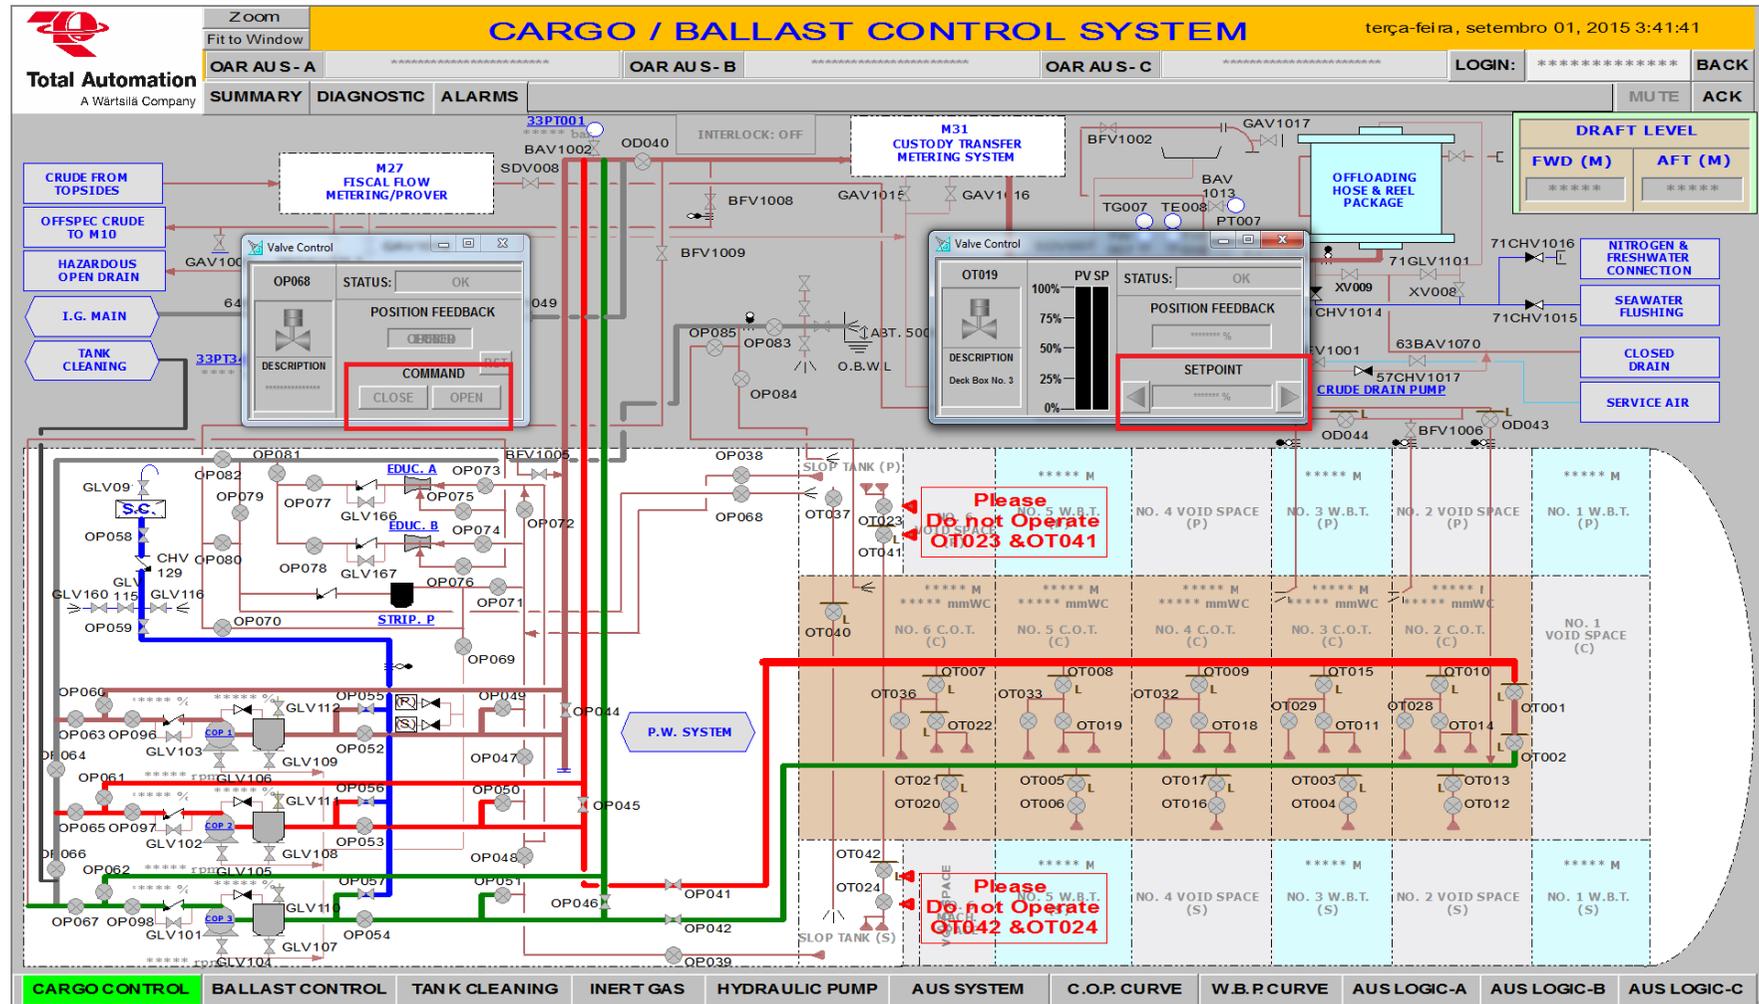
Figure 59 – Windows pop up in the HMI supervisory system for operating the valves

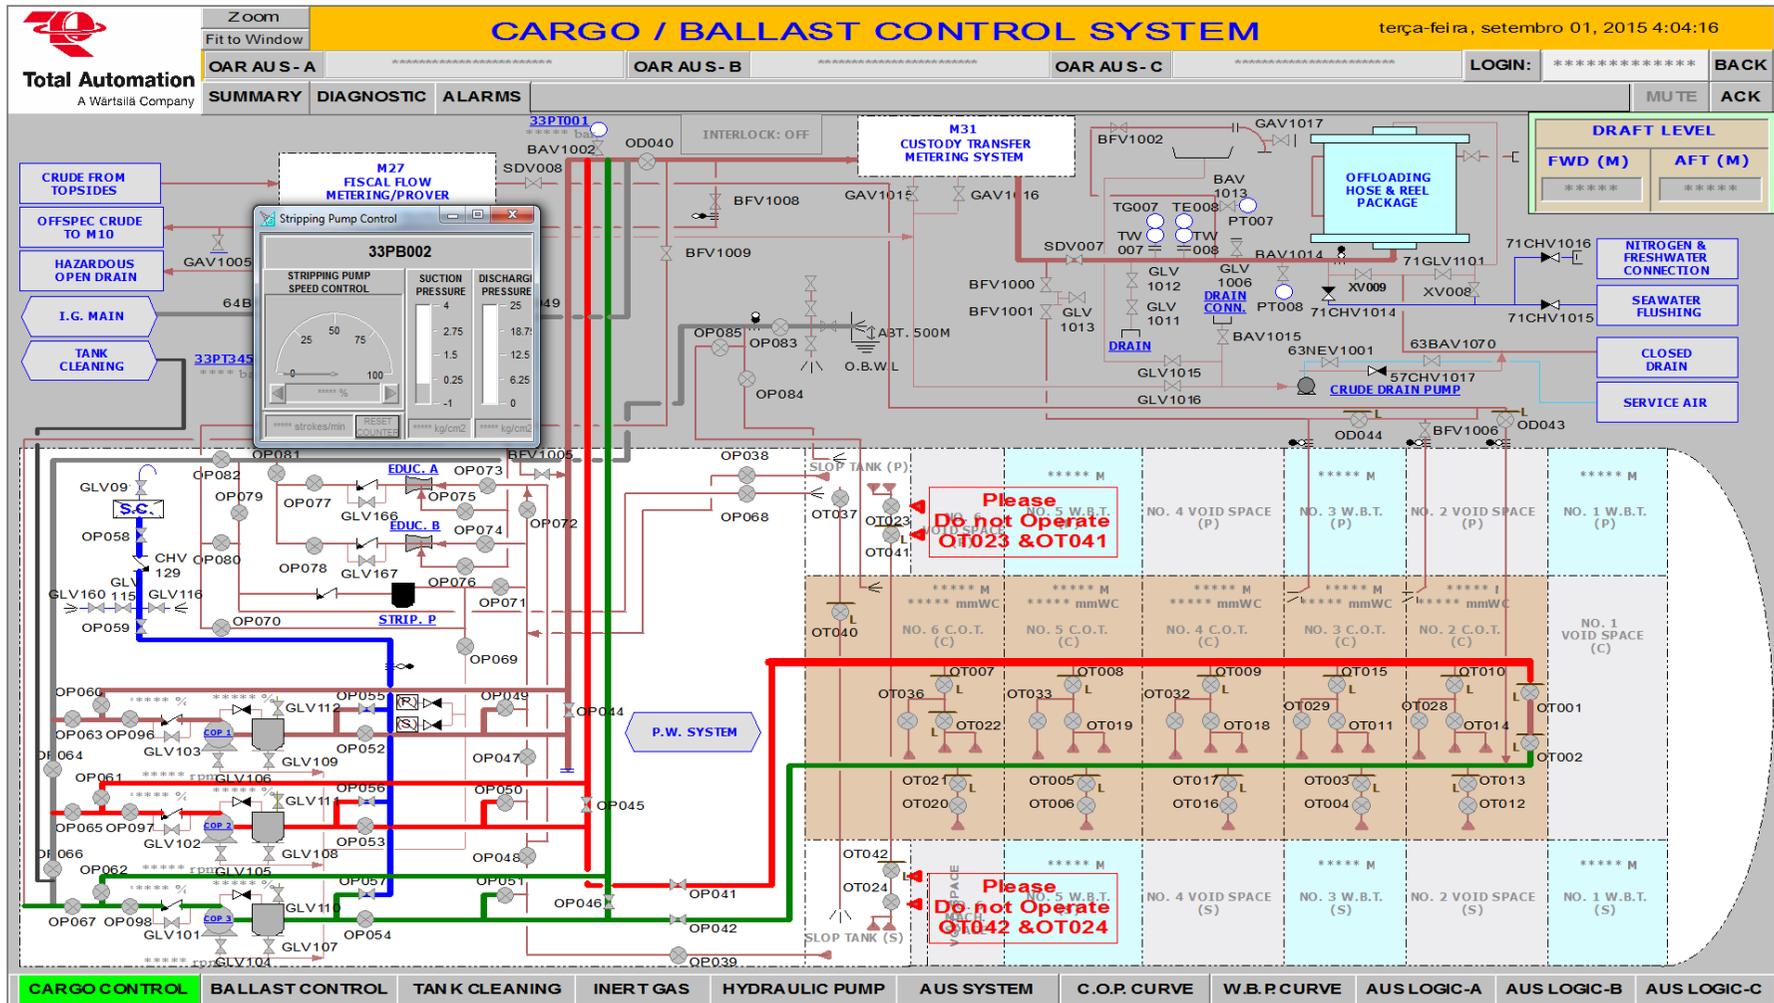
Figure 64 - Screen control and monitoring of stripping pump

The information available in CCRM for marine operator were: (i) the percentage of opening of the vapor control valve, (ii) suction pressure and (iii) the offload pressure. The stripping pump was endowed with by minute strokes counter (strokes / min) as its datasheet, and had the foresight to display the amount of strokes per minute (strokes / min) of the stripping pump on screen HMI, but this information was not available to the marine operator.

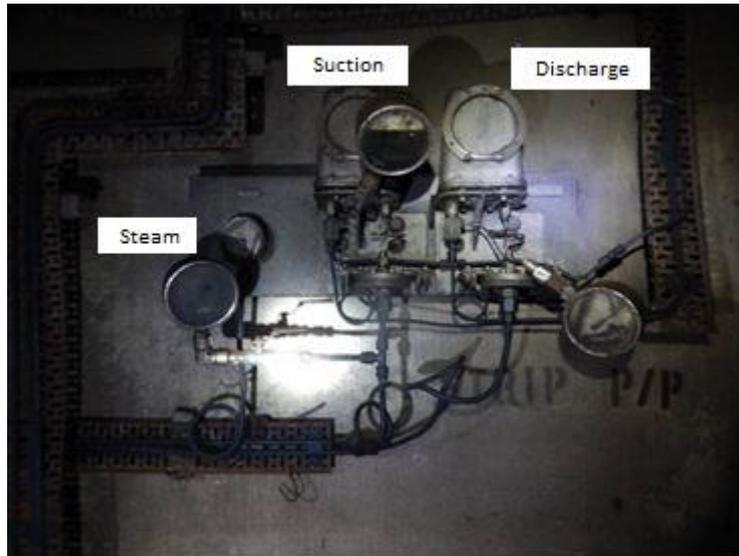
In the meantime the pump operator was in the pumps room, he had the access to the vapor pressure information, pump suction pressure and offload pressure of the pump through local indicators, as shown in Figure 65.

Figure 65 - Pressure Gauges vapor, suction and offload stripping pump at the pumps room

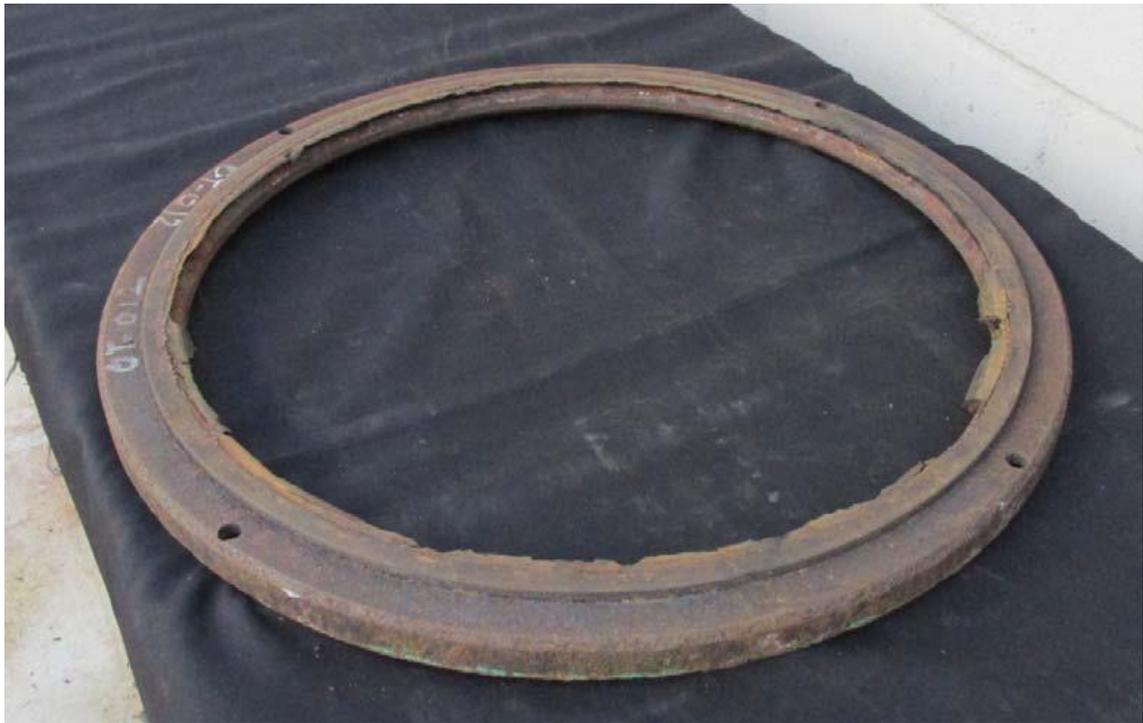
Tests performed in the rubber seal where the failure occurred showed that it was made of elastomeric material with absorption characteristics of a Nitrile Rubber (NBR), being a remarkable

fact from its composition with 9.8% of volatile materials. The report indicates this is a relatively high amount of volatile materials which can be associated with the condensate absorbed by the elastomer.

Figure 71 - Seal assembly Aspect received for analysis - photo contained in the report

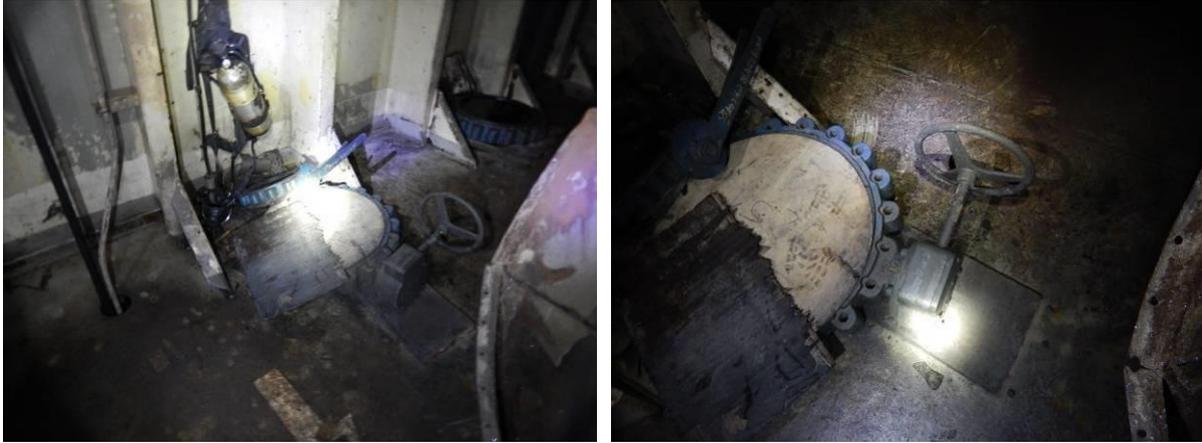
The change request for the installation of five manual valves (on the suction of the slop tanks, and between the port slop tank and 6C tank) was approved by the Operations Manager in February 2012 and evaluated by the engineering sector of BW Offshore. The valves were purchased in 09/10/2012<sup>84</sup> and embedded in the unit, but by the time of the accident it had not been installed, as shown in Figure 75.

Figure 75 - Manual valves not installed inside the pump house

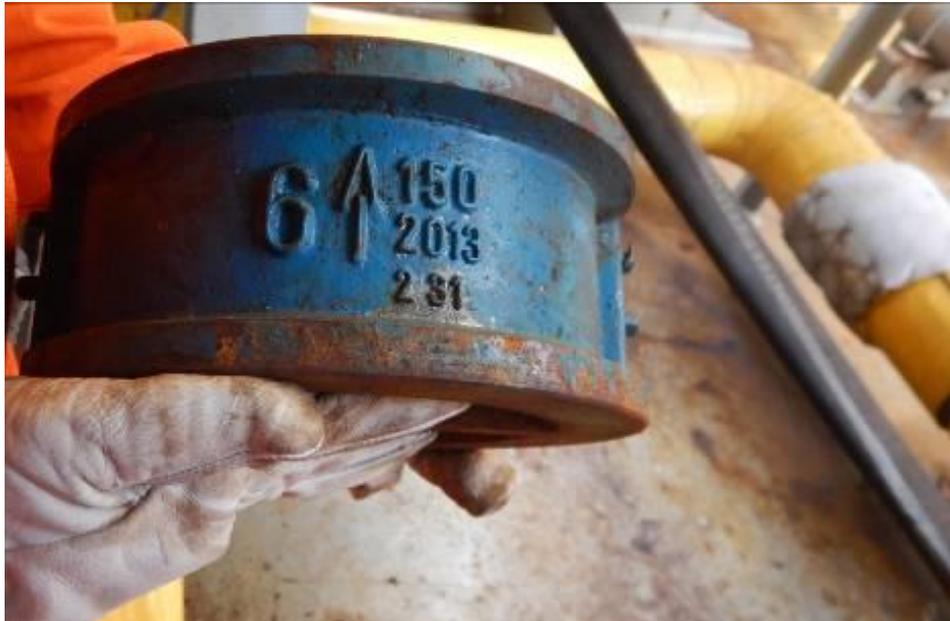
Figure 79 - Check valve which was installed (the line removed after the accident)

On 13/09/2014 the check valve installed in the inert gas drying line is reversed by setting a modification in relation to the MOC-CSM-091. In the marine superintendent of the Service Form November 2014<sup>105</sup> was recorded 6C that the tank had to be loaded (condensate production), then the line check valve MOC-091 should be inverted. Since then, the flow direction changed to the opposite in inert gas drying line, that is, through the course of the pump house to the cargo tanks, as illustrated in Figure 89. This change to the management MOC-CSM-091 change was made without hazard assessment and the overall impact on activities before implementation. The operation performed on this day was the use of stripping pump for transferring the contents of the slop tank port to 3C tank, by opening the valve in the OD-043 line run down.

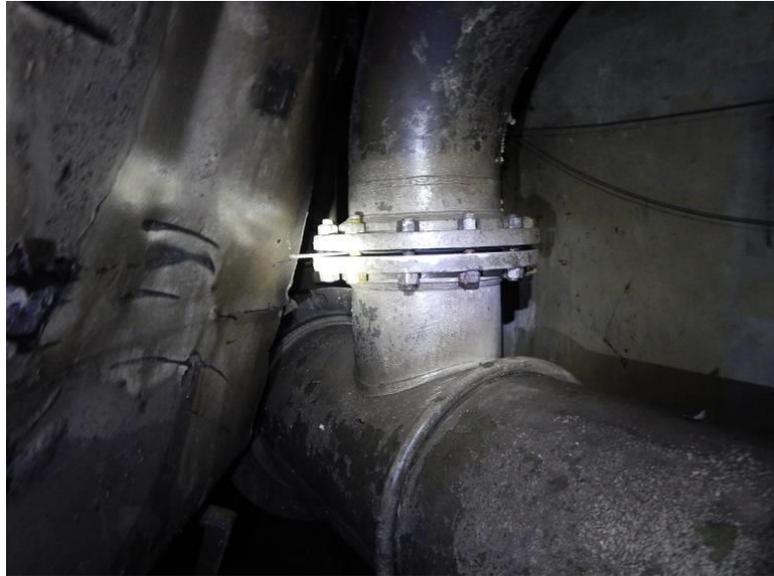
Figure 85 - Spade installed for valve insulation BFV-1005

It adds that, although the installation of spades for insulation of OP-068 and BFV1005 valves were registered in the drawing to change management MOC-CSM-091, such insulations were recorded in long-term insulation of control<sup>94</sup>. It is analyzed below in detail as were the controls and the procedures set out guidelines for insulation systems and insulation control long-term FPSO CDSM.

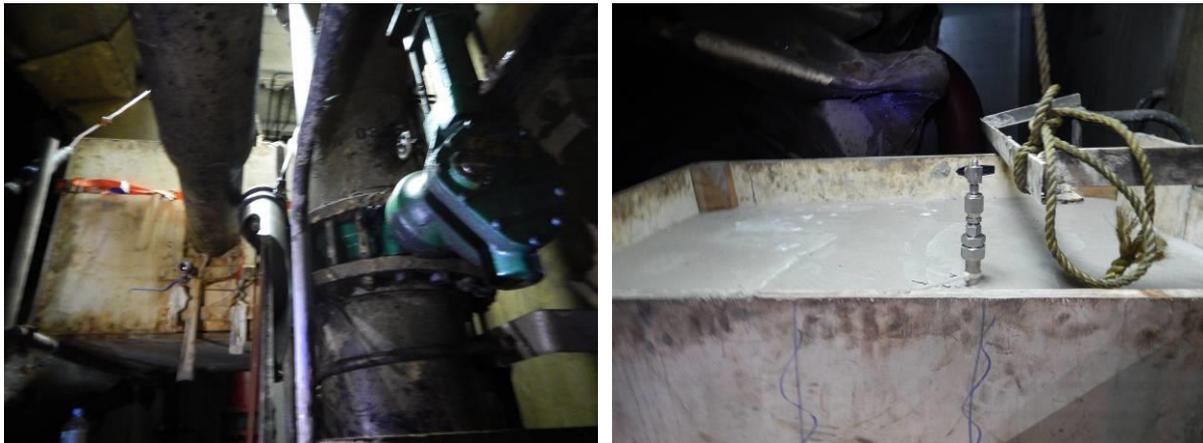
Figure 86 - Insulation (post-accident) in concrete box around the spade to installed valve insulation OP-068

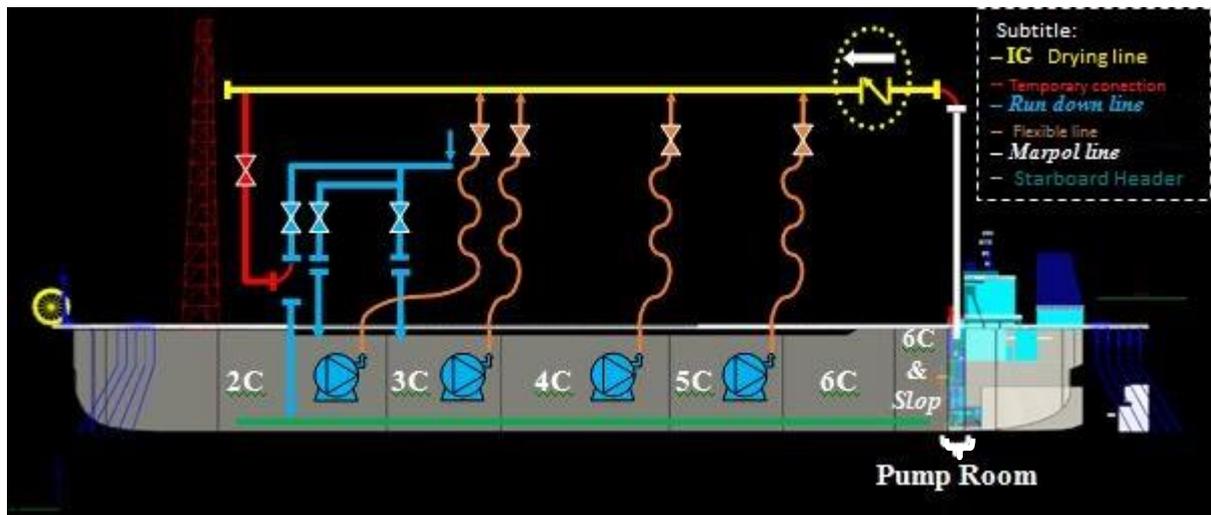
Additionally, it was found that, during and after repair of the valves of the tanks 2C to 5C and slop tank port, activities were carried unplanned changes that used in relation to own MOC-CSM-091<sup>106</sup>, distorting the originally intended use of the alternative alignment installed.

Figure 89 - Change in the MOC-CSM-091

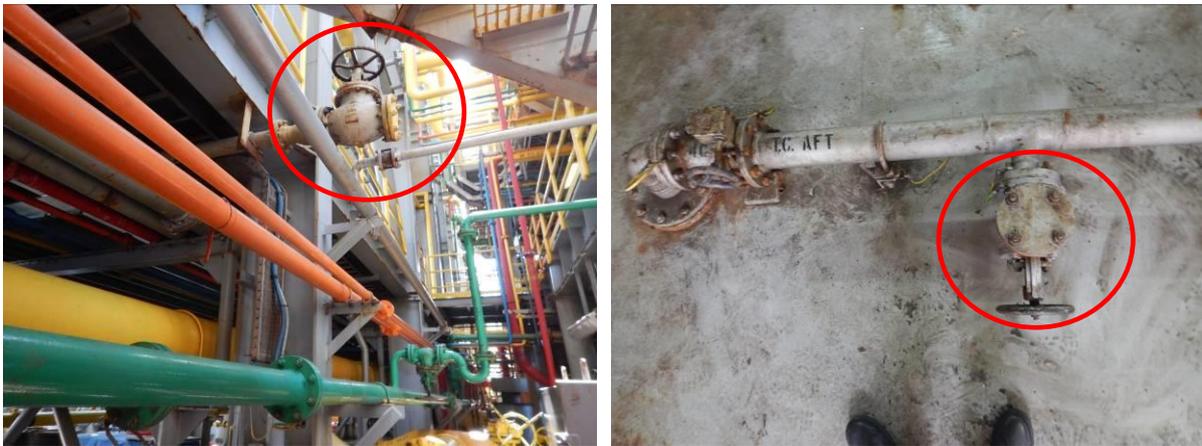
The contents of the port side slop tank was being directed to the tank 4C using the stripping pump and, therefore, it was necessary to use the washing line 4C tank (4C aft COW line). This alignment with COW line with installing insulation to isolate the 4C of other tanks, shown in the following figures, is yet another modification that occurred without prior assessment of the dangers and the overall impact on the activities, i.e., without using the tool change management.

Figure 90 - Flexible hose connection points between closed drain and 4C aft COW line

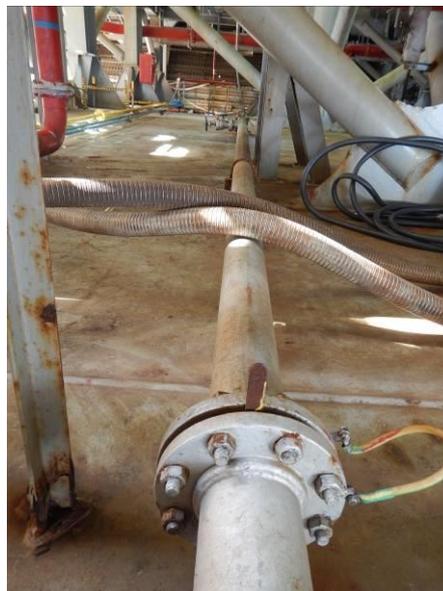
Figure 10 – Insulation of 4C aft COW line

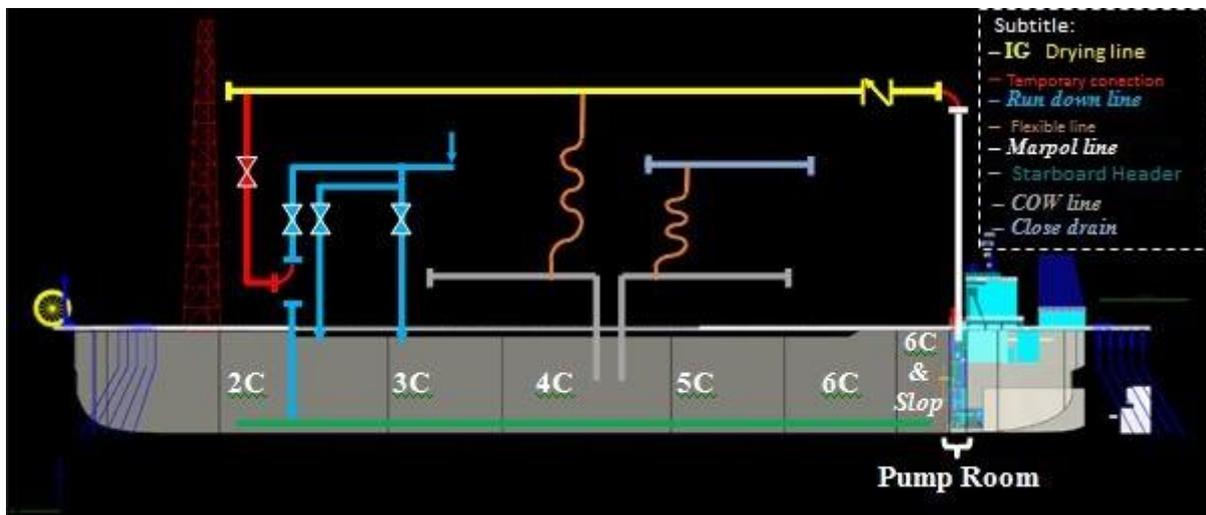
It was shown that in this period in January, the situation of use of inert gas drying line connected to 4C tank as well as the direction from the drain to the 4C tank was as follows.

Figure 92 - Wiring diagram of flexible hoses to the tank 4C

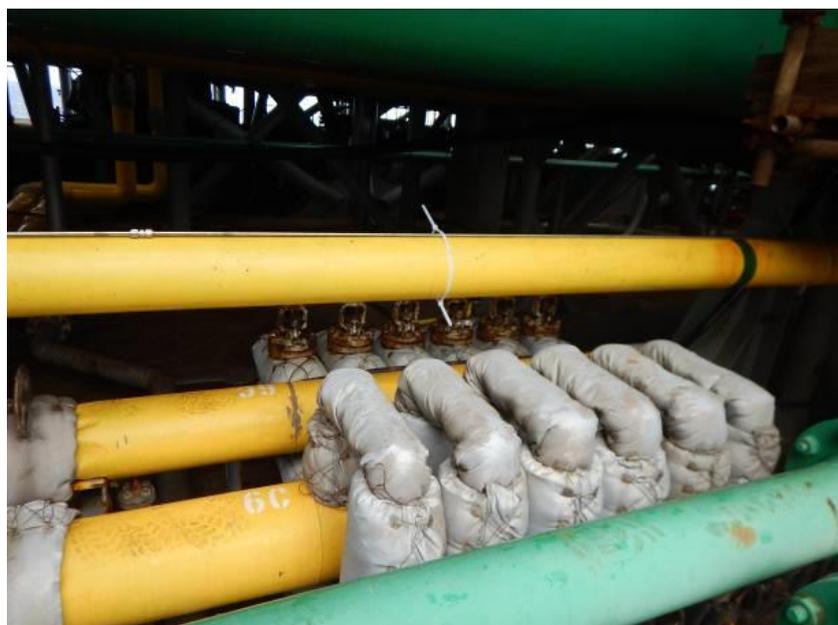
As evidenced in audit, on 17/01/2015 it was started this a try operation 6C empty the tank through the condensate vaporization. This shutdown was initiated due to the difficulty to empty the tank with the stripping pump. The objective was to heat the water inside the tank 6C utilizing the existing steam line within the tank. This operation was evidenced by the early 6C tank temperature record in office log book to book, which so far contained no temperature record in this tank.

Figure 93 - Valves in the upper deck of the heating line (steam) of 6C tank

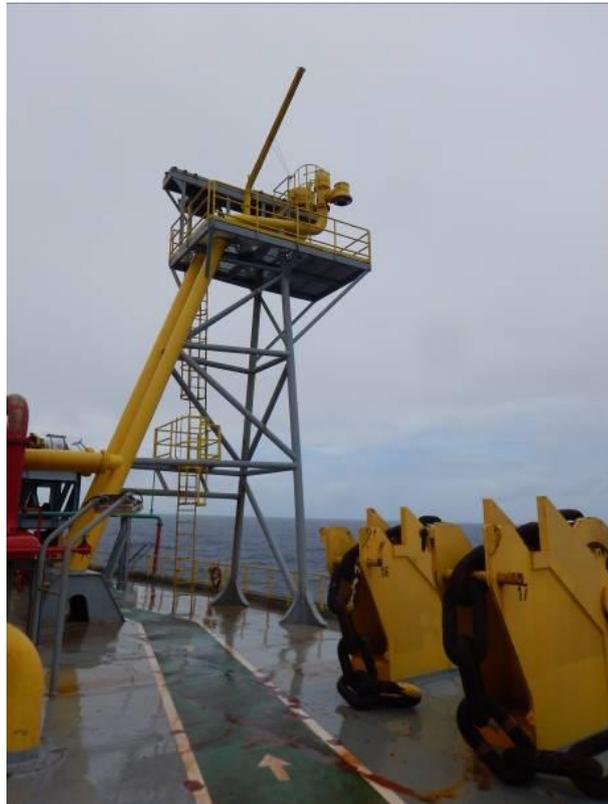
The expected result was that the condensate layer above water was sprayed at about 35 ° C. Vapors were continuously vented by the vent riser (shown in Figure 94) daily, the day shift, with inhibition of gas detectors on the main deck, in the area near the exit of the vapors. The scheme used to blow the gas is shown in Figure 95.

Figure 94 - Vent riser, the ship's starboard side

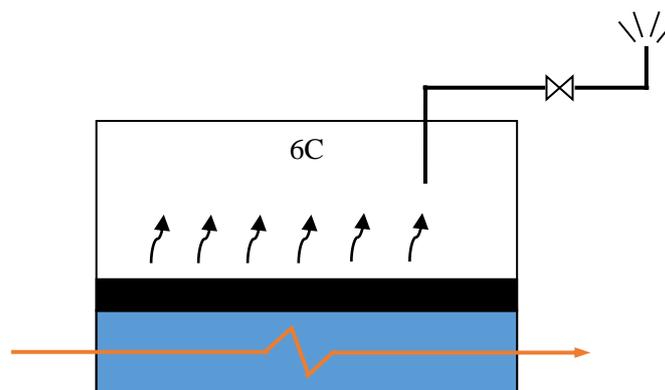
Figure 95 - Simplified scheme condensate vaporization operation

This task was also not assessed by change management and was not part of MOC-CSM-091 records. On the day of the overseer service passage 21/01/2015 this operation were recorded, there

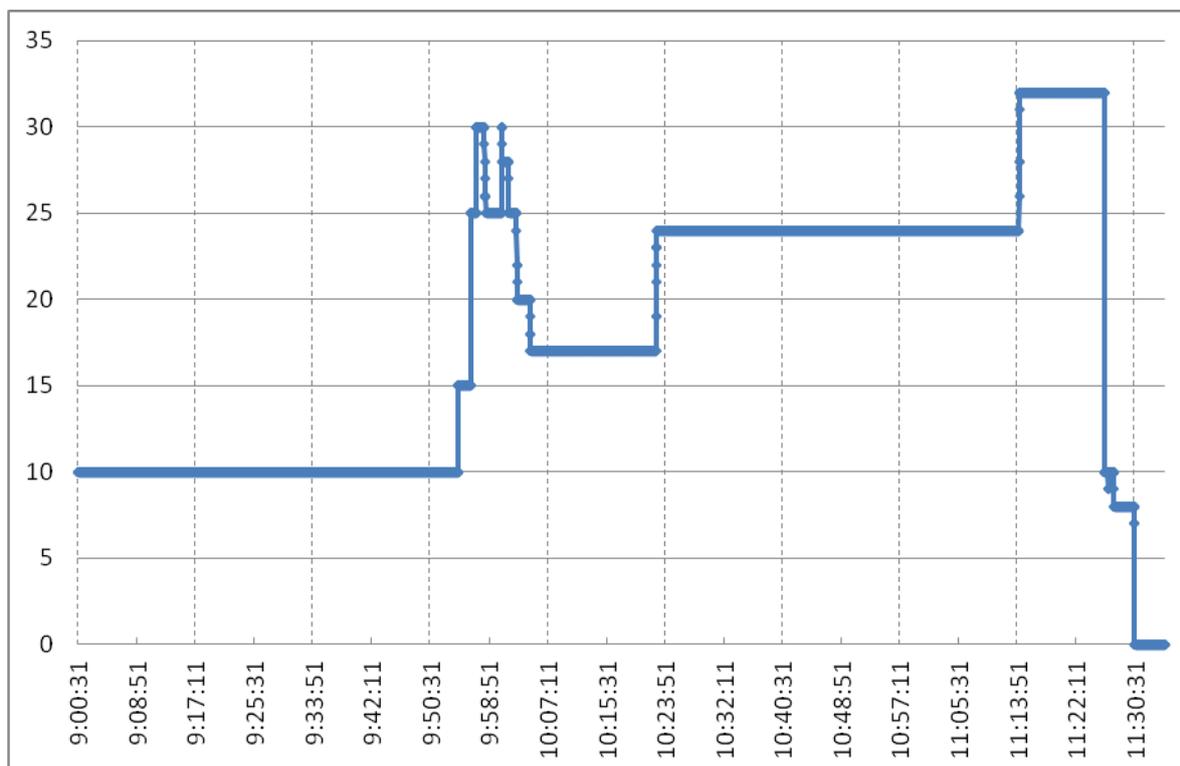
According to digital information recorded by the supervisory system, on 02.11.2015 the supply of steam for stripping pump was started at 09: 00 am, with an opening percentage of the control valve by 10%, as shown in Figure 96 as follows.

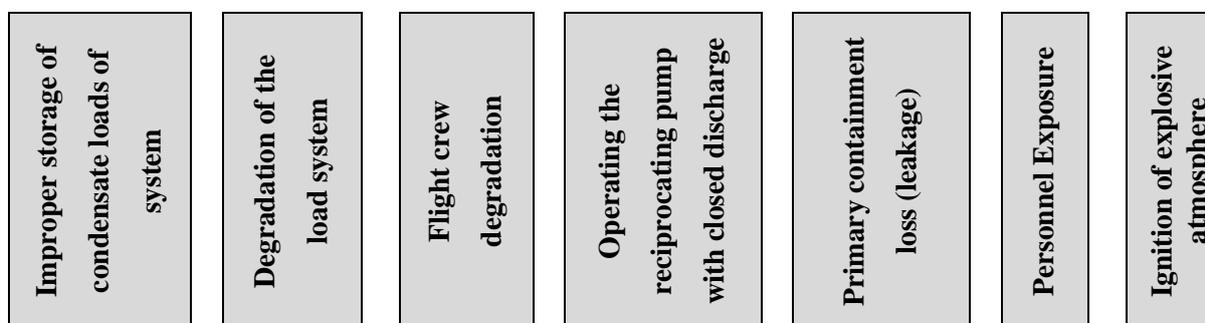
The event was considered condensate leak followed by explosion in FPSO CDSM the pump house that caused the death of nine people twenty-six wounded, seven serious damage to the installation, partial flooding and interrupting the production of two production fields indefinitely without damage to the environment.

For the accident FPSO Cidade de São Mateus, Figure 97 represents the sequence of causal factors identified in this investigation. For a better understanding of the public not knowing the SGSO, the root causes have been reported both in general appearance (proximate causes), as related to SGSO requirements (root causes), with the respective item infringed management indicated in bspades .

Figure 97 - causal factors of the explosion accident in the FPSO City of St. Mateus on 11/02/2015

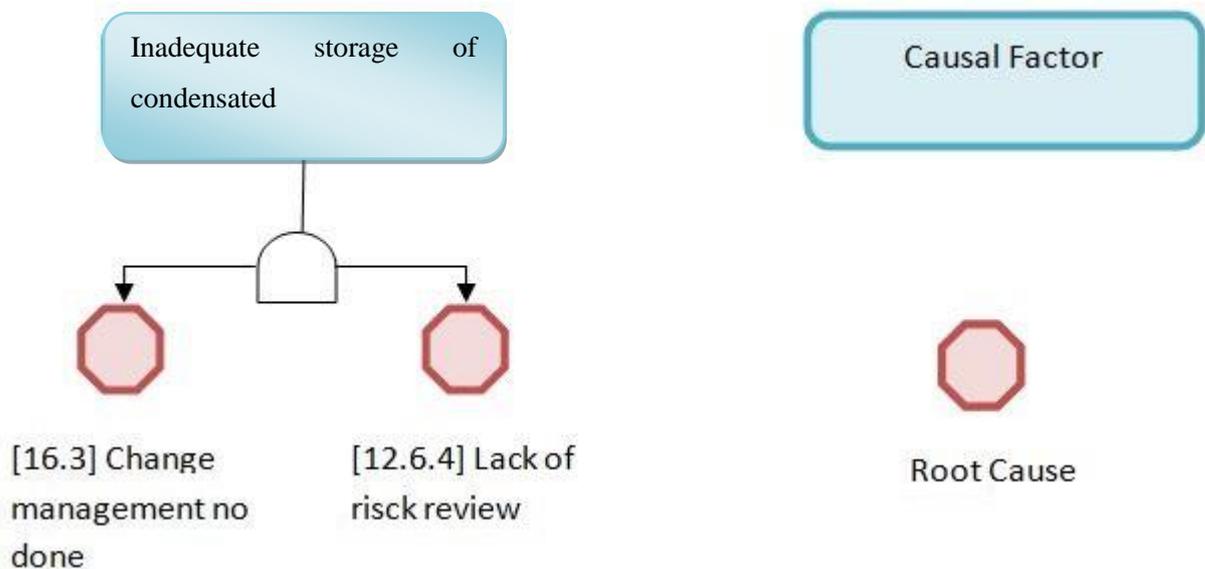
Figure 98 - Causal Factor # 1: Inadequate Condensate Storage

Despite this, there is another opportunity to correct such deviation, since there was a requirement that risks were reviewed at the beginning of the production phase. This review could not be evidenced during this investigation, since the safety studies issued at the design stage were still in force on the date of the accident, also considering the initial specification of not stock condensed without being mixed with oil.

Hence, it is found that, due to the lack of a change management process before the unit operation and lack of risk review at the beginning of unit operation as described in the following sub-items, was stocking inadequate condensate on the platform..

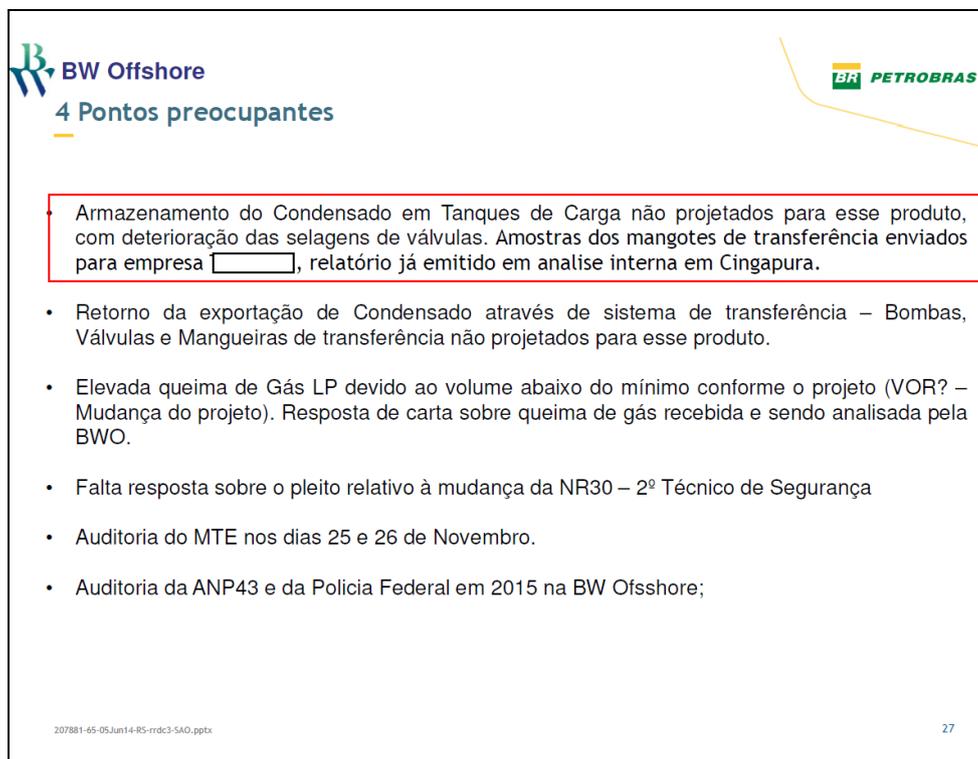
Figure 100 - BW indication Petrobras that the condensate storage in the FPSO CDSM was done improperly

It was evident during the investigation that the improper storage of condensate was known both as BW Offshore Petrobras, as it indicates presentation by BW Petrobras Operational Meeting Monitoring (ROA) of 01.26.2015. Figure 100 shows the slide with pain points indicated by BW.

- Armazenamento do Condensado em Tanques de Carga não projetados para esse produto, com deterioração das selagens de válvulas. Amostras dos mangotes de transferência enviados para empresa [redacted], relatório já emitido em análise interna em Cingapura.
- Retorno da exportação de Condensado através de sistema de transferência – Bombas, Válvulas e Mangueiras de transferência não projetados para esse produto.
- Elevada queima de Gás LP devido ao volume abaixo do mínimo conforme o projeto (VOR? – Mudança do projeto). Resposta de carta sobre queima de gás recebida e sendo analisada pela BWO.
- Falta resposta sobre o pleito relativo à mudança da NR30 – 2º Técnico de Segurança
- Auditoria do MTE nos dias 25 e 26 de Novembro.
- Auditoria da ANP43 e da Polícia Federal em 2015 na BW Offshore;

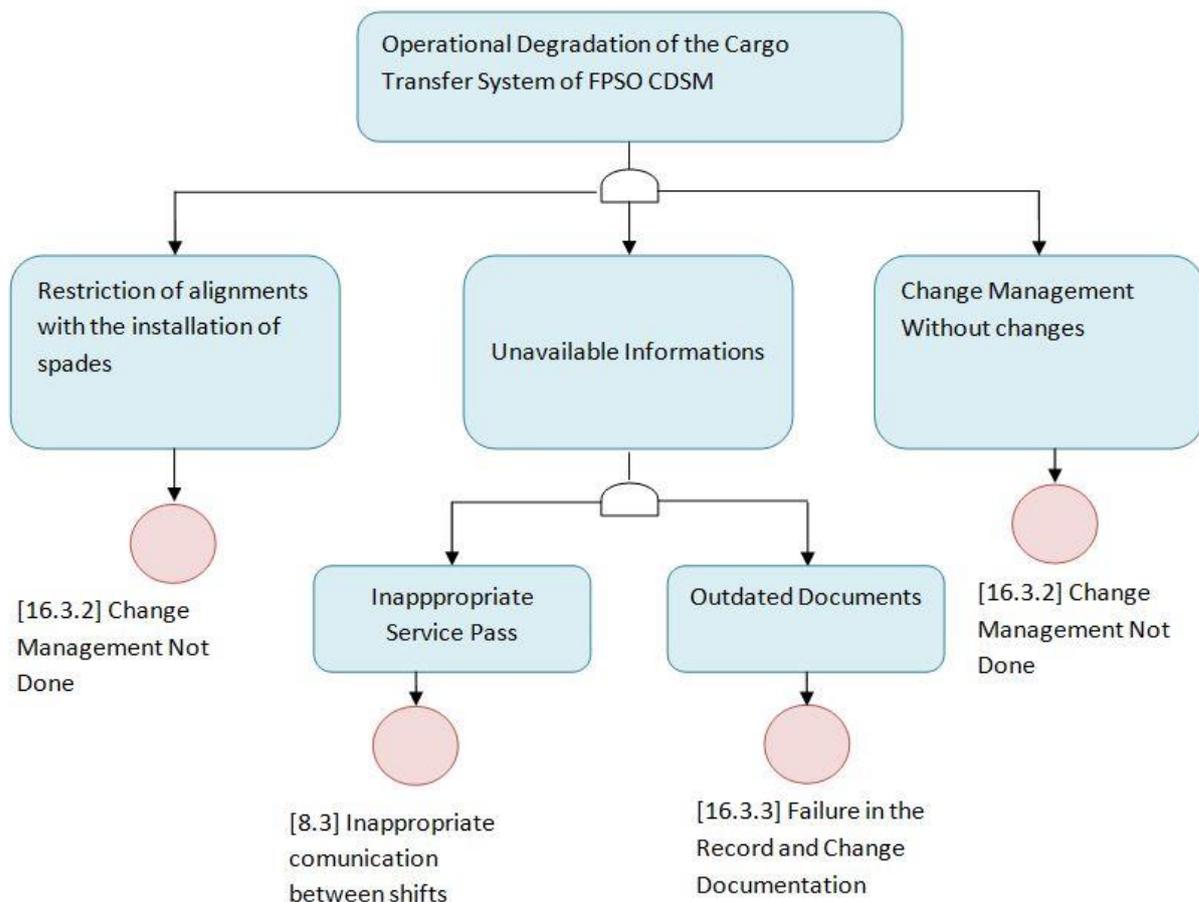
Figure 104 - Causal Factor # 2: storage system degradation FPSO CDSM

In this way, by storing different fluid other than that for which it was designed without there being previous change management to identify and mitigate the impacts, the FPSO storage system was to be degraded over time in relation to its design condition.

The degraded state of the charge transfer system restricted common transfer operations between tanks and drainage tanks, so that means were used that introduced risk and some unfit for operations as inadequate spades and the use of a pipe for condensate which had been designed to conduct inert gas.

The actions taken to try to correct the degradation of cargo transfer system without the machine operator was paralyzed were sometimes made without risk analysis or any evaluation of hazards and the global impact on activities before the change implementation. In addition, some of the changes to the project were not adequately documented and relevant information for operating the system have not been reported in the service passage. These factors contributed to the accident and their causal factors are described below.

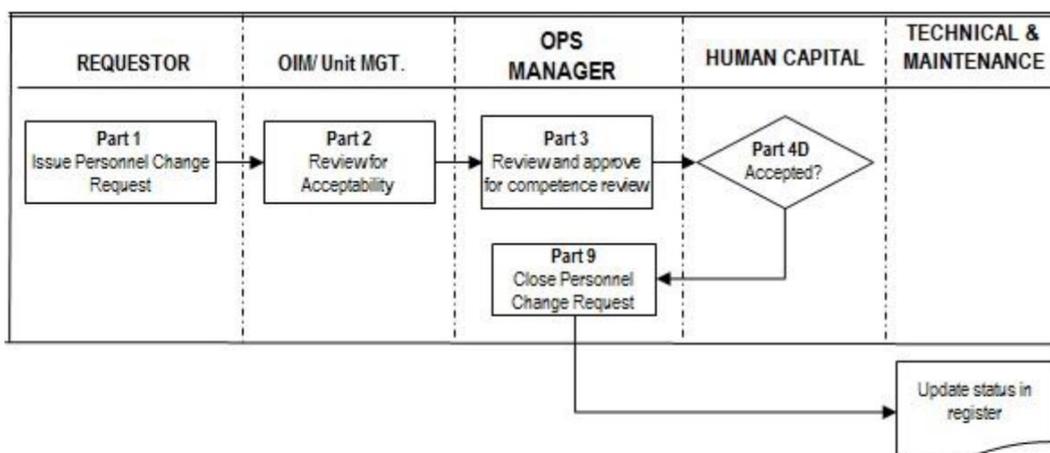
Figure 107 - Flow management change people contained in the BW procedure

According to this procedure, the flow of personal change management would be approved by the Division of Human Resources of the company - but should be opened / started by a requester, approved by the IOM of the FPSO and reviewed / approved by the Operations Manager, as illustrated in Figure 107, removal of the change management procedure. However, it was evidenced both by testimony and by historical service ticket and performance evaluations that all Marine and OIMS team knew the lack of marine superintendent position, however, there was no opening of a Change Management form by no "requesting" (the identifier change agent)..

Additionally, it was observed in audit that this procedure was not being applied in any case of change of people in the FPSO CDSM and was conducted either at the output of marine superintendents.
