**INVESTIGATION REPORT OF THE  
EXPLOSION INCIDENT OCCURRED ON  
11/02/2015 IN THE FPSO CIDADE DE SÃO  
MATEUS**

**anp**  
Agência Nacional  
do Petróleo,  
Gás Natural e Biocombustíveis

**Safety and Environment Department**

**August/2015**

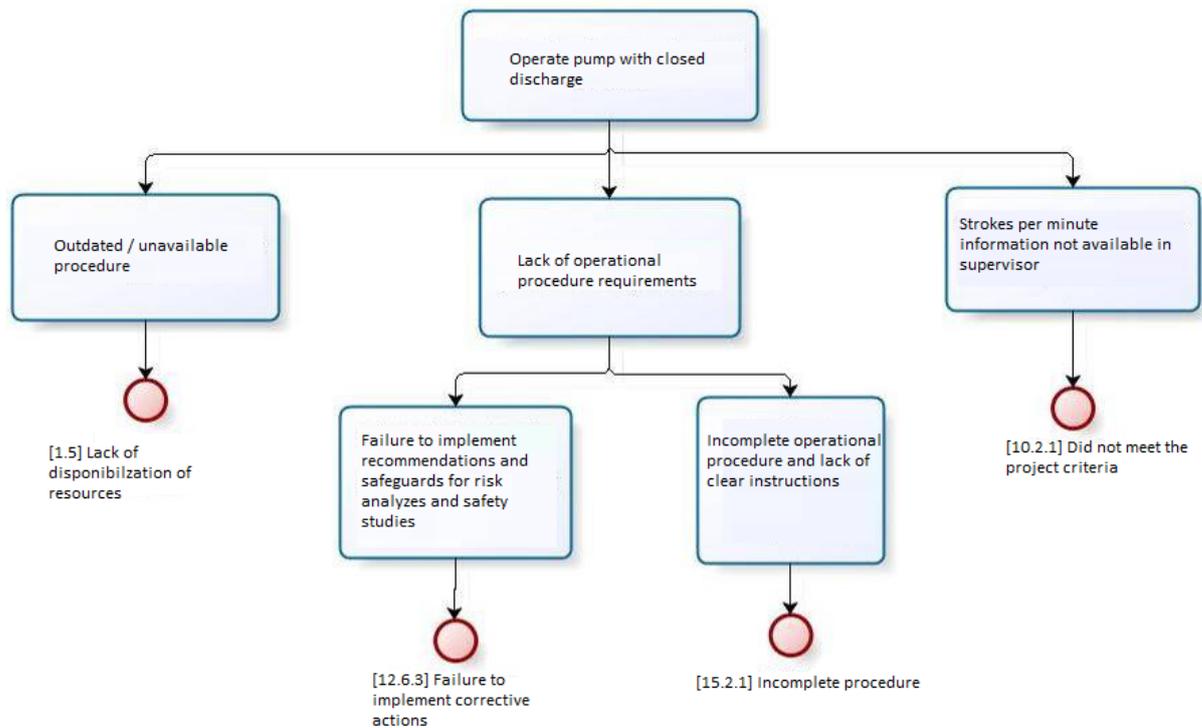
Figure 111 – Causal Factor n° 4: Operating the stripping pump with the offload sealed

Such associated facts led to the situation where it is allowed to operate a reciprocating pump with its offload lines closed, a fact crucial to the accident. This causal factor and their causes, which are described below, are indicated in Figure 111.

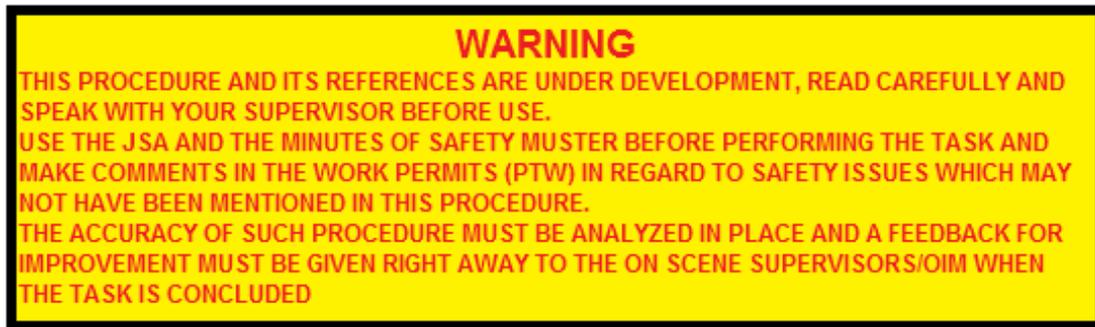
Figure 112 - Warning contained on the cover of the operating procedure of charging system

These inserts capitalized in operation, associated with lack of control of the information by using different means to control information set by BW Offshore discourages its use, making it inefficient. Such a condition was considered analogous to the lack of operating procedure, since such a risk control mechanism was not kept by the BW and its use was discouraged by the procedure itself.

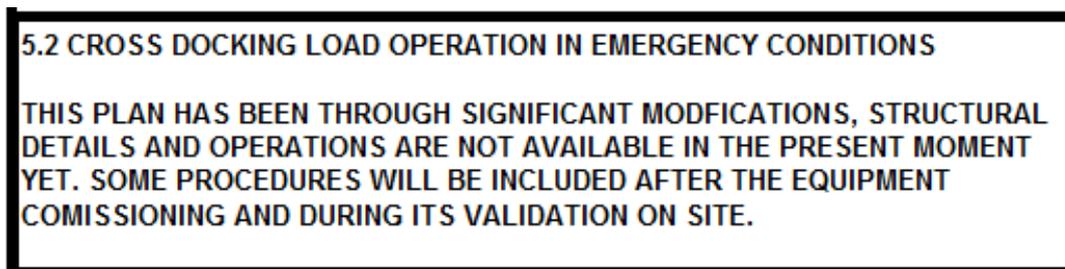
Figura 12 – Item referente à operação de transferência de carga em situação de emergência

Additionally, in this procedure, the section in which is described the charge transfer operation in an emergency situation, there is described below acknowledgment confirming that the procedure was obsolete:

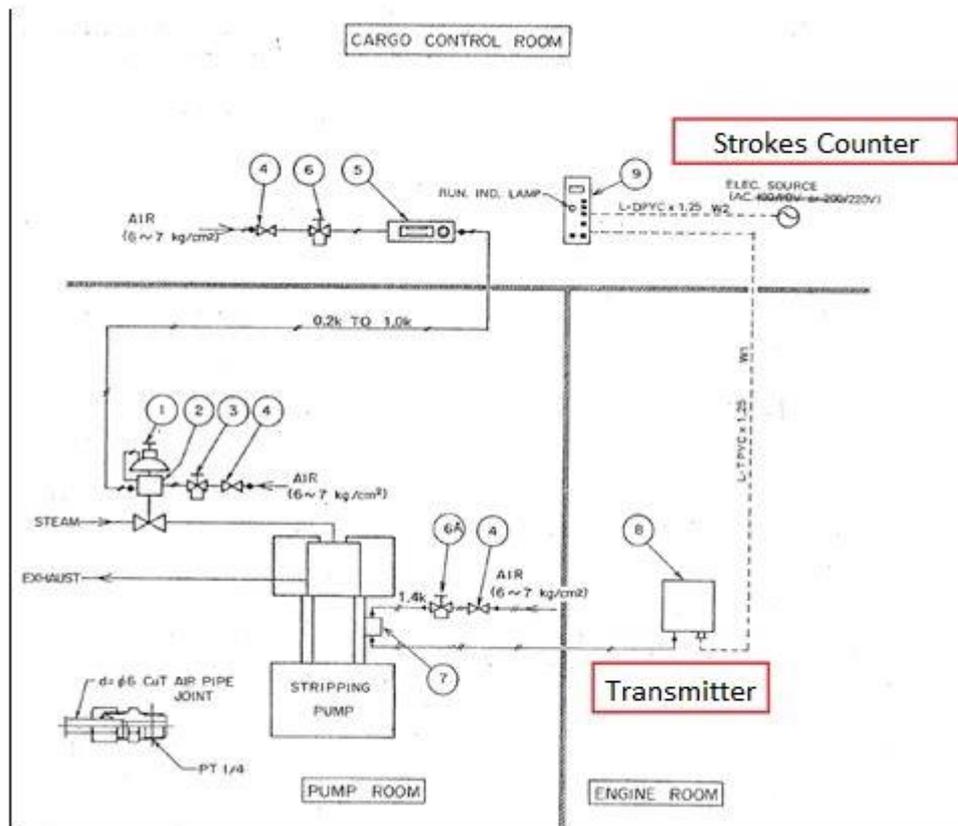
Figure 118 - Wiring diagram between the stripping pump and the CCR for the transmission of strokes count

According to data sheet stripping pump<sup>177</sup>, it could provide information of strokes count for CCR. The circuit diagram can be seen in Figure 118.

The strokes counter was not available to the marine operator since the commissioning of the unit, as (i) information provided by the plant operator<sup>178</sup>, (ii) audit evidence and (iii) change management on incomplete commissioning of the charging system and ballast control system and (iv) evidence obtained through hearings.

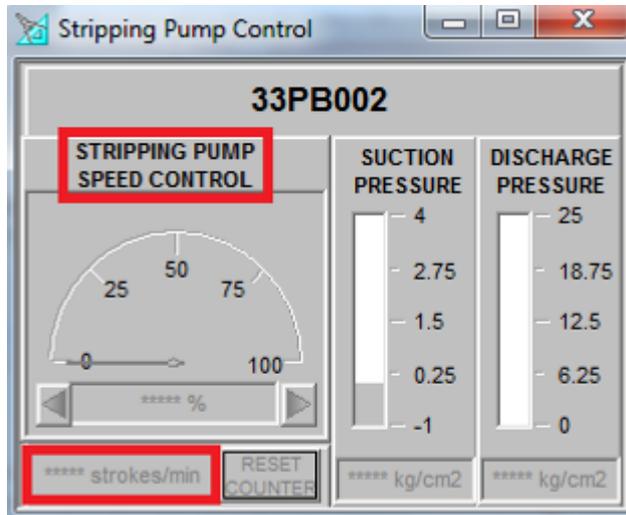
Figure 119 - supervisory system of the window where stated field to pump reading speed in strokes / minute

The supervisory system was designed to provide information of the number of strokes / minute as shown in Figure 119.

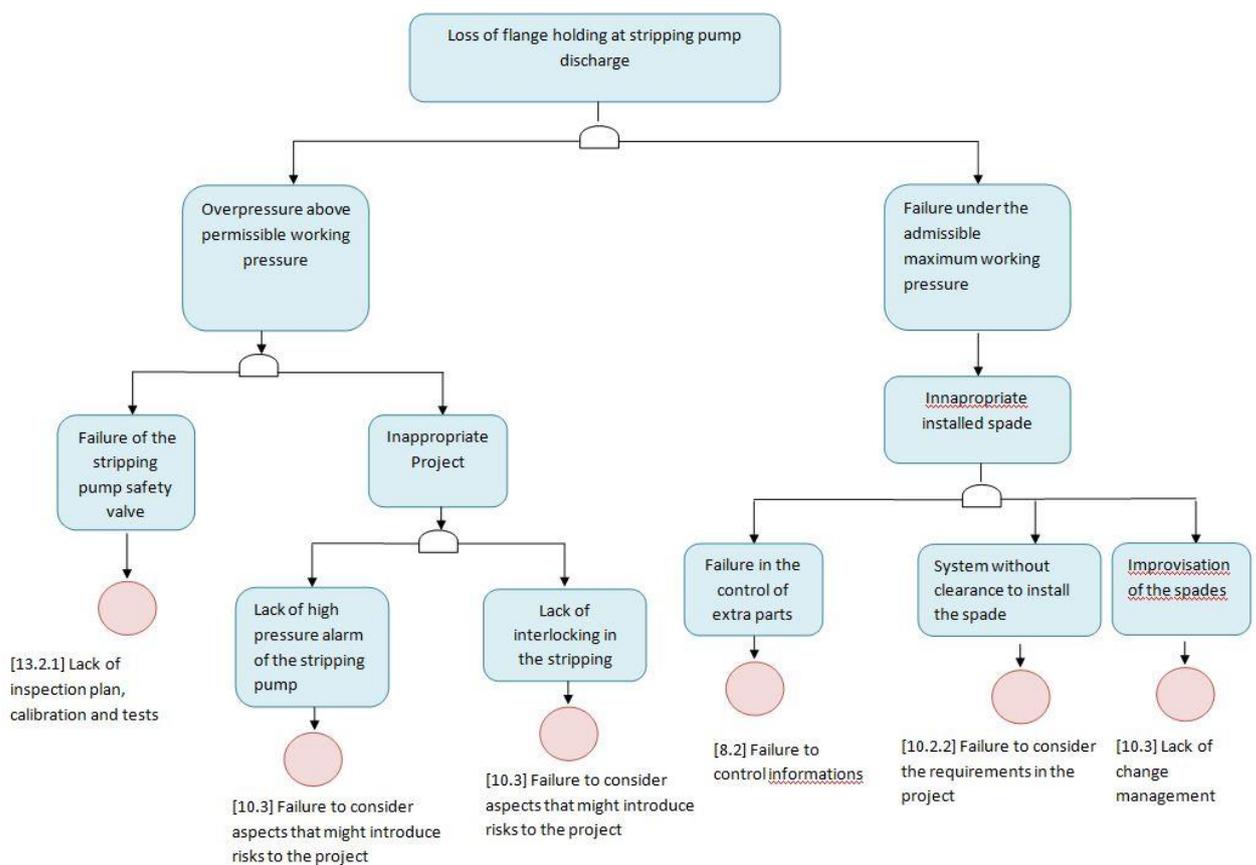
Figure 120 - causal factor 5: primary containment loss condensed material

the load transfer system for unit conversion and various managerial failures that led to the leak in the pump house.

Above the MAWP, considers the absence of PSV calibration routine (critical system) and no alarms and interlocks as possible causes. Below the MAWP, it was found that the unavailability of type JIS spades (Japanese standard), the lack of space (allowance) for the installation of pressure class spades appropriate to the system, the lack of spades installation control procedures and improvisation spades are possible causes. These causes are detailed as below.

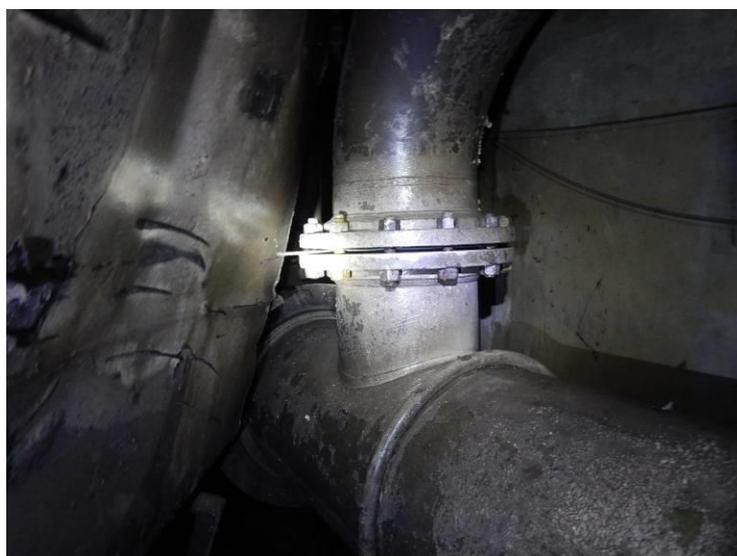
Figure 123 - Example of installed spade Online load transfer system

The lack of gaps in the lines of charge transfer system meant that the crew members could not properly carry out the insulation in the flange to the amount of OP-068 valve, then proceeding isolation with a spade with a thickness possibly less than that required for line pressure class.

The Figure 123 shows an example spade installed in-line load transfer system. You can see that its thickness is notably much lower than the flanges, showing that it is probably spade not specified for the line pressure class.

Failure to apply for the pump house the same engineering standards used for the process plant for the conversion project prevented the installation of proper spade, contributing to the insertion in line with a permissible pressure element probably below the MAWP system. Such

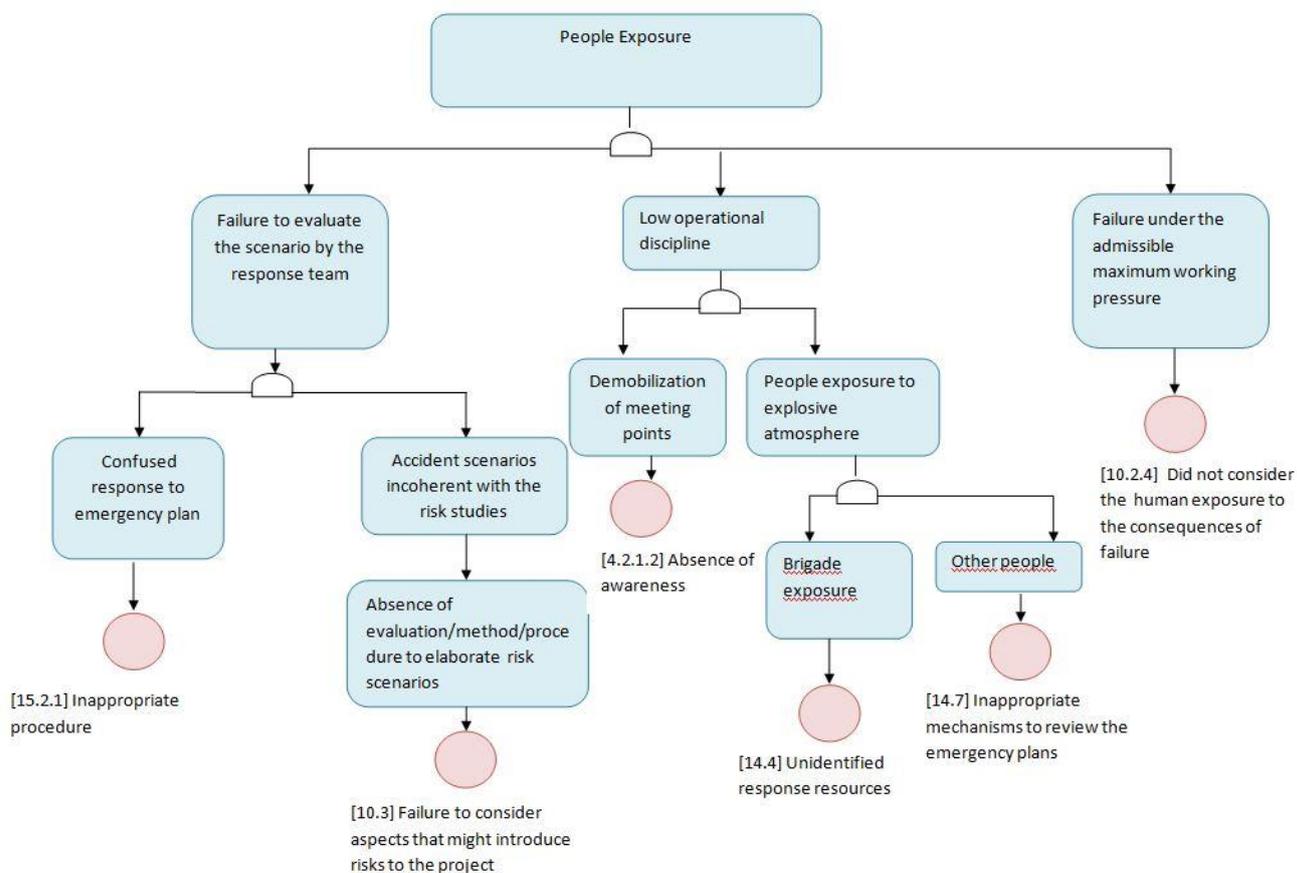
Figure 126 - Causal Factor 6: Exposure to Personnel

Another cause of the danger people from exposure due to the setting of the meeting points for people with response function to the emergency, made without being considered safety studies of FPSO CDSM therefore without proper assessment of the effects of a possible explosion scenario in the pump house (or staggering) about the points against. It is noteworthy that one person was killed and others were injured as they stood in their respective meeting points.

The causal factor called exposure of individuals is shown in Figure 126 and their causes are shown below.

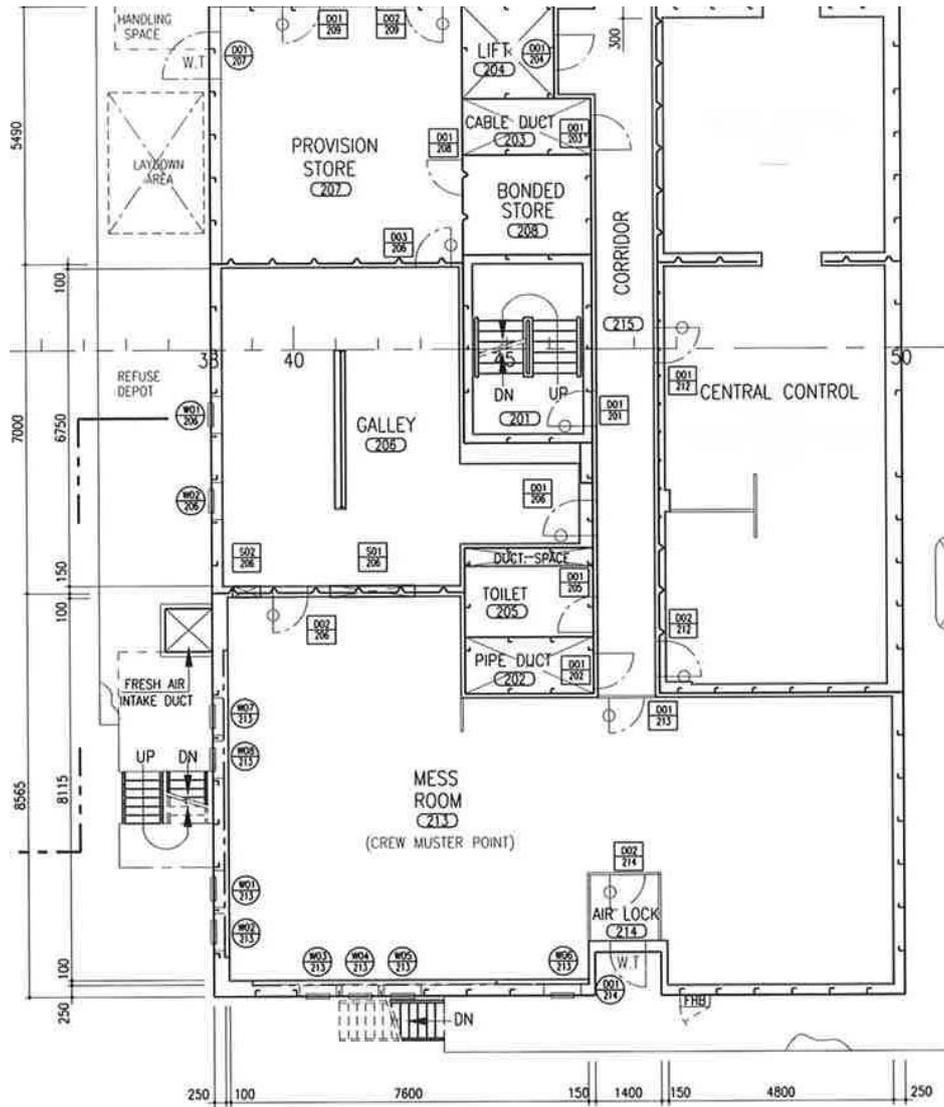
Thus, based on guidance from the offshore incident command, the meeting place of temporary refuge (cafeteria) was demobilized and the meeting points of the infirmary and the engine room control room were partially demobilized. The position of the temporary refuge of the meeting point is shown in Figure 129.

Figure 129 - temporary shelter position and response command to the emergence of FPSO City of St. Mateus

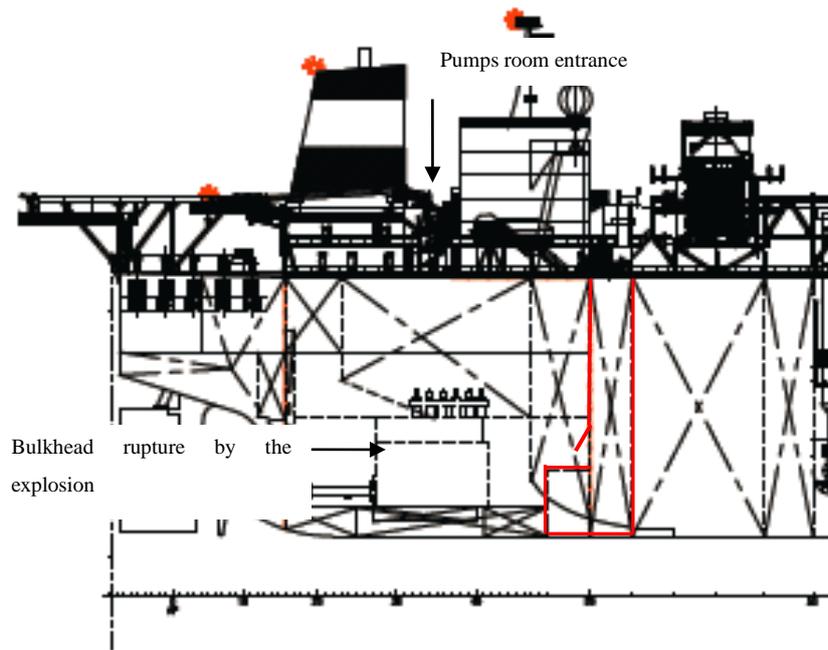
In the accident in question, the rupture of the bulkhead between the pump house and engine room caused the death of an operator in their meeting point in the engine room control room (ECR). In the upper deck, two people were injured seriously in their meeting point to be affected by pressure near the fast rescue boat.

The location of the ruptured bulkhead and access to pump room located on the upper deck of the installation are shown in Figure 130 and Figure 131, respectively.

Figure 130 - Indication of the pump house on the FPSO City of St. Mateus

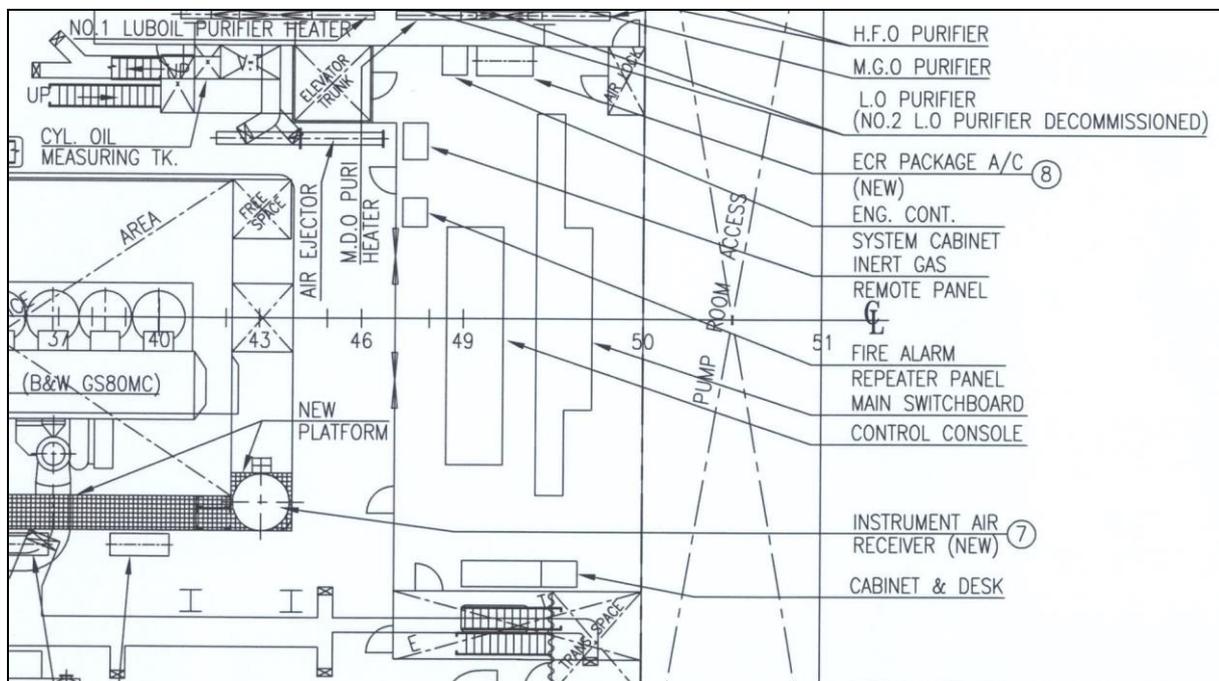
Figure 131 - Location of access to pump room in the upper deck installation

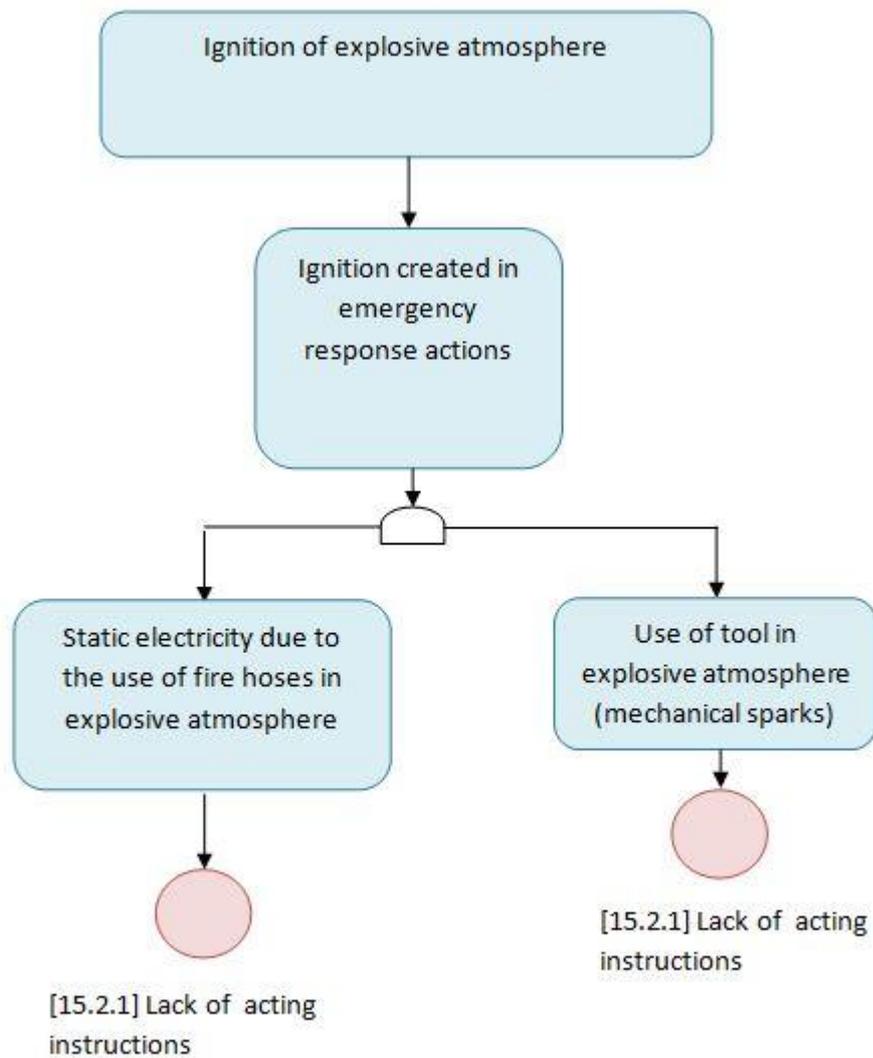
By the facts, it was concluded that the root cause for the ignition source of this accident was introduced by the action of people in potentially explosive atmospheres.

The Causal Factor called "ignition of explosive atmosphere" is shown in Figure 135 and its cause is presented below.

Figure 135 - causal factor # 7 - ignition of explosive atmosphere

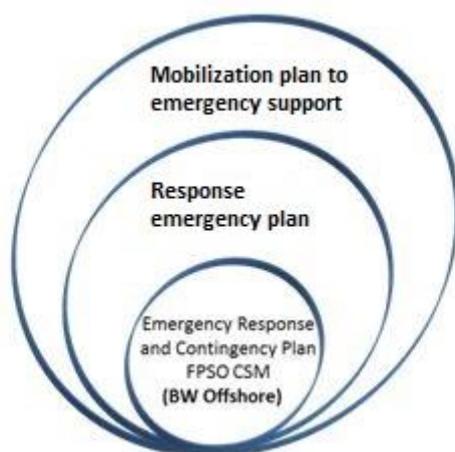
The emergency response structure previously established for the FPSO City of St. Matthew, which can be mobilized in the event of emergency, in order to define responsibilities and actions to be taken to the emergency control and mitigation of its effects, as it can be synthesized from Figure 136.

Figure 136 – Estructure of Response to Emergency

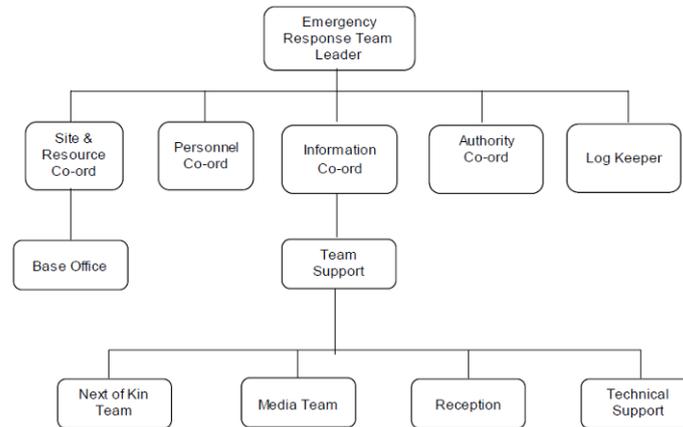
The response structure for the emergence of BW level 3 incidents is shown in Figure.

Figure 137 - Response Structure BW Offshore

Another point worth mentioning is that, considering the two response structures set up by the operator of the installation (Figure 137) and Petrobras (Figure 140), could not be identified to establish an interface between the two structures that demonstrate a systematic action joint between the two companies to manage the crisis.

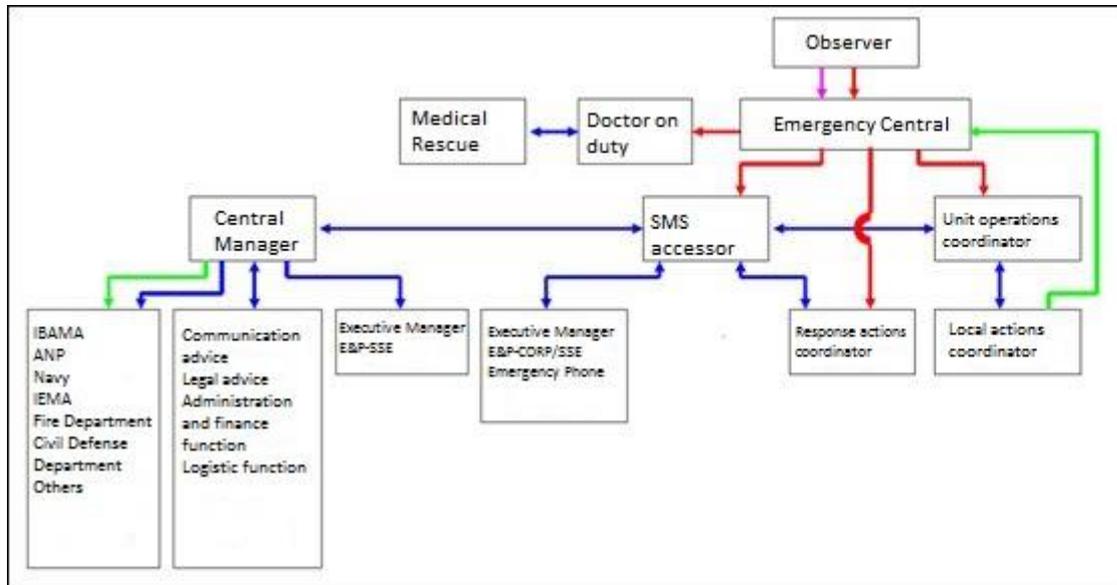
Figure 139 - Flowchart of Communication - structure should be established during an accident

In addition, as can be seen in Figure 140, Unit Operations Coordinator function is not included as part of the EOR and the PRE OU-ES does not provide the definition of who should exercise this function, only consisting on such attribution in the structure of communication of the accident (Figure 139). However, it was observed that the Operations Coordinator of the FPSO CDSM attended the EOR in managing the accident on 02.11.2015.

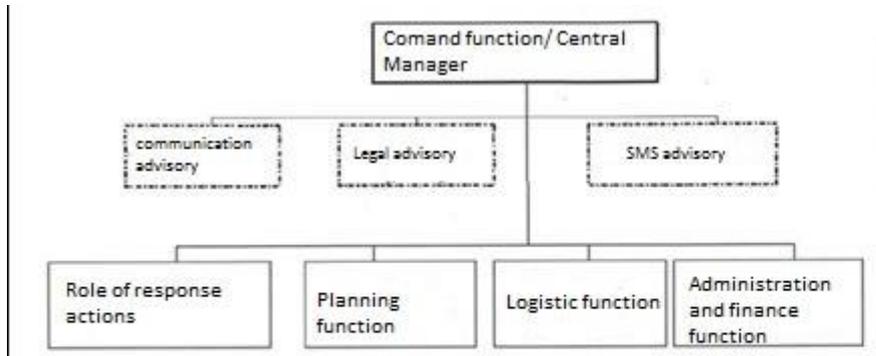
Figure 140 - Communication Flowchart - organizational structure of response should be triggered

However, it was observed that in Figure 140 is not in the role of the Integrated Operations Coordinator (CIOP), although it provided the actuation by the Emergency Call Center and it has been triggered during the emergency of the day 02.11.2015.
