Safety Alert 017 - ANP/SSM

Deck Boiler Overheating

This Operational Safety and Environment Superintendence alerts the oil and gas industry and other stakeholders about Deck Boiler Overheating in FPSO.

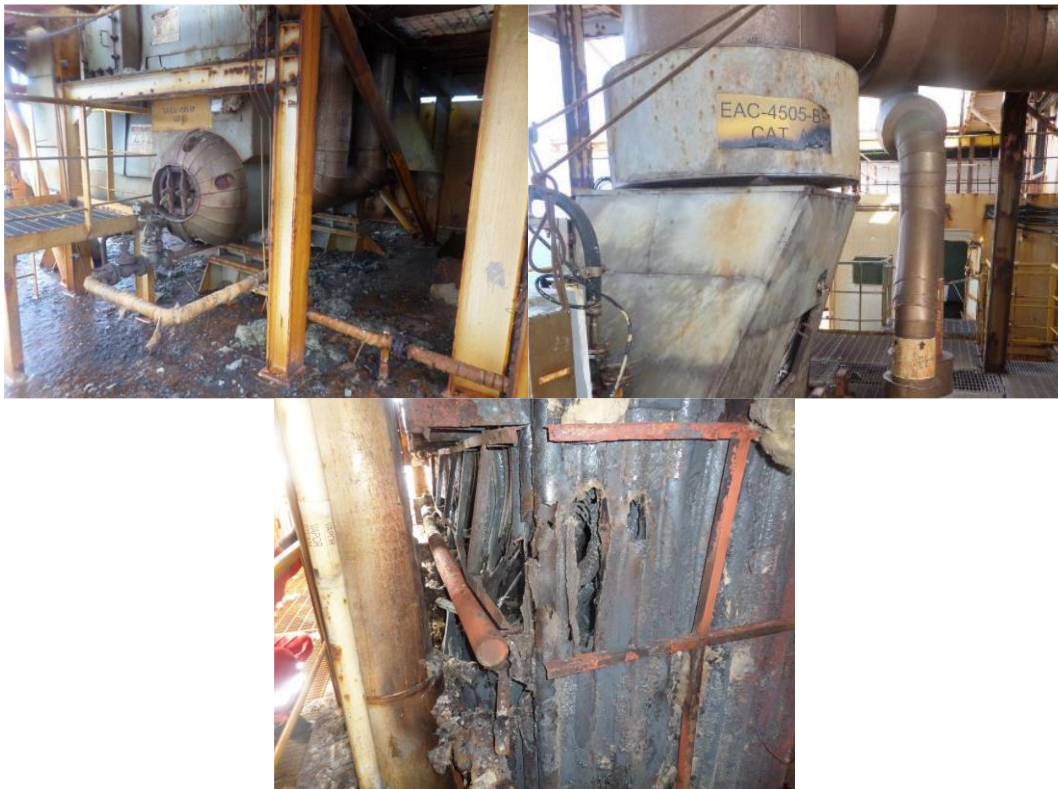
Boiler overheating induced by lack of water inside it. The equipment was supplying steam to the charge pumps turbine. The lack of water occurred due to possible damage to the boiler pipes, bringing water from the pipes to the oven. Once the water level decreased, the steam pressure and the temperature of the combustion gas increased: the pressure reached the set point of the PSVs, being limited to 17 barg, while the temperature reached values that were sufficient to melt the metal of generating tubes and the wall of the boiler membrane. The smoke detectors triggered the platform's general alarm and the temperature reduction of the equipment and adjacent areas occurred about 30 hours after the start of detection. There were no casualties.

Images of the damaged boiler.

- Failure in Management of Mechanical Integrity:
 - Inspection method used was not able to identify the entire length of the boiler pipes, causing the non-inspection of structures with less thickness that collapsed in the event;

- the quality of the water used was outside the parameters for a long period, contributing to the wear of the boiler tubes;
- Failure in Management of Change - the high-high pressure switch setpoint was not reduced as suggested change due to poor boiler integrity, making impossible for it to work in a way that cuts off the gas supply);

- Ensure that inspections take place in accordance with the requirements of NR-13 and its good practices;
- Ensure that all boiler components comply with the maintenance philosophy;
